FIELD NOTES SUMMARY

Customer: City of Lynn (Goldfish Pond)

Site Location: Lynn, Massachusetts

Date: 5/10/22, 8:25 AM

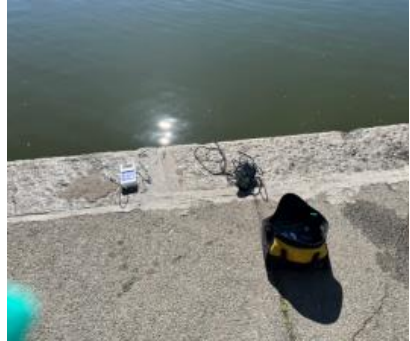
Basic water quality parameters were assessed on-site using calibrated meters (photo 3) and a Secchi disk (photo 5). The Secchi disk reading (which is a measure of water clarity) was roughly 1’6”, which was to the bottom around majority of the outer edge of the Pond. The pH resulted in 6.9, which is average for waterbodies in the northeast and is considered neutral. The dissolved oxygen was by no means excellent, but was sufficient to support fish and wildlife and was high enough to allow for treatment.

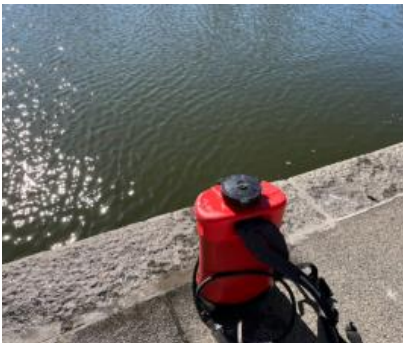
Based on the observed conditions, a treatment was conducted targeting microscopic algae (photo 4). EarthTec liquid copper sulfate formulation was applied to the Pond per label rates. The water temperature of the Pond has increased since the April visits, allowing for beneficial bacteria (photo 6) to be applied to the pond to help consume nutrients and muck/organic matter. These products help benefit water quality. There are no restrictions affiliated with either treatment.
