FIELD NOTES SUMMARY

Customer: City of Lynn (Goldfish Pond)

Site Location: Lynn, MA

Date: 6/6/22, 8:51 AM

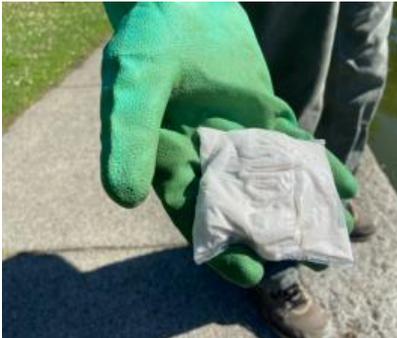
even coverage within the treatment areas. The product, EarthTec is also labeled as a bactericide. A beneficial bacteria/enzyme was also applied to the pond (Photo 1), as is the plan throughout the season. These bacteria products stimulate the breakdown of nutrient rich muck at the bottom of the pond, and also aid in breakdown of nitrogen and improvement of water clarity. There are no restrictions affiliated with either treatment.

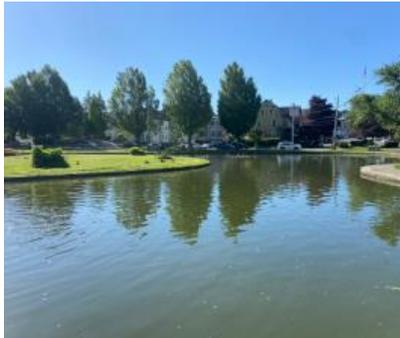
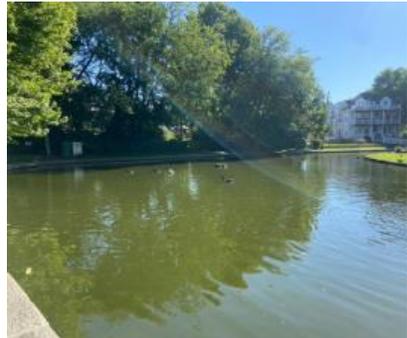
Photos

Upon arrival, a survey was conducted using visual observation. There was a microscopic algae bloom, which as a result creates poor water clarity. In addition, there was pollen on the surface of the water. The aeration system was inspected and was running well. The fountains were all off, we are unsure if these were intentionally turned off due to high winds, as this sometimes occurs at Goldfish Pond.

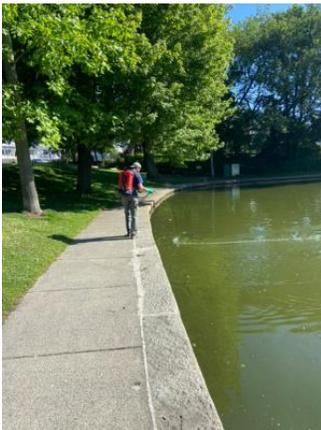
Based on the survey, a treatment was conducted for the control of microscopic algae. The algaecide was applied using a calibrated backpack spray applicator (Photo 4). This application methodology allows for
