## FIELD NOTES SUMMARY

**Customer:** City of Lynn (Goldfish Pond)

**Site Location:** Lynn, Massachusetts

**Date:** 8/22/22, 10:05 AM

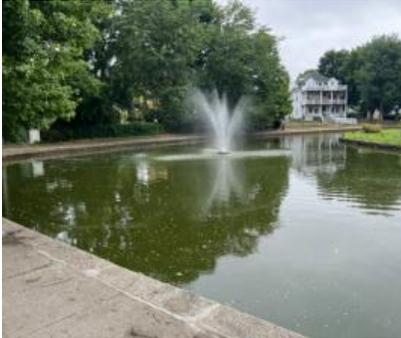
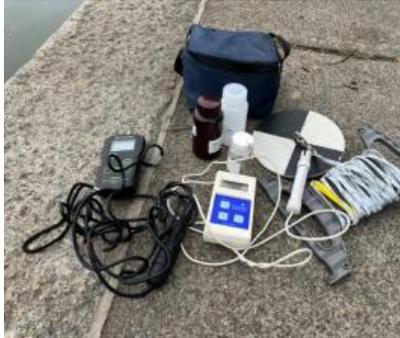
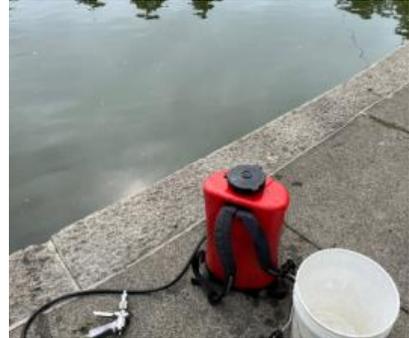
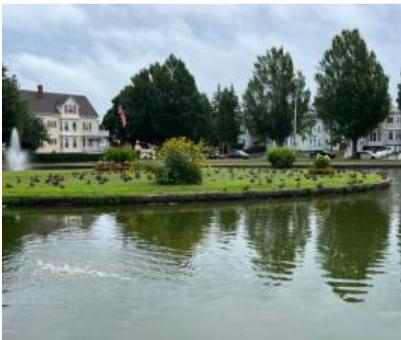
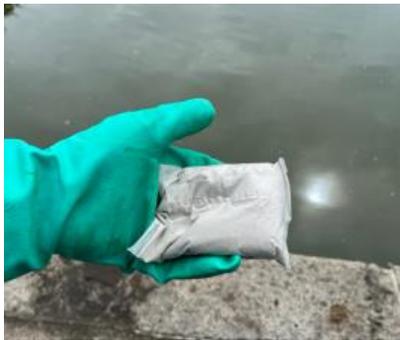
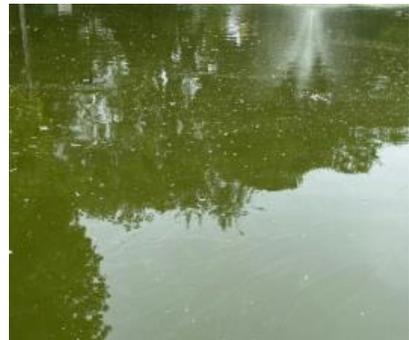
**Photos**

Upon arrival, a survey was conducted using visual observation paired with a standard throw-rake, as applicable. There was a dense microscopic algae bloom occurring throughout the Pond. This was visible throughout the water column and on the surface. The algae bloom coincides with the green color of the Pond. Numerous waterfowl were observed within the Pond and on the island. There was a large amount of geese/duck feces noted on the walk way around the Pond. All fountains and aeration were inspected and were functioning well.

Based on the survey, a treatment was conducted for the control of microscopic algae. Liquid algaecide was applied using a calibrated backpack sprayer. This application methodology allows for even coverage within the treatment areas. Bacteria packets were also applied to help increase the breakdown of muck/organic matter on the bottom of the Pond, and to assist with the control of nutrients fueling algae blooms. There are no restrictions associated with this treatment.
