## FIELD NOTES SUMMARY

**Customer:** City of Lynn (Goldfish Pond)

**Site Location:** Lynn, MA

**Date:** 9/21/22, 9:40 AM

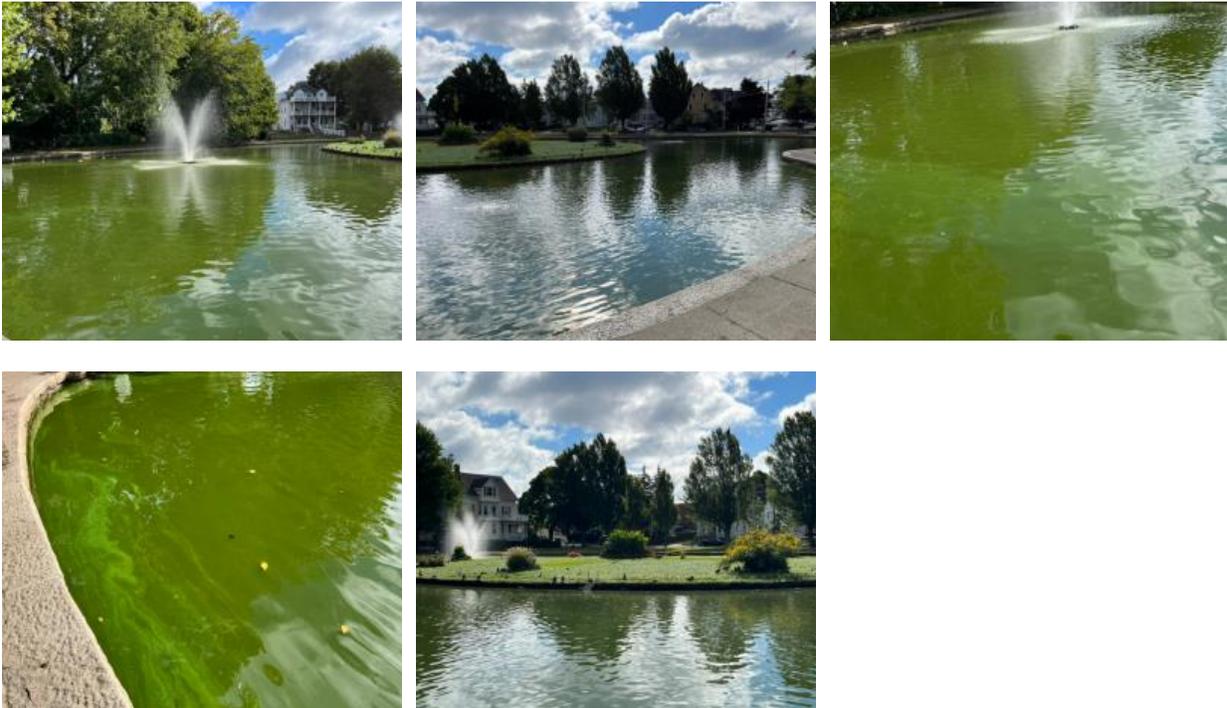
### Photos

Upon arrival, a survey was conducted using visual observation paired with a standard throw-rake, as applicable. A microscopic algae bloom was documented throughout the Pond, both visible throughout the water column and on the surface. It was particularly visible on the surface against the wind-blown shorelines. Two out of the three fountains were on, and the aeration unit was working per normal. Several flocks of waterfowl were documented around the Pond and within the Island. Sparse waterfowl fecal matter was documented along the walking path surrounding the perimeter of the Pond.

As planned, and based on the survey, a treatment was conducted for the control of microscopic algae. The liquid algaecide was applied using a calibrated backpack sprayer. This application methodology allows for even coverage within the treatment areas. There are no restrictions associated with this treatment. Bacteria packets were also applied to help increase the breakdown of sediment/organic matter. We have treated Goldfish Pond each and every visit during the 2022 season for the control of the persistent algae, driven by high phosphorus, waterfowl, etc.
