## FIELD NOTES SUMMARY

**Customer:** City of Lynn (Goldfish Pond)

**Site Location:** Lynn, Massachusetts

**Date:** 9/7/22, 8:05 AM

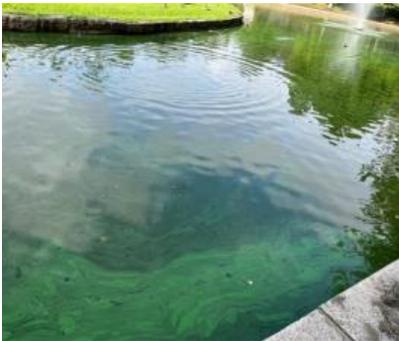
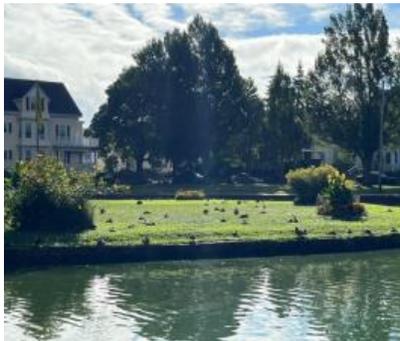
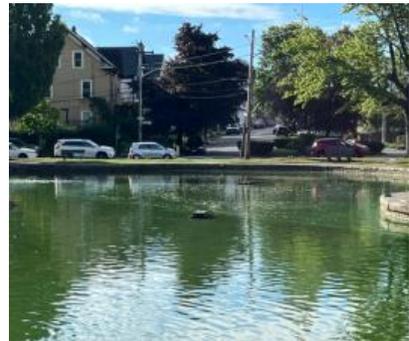
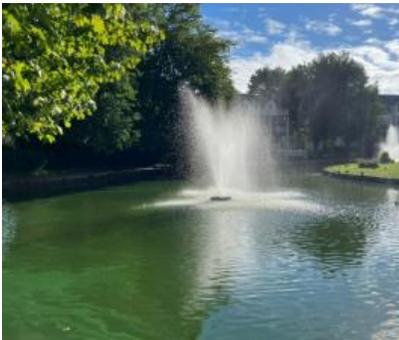
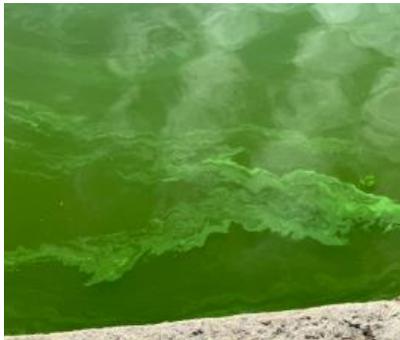
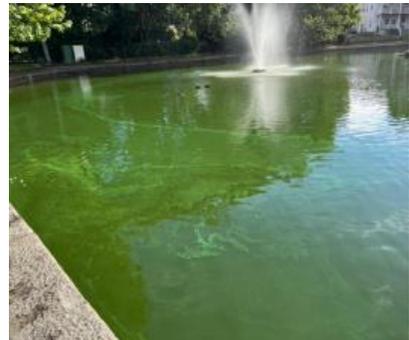
**Photos**

Upon arrival, a survey was conducted using visual observation paired with a standard throw-rake and handheld, as applicable. There was a dense microscopic algae bloom documented throughout the Pond, both visible within the water column and observed on the surface. The Pond is green in color as a result. An algae sample was collected and transported to the lab for further analysis. The aeration system were working per normal. One of the fountains was shut off, the other two fountains were working great. An estimated 50+ waterfowl were noted on the island of the Pond, as well as an excessive amount of waterfowl feces located on the walkway around the Pond. No vegetation was documented.

As planned, a treatment was conducted for the control of microscopic algae. The liquid algaecide was applied using a calibrated backpack sprayer from the perimeter of the Pond. This application methodology allows for even coverage within the treatment areas. There are no restrictions associated with this treatment. Half of the Pond was treated per label. Bacteria packets were also applied to the Pond, which helps increase the breakdown of muck and organic debris. We have treated Goldfish Pond every visit during the 2022 season to try to maintain conditions against the persistent algae. We are aware that there is an event at the Pond this upcoming weekend and are happy we were able to come out to treat several days before.
