1967 Kaiser Ambulance Jeep...BY M. KATZBURG

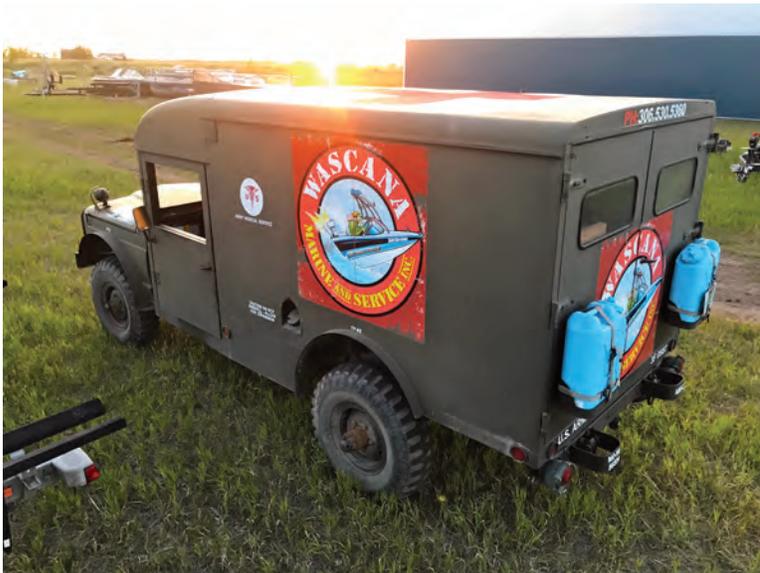
Looking it over revealed a clean body with no rust, original paint and fresh Ambulance badging. Opening up the doors revealed a very clean cab and bunk area. All great so far. I lifted the hood to find an original 230 Tornado straight Six overhead cam engine, 24 volt wiring and an engine bay clean of all extra's other than what it takes to move from point A to B.

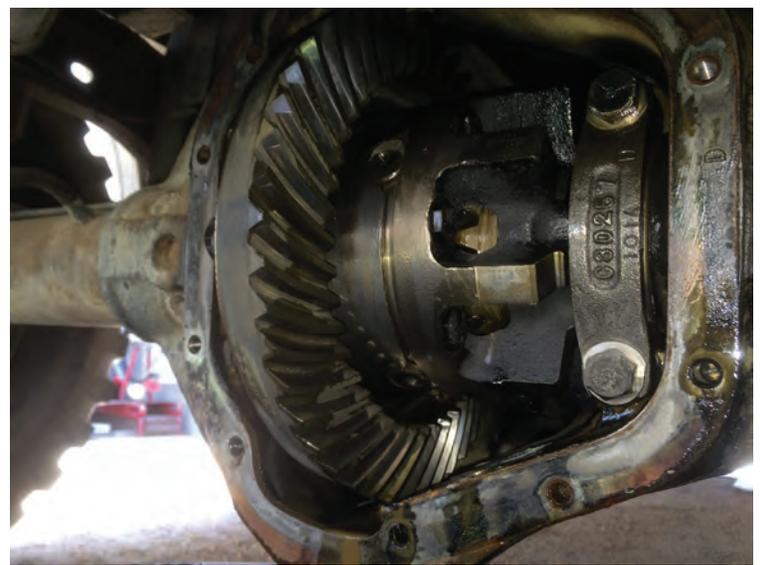
I jumped in and fired it up instantly. I was surprised how well the Overhead Cam Engine ran. It did smoke but there is medication for that. A few minor oil leaks that showed years of dirt on it.

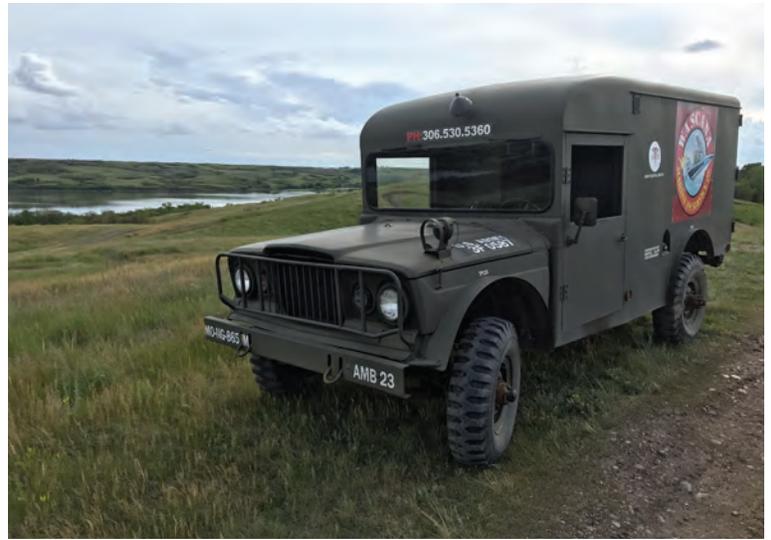
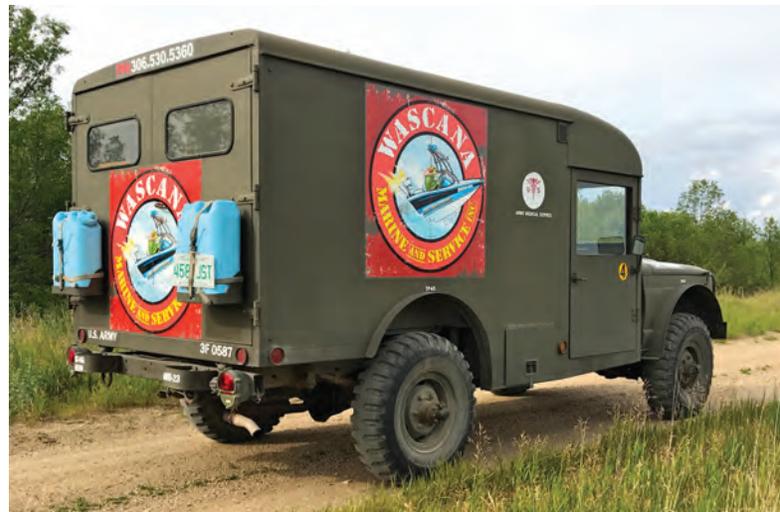
The spark plugs are of the waterproof design with wires that screw onto the plugs and distributor. A little difficult to remove but still accessible with a simple combination wrench and ratchet. While removing the plugs, I found two that were loose. Cleaning them and retorquing went a long way in solving the bad miss the engine had. I replaced the plugs A year later with new Autolites I discovered a marked improvement on power. The 5.88 gears now allow the six to climb any hills that the truck may encounter. No downshifting required climbing hills. Once the snow had melted and I got under the

M725 to replace all the fluids. The axles were clear of rust. Something I was warned of because of the water that many had been driven in. The engine greatly reduced the smoking with fresh oil and fires with a lot more power from the new plugs. The antifreeze looks normal now with the leaves removed from the rad and fresh fluid.
