## **Featured Technical Topic Summary** **FGI Monthly Members Meeting** **Friday, May 1, 2025**

### **TOPIC: Subgrade Drainage, Venting, and Possible Ballasting**

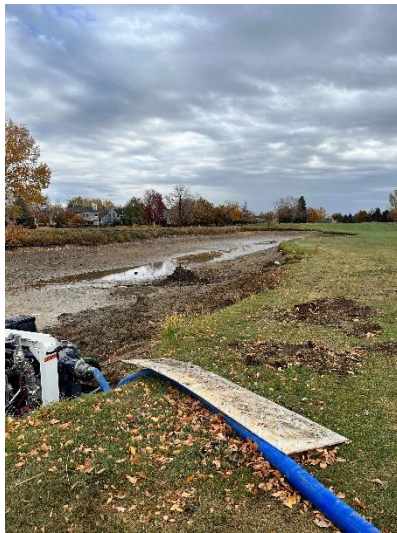
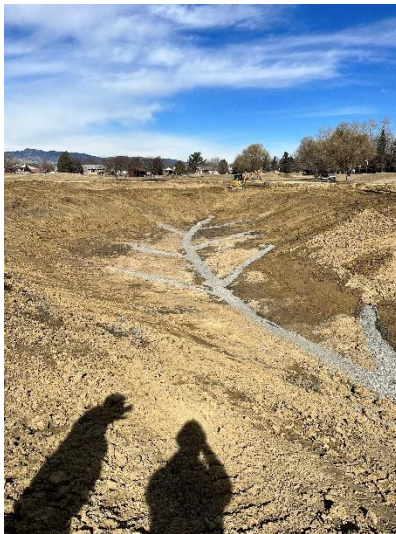
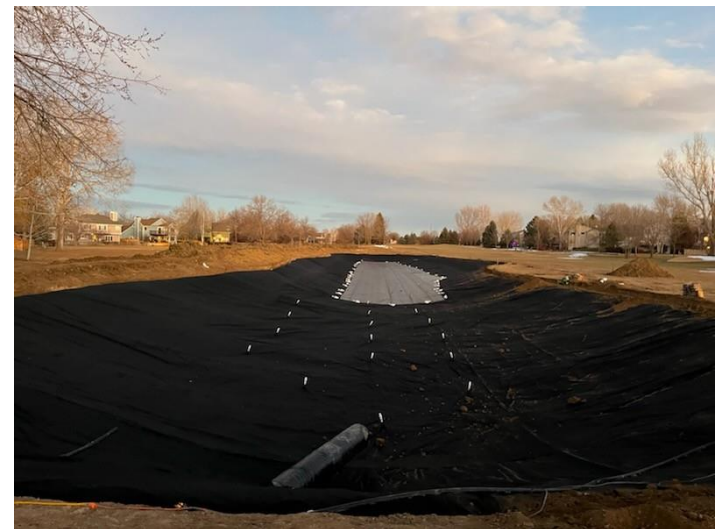
- Pat showed a photo with a groundwater collection trench along the bottom of water containment facility with a pump to recycle the water back into the reservoir (see photo below). This photo shows groundwater build up with 4 to 6" in the bottom of the pond (see photos below)

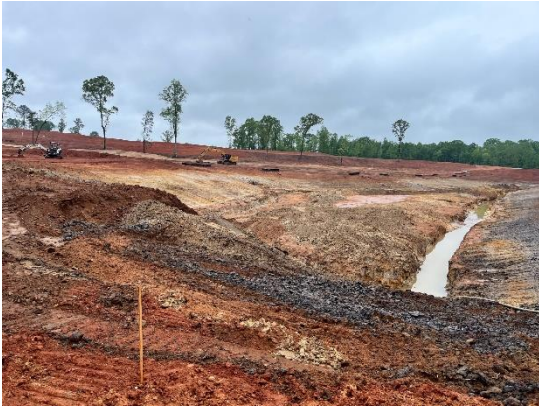
- Pat showed an underdrain system with branches and one-way check valves installed through a geomembrane to dissipate groundwater pressures if they build-up below the geomembrane

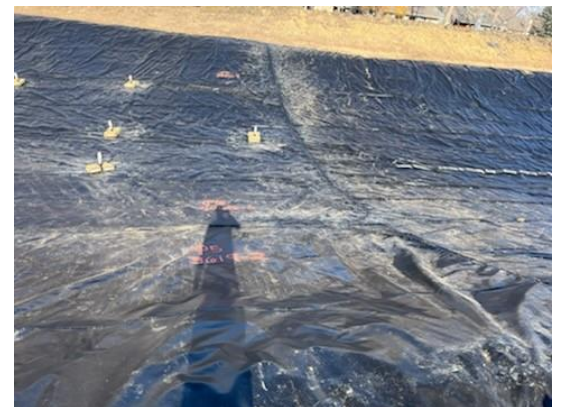
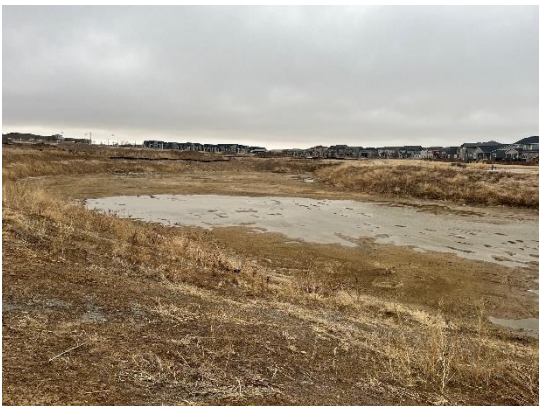
- 
- Annette Dehavilland showed a photo of groundwater seepage from sandy glacial till, which is usually solved with an under drain
  - Another photo showed groundwater bubbling up into subgrade and the selected repair was just placing fine-grained soil over the spring, which did not work

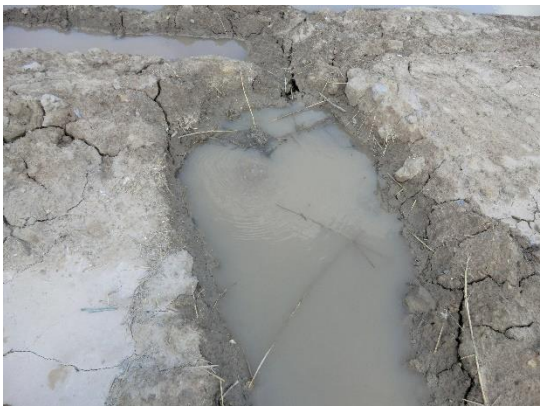
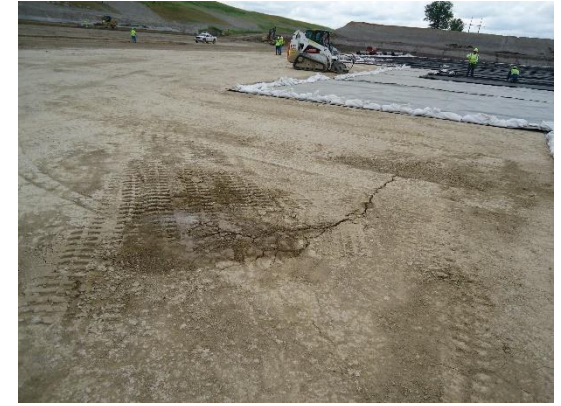
- Another photo showed piping of subgrade materials due to a leak in an adjacent geomembrane
  - Another photo showed seepage underneath an unreinforced geomembrane-backed GCL, which resulted in hydration of the bentonite in the GCL and slope movement – excess pore-water pressures developed under the geomembrane due to rapid placement of heavy relocated waste – water squeezed out of the compressible subgrade and hydrated the GCL leading to slope movement – no drainage was installed prior to installation of the geomembrane-backed GCL.

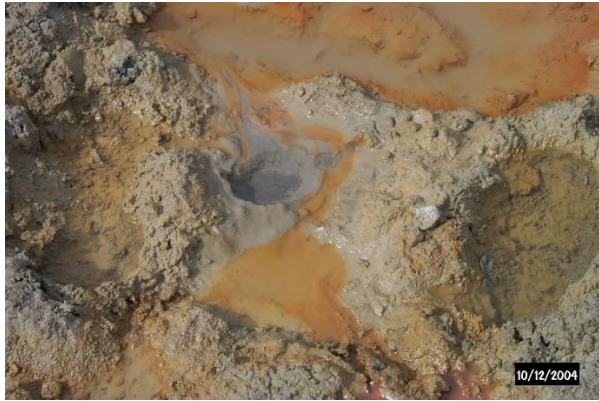
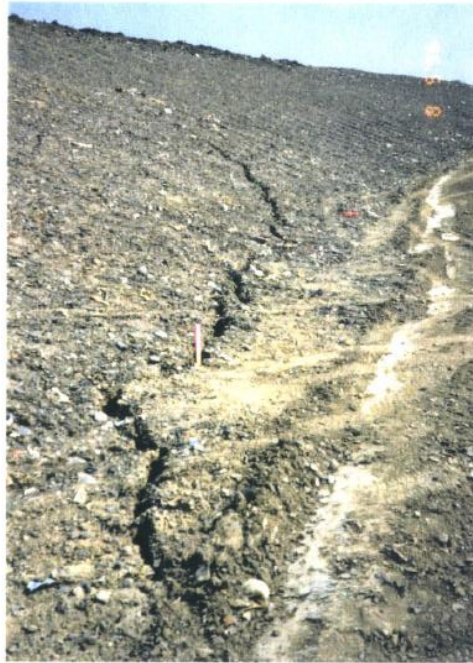
- Brain Fraser started the venting discussion with a project involving gas under a geomembrane at a food processing plant in Central California – The project involved a 60 mil HDPE geomembrane that was used to line a pond. The HDPE geomembrane could not withstand the elongation caused by the ballooning, which caused yielding of the geomembrane. The repair involved installing a geosynthetic drainage composite and vent strips under a new LLDPE geomembrane.
- Tim showed a video of an agricultural wastewater pond lined with an HDPE geomembrane. The video shows a number of bubbles/whales in the pond probably due to use of aerators/agitators. The teleconference attendees agreed the repair would probably consist of dewatering the pond, installing local vents, which

usually are not effective. The recommended repair would include dewatering the pond, removing the geomembrane, excavating all of the contaminated soil, giving the pond bottom a slope, installing a gravel vent layer over the entire pond bottom, installing a new double-sided drainage composite, and a new overlying flexible geomembrane.

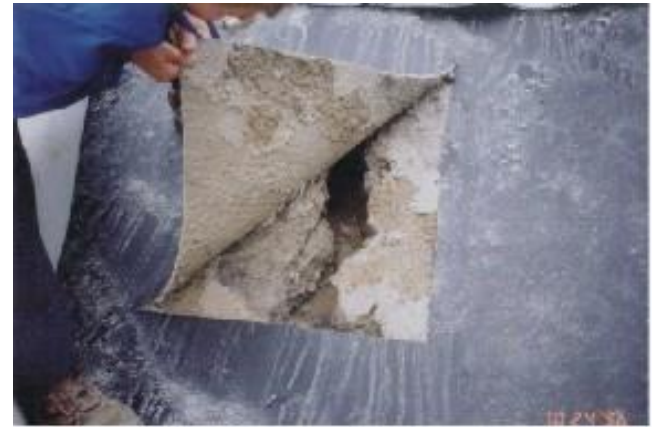
- It is recommended that a vent be installed at the top of the slope to vent the drainage composite via drainage composite strips up the pond side slope – the vent consists of a screen with part of a PVC pipe over top of the screen to prevent rodents and debris from clogging the vent. These vents should be installed every 50 ft. The drainage composite strips or wrapped flat pipe are placed every 30 ft – vents should be kept clean of soil and vegetation.
