Featured Technical Topic Summary FGI Monthly Members Meeting Friday, April 4, 2025

TOPIC: Hail Damage and Extreme Weather Installations

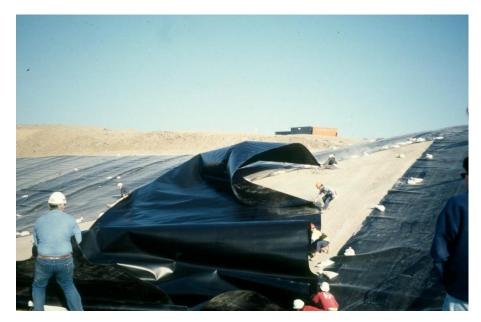
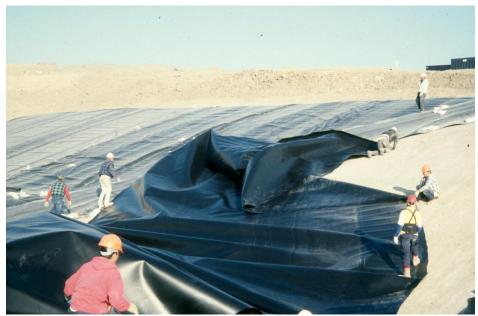
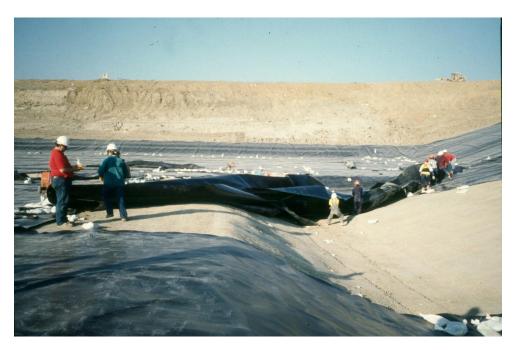
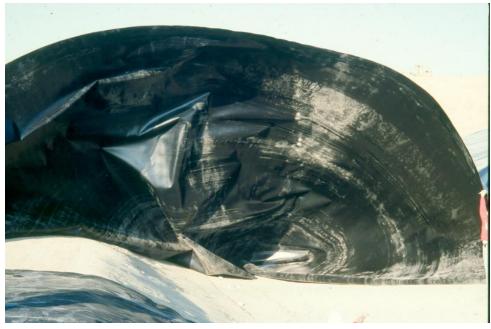
- Can use Welding Tents that are heated and prequalify welds at room temperature
- Material is hardening due to cold temperatures
- Tim Stark also showed photos of wind damage (see photos below)

- Wind Quiz?
- Remove the sheet? Yes or No?
- Yes remove sheet because geomembrane is creased, which can stress crack because unreinforced
- Any material (HDPE, LLDPE, fPP, PVC) lost in the wind should be tested and possibly replaced

- If displaced and flapped in wind, must prove GM is still viable most likely remove that sheet
- Can never have too much ballast Ballast design is important GOOD Webinar Topic

- Wind whipped geomembrane was left in now has gas migration problem
