157 E 72ND STREET

157 E 72ND STREET NEW YORK, NY 10021

LANDMARK: UPPER EAST SIDE HISTORIC DISTRICT EXTENSION

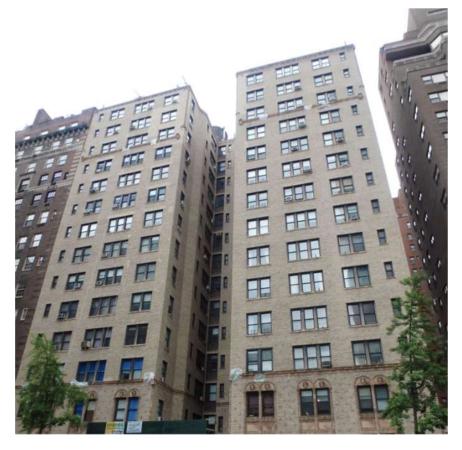
HISTORICAL EXTERIOR RESTORATIVE WORK: Many of the decorative terra-cotta block window enframements and band blocks had been cracked or chipped over time. The deteriorated elements were replaced with caststone replicas to match the original appearance. A two-part stain with applied paint flecks was used by the manufacturer to match the speckled variated tone of the original terra cotta blocks. In addition, cutting and pointing of brick masonry joints, replacement of cracked face brick, and replacement of deteriorated window lintels was completed at all sides of the building to bring it into compliance with FISP regulations.
