CLUBHOUSE ROOF OVER POOL AREA

**Subject:** Re: Rainbow Bend Clubhouse roof investigation

# Roof Replacement Proposal

Roof Damage Pictures over Clubhouse Pool

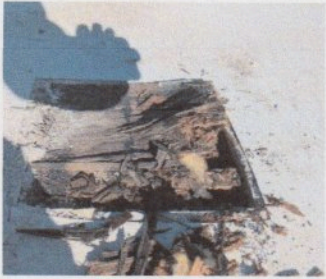
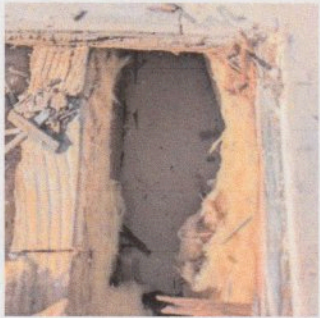
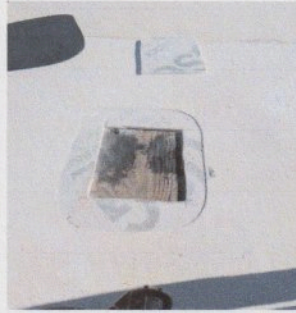
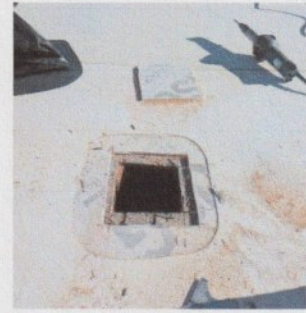
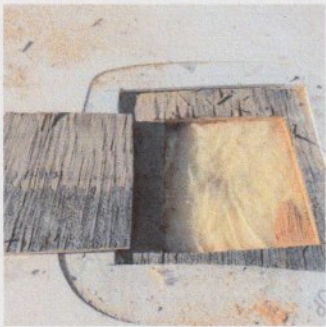
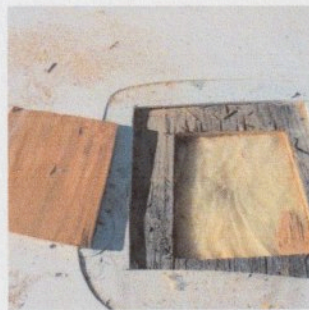
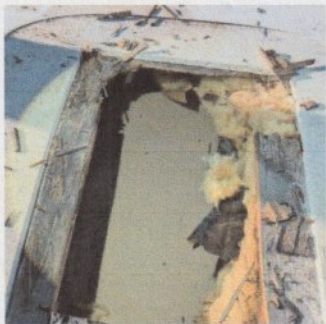
1. The decking is definitely rotted but the condensation is occurring on the underside of the membrane and is damaging the plywood from above.
2. Essentially, the warm air from inside is beading water on the backside of the roof membrane and absorbing in the plywood and rotting it.
3. The roof needs insulation at the very least and we recommend a vapor barrier to further protect the temperature difference.
4. Attached is a proposal to remove all the roofing. There is an option to add vapor barrier which we recommend and to replace the wood decking.
5. I have a combined price for the entire roofing system, vapor barrier, Insulation, and PVC that I really recommenand to replace the wood decking.
6. I have a combined price for the entire roofing system, vapor barrier, Insulation, and PVC that I really recommen
7. Likely you will need to replace all the decking.
