Rainbow Bend Homeowners Association

Full Reserve Study

Prepared for Year: 01/01/2026 - 12/31/2026

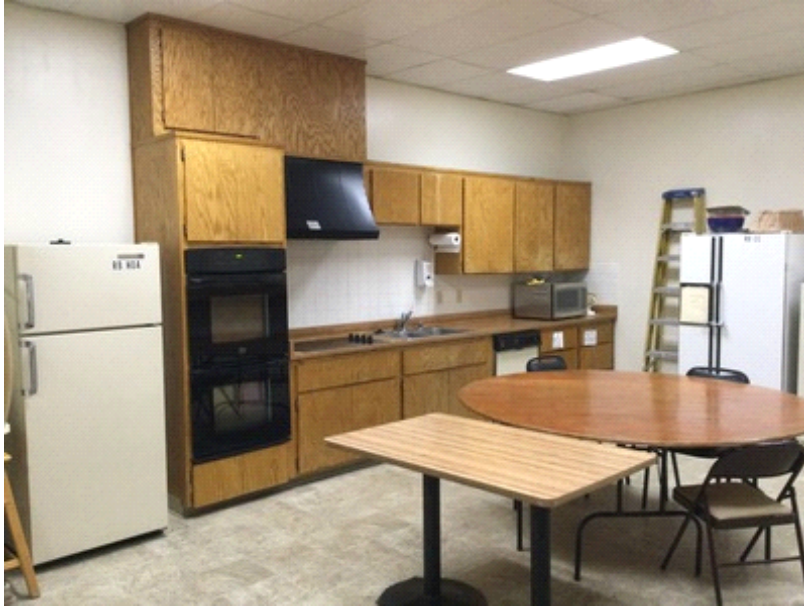
The Clubhouse Kitchen Renovation and Furniture Replacement has been included in the reserve study. The cost and useful lives were provided by the board of directors.

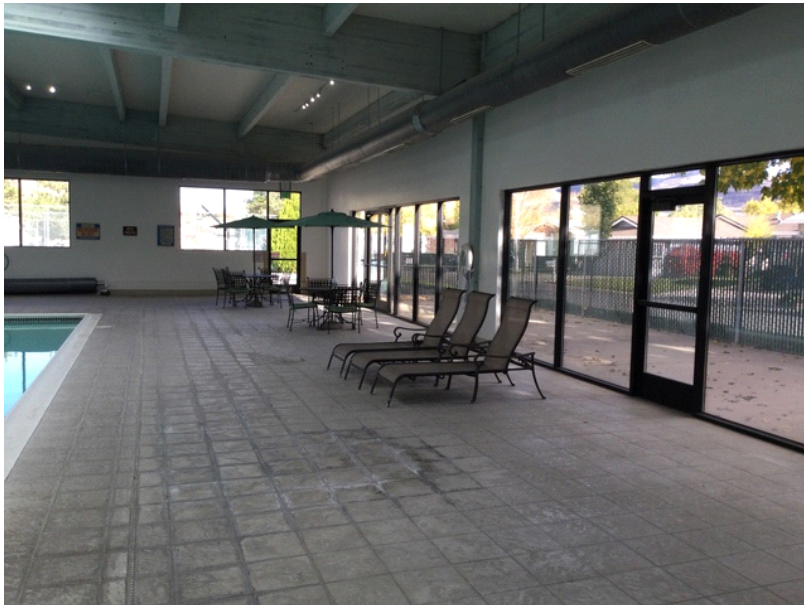
The Pool Area Renovation is being completed in 2025. The many components will have a "like new" estimated useful life. The costs are based on actual bids and invoices presented by the vendor.

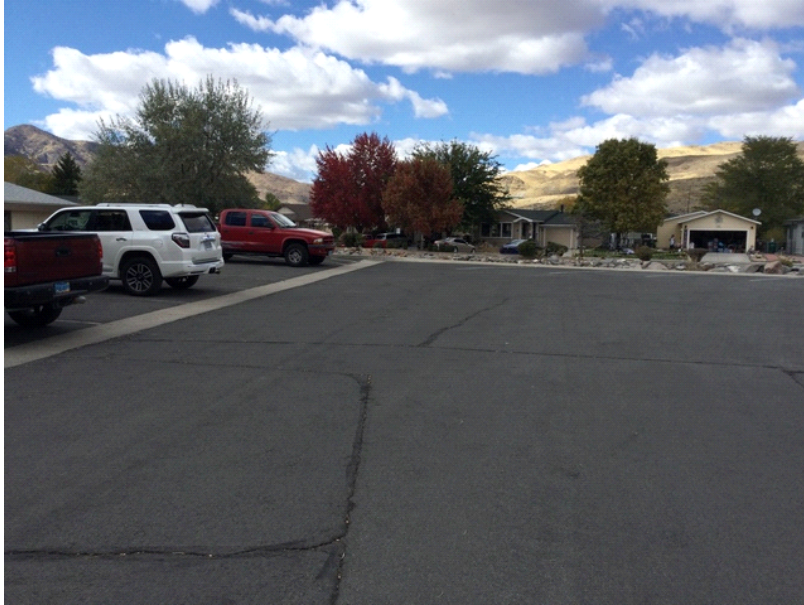
The asphalt parking lot maintenance schedule includes surface maintenance treatment, crack seal, overlay, cut and patch and striping.

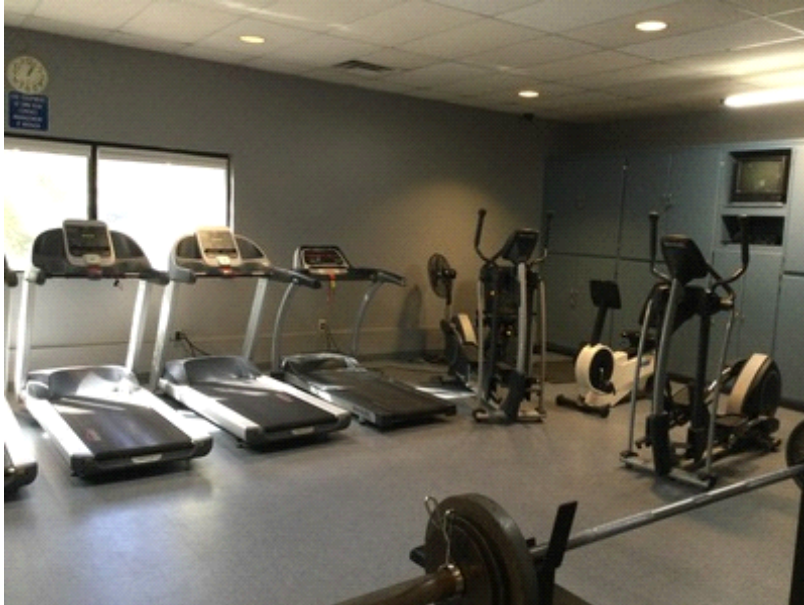
Complete replacement of the exercise equipment has not been scheduled. Instead, replacement is scheduled to be done as needed, through an allowance.

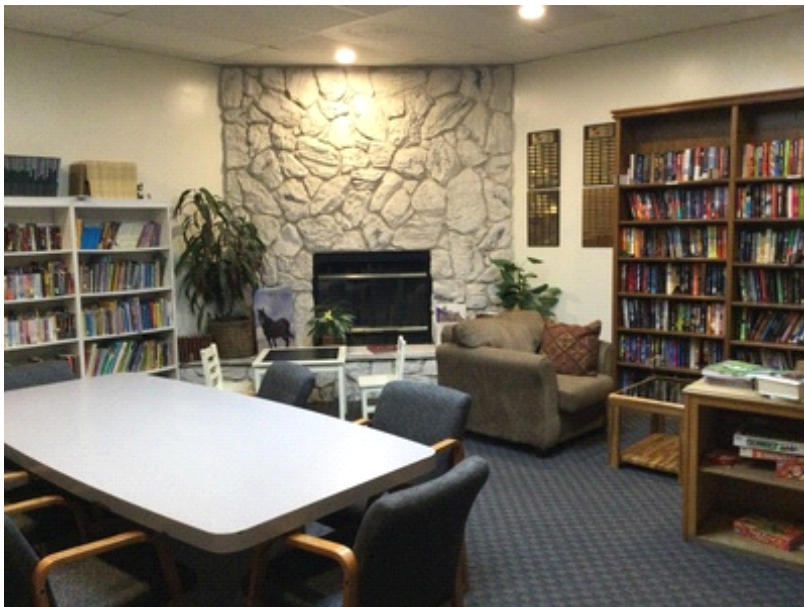
The Clubhouse Interior Components include Flooring, Painting, Furnishings, Pool Area Renovations, Lighting, Heating and Equipment. The costs and useful lives of each component were provided by the Board of Directors.

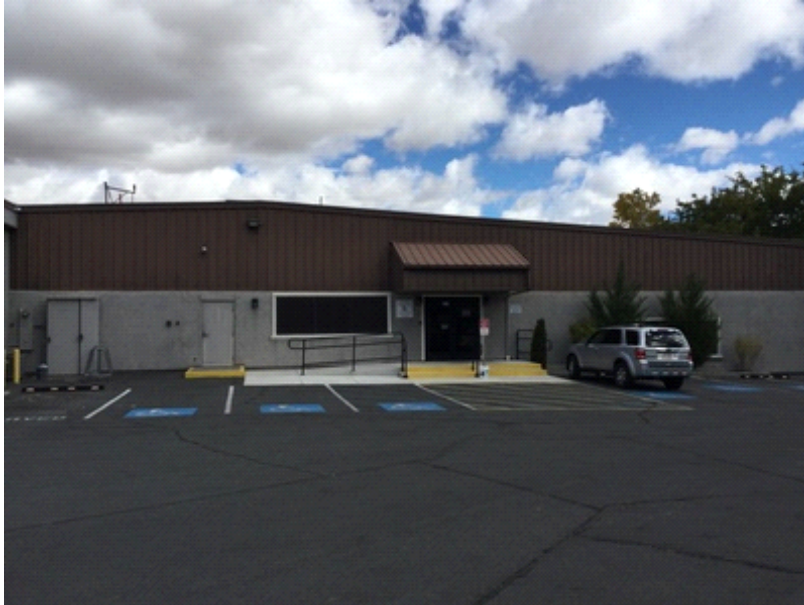
The Clubhouse Exterior Components include Painting, Roof Replacement and Repairs, Windows and Doors. The costs and useful lives of each component are an estimation only.

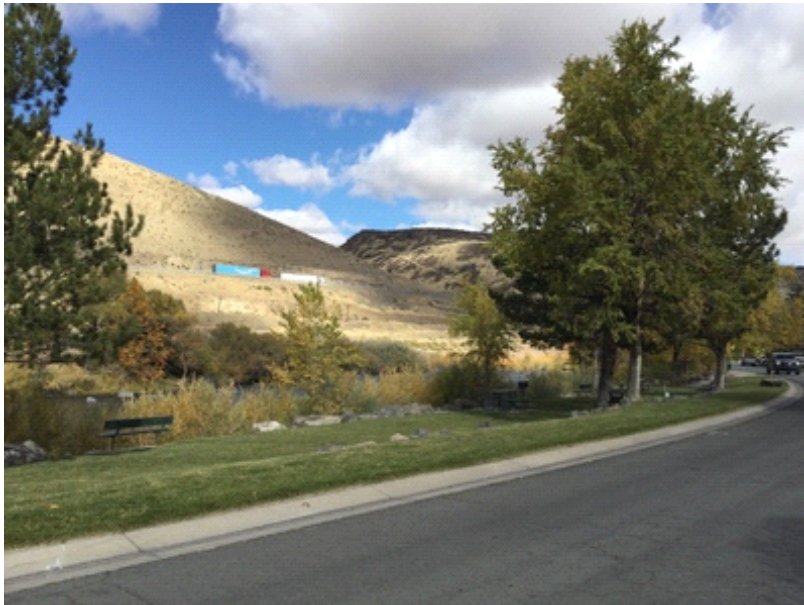
The association is well maintained and in overall good condition.

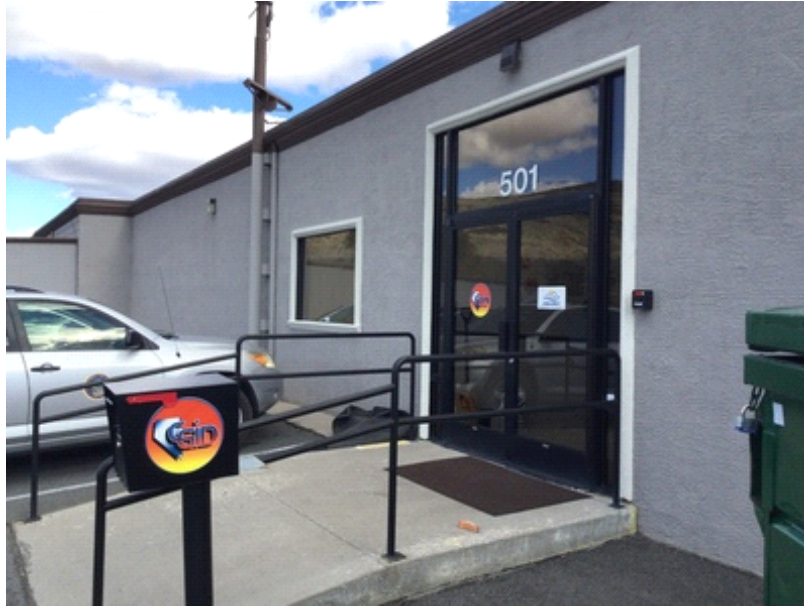
Building Exterior

8.	Lot A & B Painting and Repairs	2040	allowance	\$10,300	\$10,300	15	15
9.	Lot A & B Roof Replacement	2038	4570 sq ft	\$15.40/sq ft	\$70,378	13	20
10.	Painting Exterior	2032	all	\$41,200	\$41,200	7	15

11.	Roof Inspection and Repairs (Done 2025)	2025	allowance	\$5,200	\$5,200	0	5
12.	Roof Replacement	2037	29951 sq ft	\$2.58/sq ft	\$77,273.58	12	20

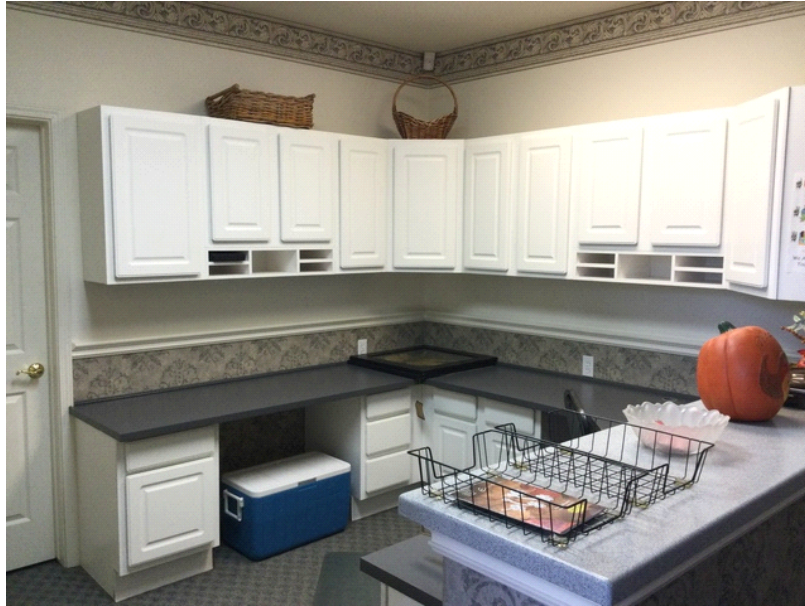
Building Interior

Component	Year Scheduled	Unit of Measure	Cost Per Unit	Today's Cost	Estimated Remaining Useful Life (Years)	Estimated Life When New (Years)
1.	Lot A & B Electrical and Lighting	2030	allowance	\$2,600	\$2,600	5	5

Component		Year Scheduled	Unit of Measure	Cost Per Unit	Today's Cost	Estimated Remaining Useful Life (Years)	Estimated Life When New (Years)
13.	Lot A & B Water Softener System (Done 2024)	2034	as needed	\$6,300	\$6,300	9	10
14.	Lot A & B Windows and Doors	2040	as needed	\$11,300	\$11,300	15	30

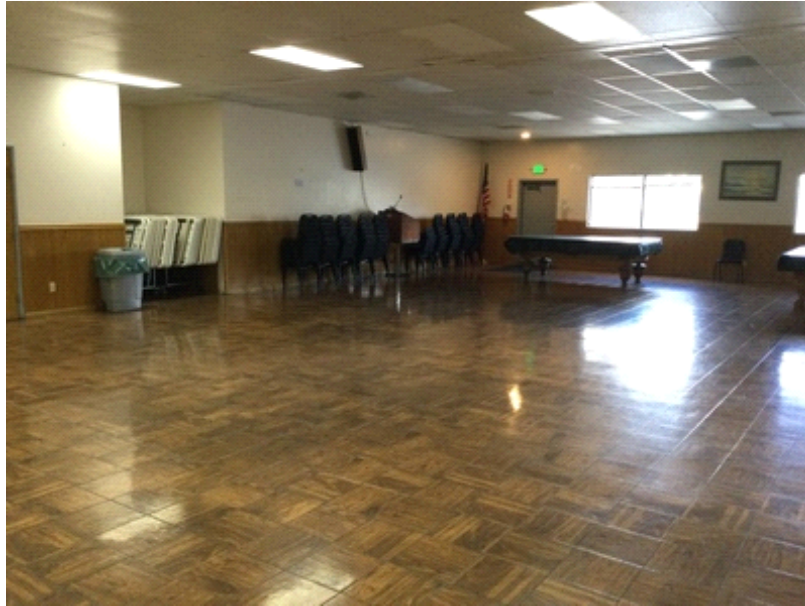
Clubhouse

Component	Year Scheduled	Unit of Measure	Cost Per Unit	Today's Cost	Estimated Remaining Useful Life (Years)	Estimated Life When New (Years)
1. Art Work and Decorations	2030	as needed	\$3,100	\$3,100	5	5

Component		Year Scheduled	Unit of Measure	Cost Per Unit	Today's Cost	Estimated Remaining Useful Life (Years)	Estimated Life When New (Years)
44.	Windows and Doors Replacement	2039	as needed	\$33,000	\$33,000	14	30

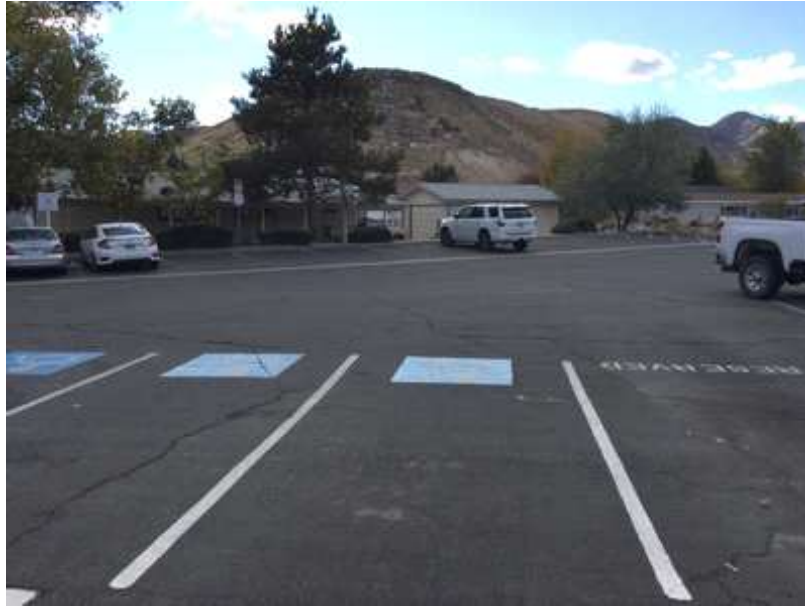
Parking Area

Component		Year Scheduled	Unit of Measure	Cost Per Unit	Today's Cost	Estimated Remaining Useful Life (Years)	Estimated Life When New (Years)
1.	Concrete Drainage Swale	2034	as needed	\$16,400	\$16,400	9	30

Component		Year Scheduled	Unit of Measure	Cost Per Unit	Today's Cost	Estimated Remaining Useful Life (Years)	Estimated Life When New (Years)
16.	Surface Maintenance Treatment	2026	15385 sq ft	\$.38/sq ft	\$5,877.07	1	5

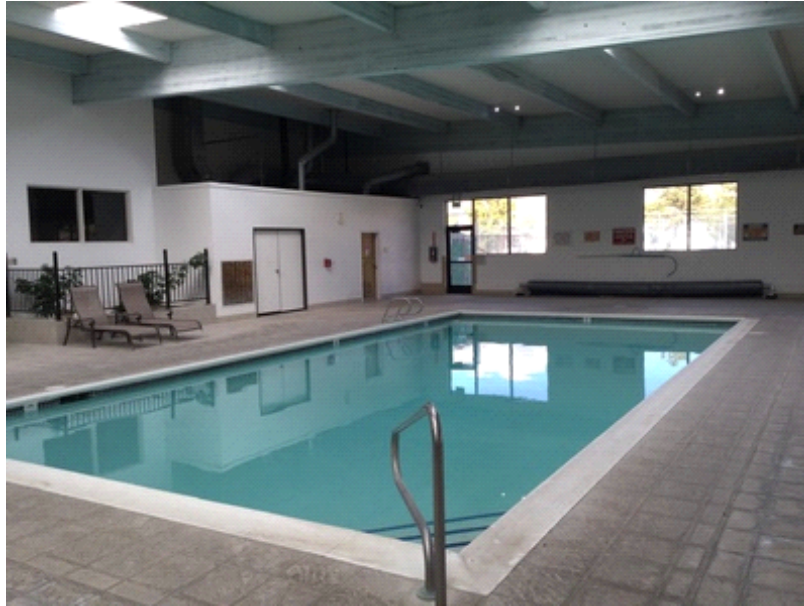
Pool Area

Component	Year Scheduled	Unit of Measure	Cost Per Unit	Today's Cost	Estimated Remaining Useful Life (Years)	Estimated Life When New (Years)
1. Deck Pavers Repairs	2035	allowance	\$5,000	\$5,000	10	10
