Verifying Di-electric Testing on Insulated Boom Trucks

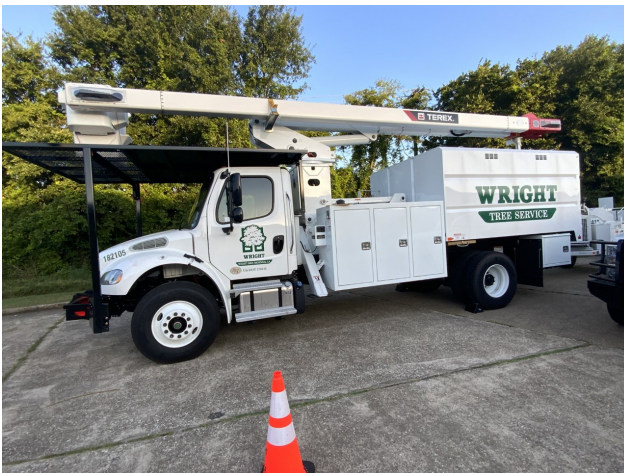
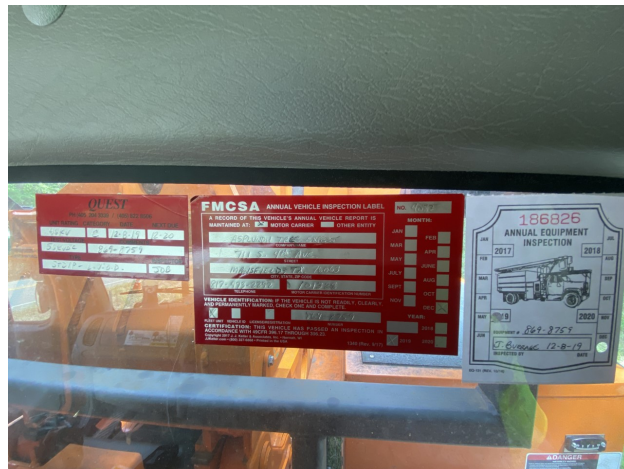
Where to look for verification of Di-electric Testing: Di-electric test stickers can usually be found in a few places. They are most often placed in the cab on the driver's side rear window. Sometimes they are also located on the side of the bucket or on the boom itself. See photo's below.
