# PROJECT: BEEF

LOCATION: HONEY BROOK, PA

COMPLETION DATE: NOVEMBER 2021

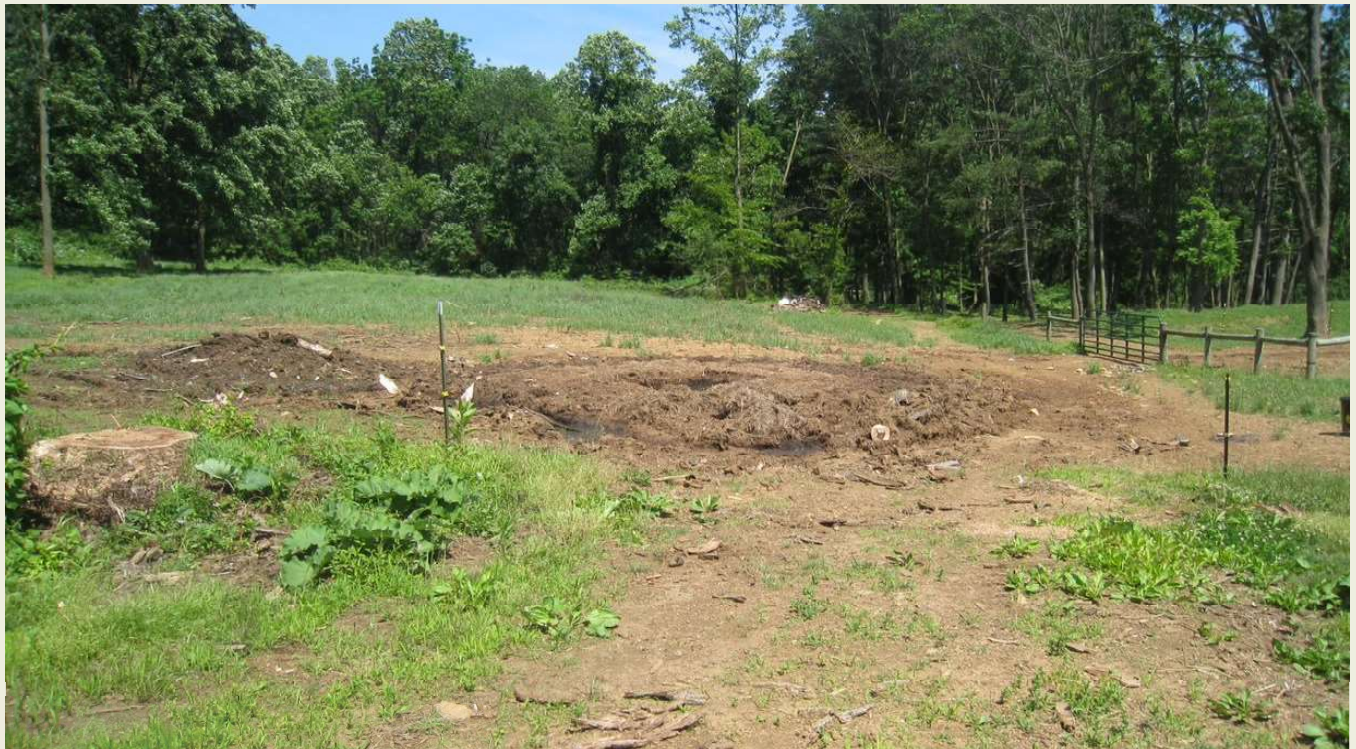
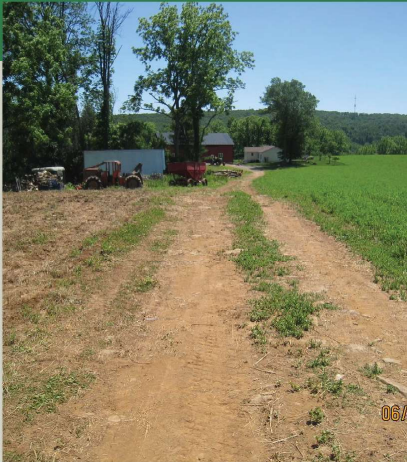
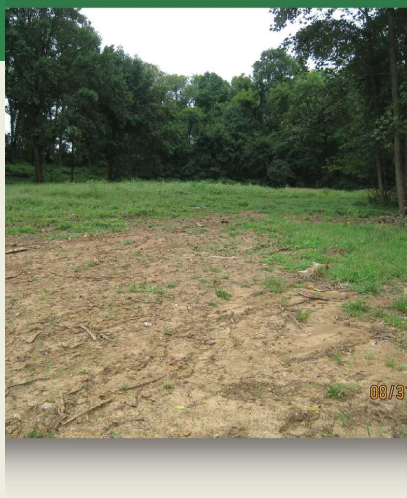
BEFORE

This project involved installing Best Management Practices (BMPs) on a beef operation with 13 cow/calf pairs. The farmer does an excellent job managing his pastures with a rotational grazing system, but lacked the appropriate infrastructure to properly manage the animals during times when they couldn't be on pasture (i.e. winter months). The cows were confined to a small area outside the barn, which was in the close vicinity of a stormwater basin. This Animal Concentration Area (ACA) was earthen, subject to erosion, and didn't allow for effective removal of accumulated manure.

- **Animal Concentration Area (ACA)**
  - Earthen, subject to erosion, hard to remove manure, too close to stormwater basin
- **In Field Manure Stacking**
  - In natural drainage area, lack of vegetated treatment area, pervious surface

- **Roofed Concrete Barnyard**
  - Impervious & Stabilized Surface
- **Roofed Manure Stacking Pad**
  - Prevent precipitation from contacting manure
  - Eliminate contaminated runoff
- **Diversion**
  - A grass swale to direct stormwater runoff around roofed barnyard and stacking pad
