PROJECT: BEEF

LOCATION: HONEY BROOK, PA

COMPLETION DATE: NOVEMBER 2021

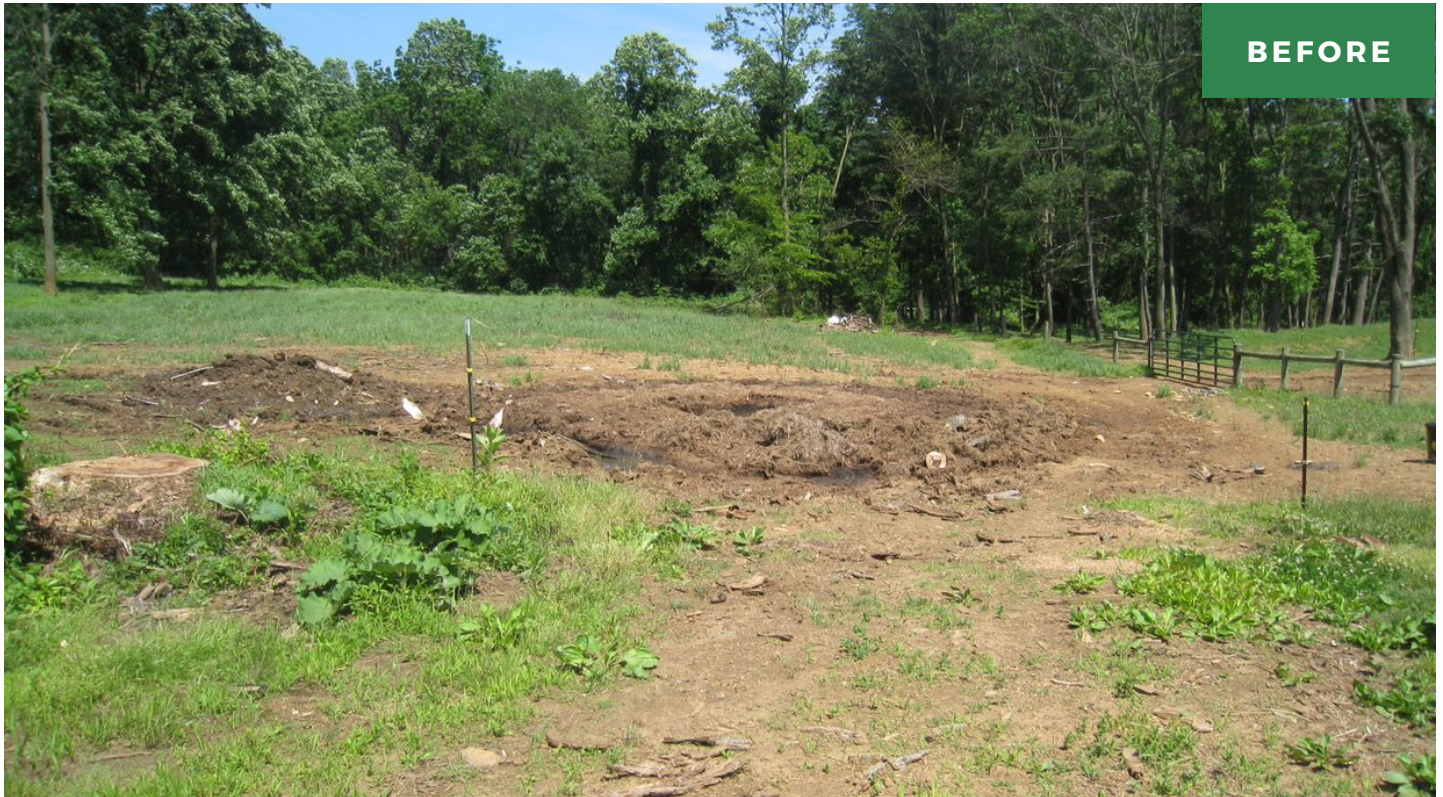
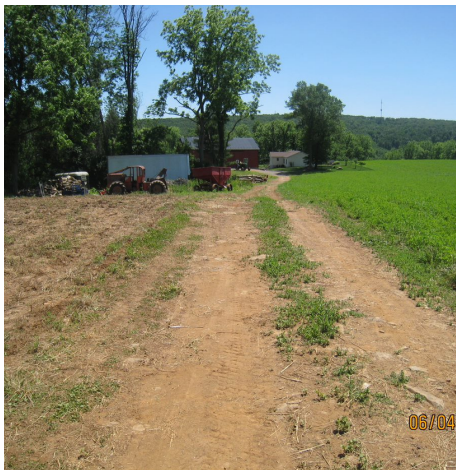
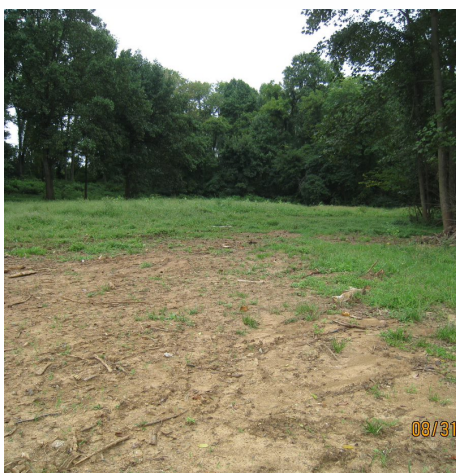
BEFORE

This project involved installing Best Management Practices (BMPs) on a beef operation with 13 cow/calf pairs. The farmer does an excellent job managing his pastures with a rotational grazing system, but lacked the appropriate infrastructure to properly manage the animals during times when they couldn't be on pasture (i.e. winter months). The cows were confined to a small area outside the barn, which was in the close vicinity of a stormwater basin. This Animal Concentration Area (ACA) was earthen, subject to erosion, and didn't allow for effective removal of accumulated manure.

- **Animal Concentration Area (ACA)**
 - Earthen, subject to erosion, hard to remove manure, too close to stormwater basin
- **In Field Manure Stacking**
 - In natural drainage area, lack of vegetated treatment area, pervious surface

- **Roofed Concrete Barnyard**
 - Impervious & Stabilized Surface
- **Roofed Manure Stacking Pad**
 - Prevent precipitation from contacting manure
 - Eliminate contaminated runoff
- **Diversion**
 - A grass swale to direct stormwater runoff around roofed barnyard and stacking pad
