# PROJECT: DAIRY

LOCATION: NOTTINGHAM, PA

## PROJECT DESCRIPTION

COMPLETION DATE: MAY 2021

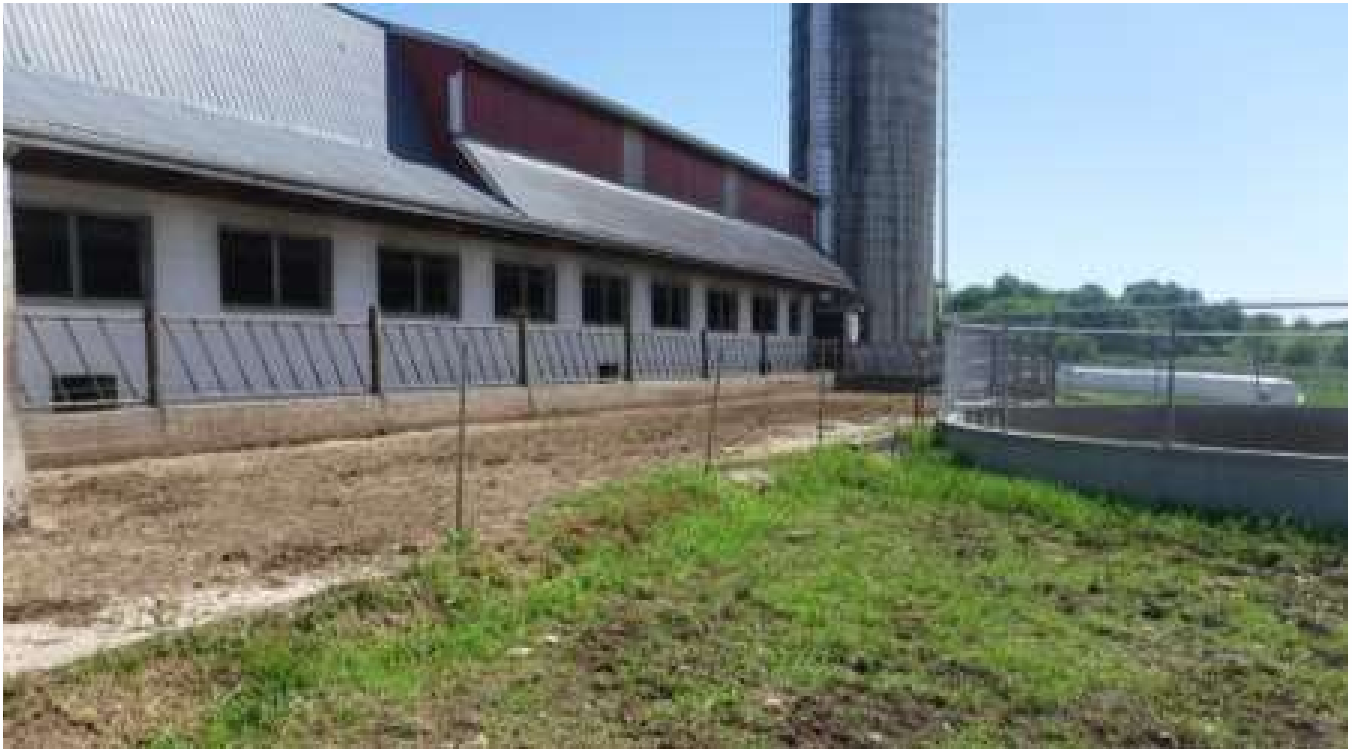
BEFORE

- Runoff from Barnyard (not collected and in close vicinity to a stream)
- Silage Leachate (not collected and close vicinity of a stream)
- Lack of Forested Riparian Buffer (elevated water temperatures in stream due to lack of shade)
- Unstable Access Road (erosion on access road due to consisting on an existing soil surface)

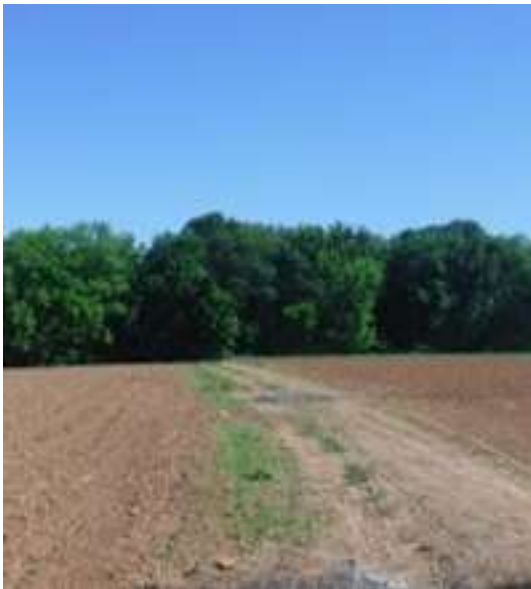
This project involved installing Best Management Practices (BMPs) on an Amish dairy farm with approximately 50 milk cows, 15 heifers, and 8 horses. The farm was in need of various upgrades including addressing barnyard runoff, installing streambank fencing, off-stream waterers, and a riparian forest buffer, addressing silage leachate, and stabilizing an access road.

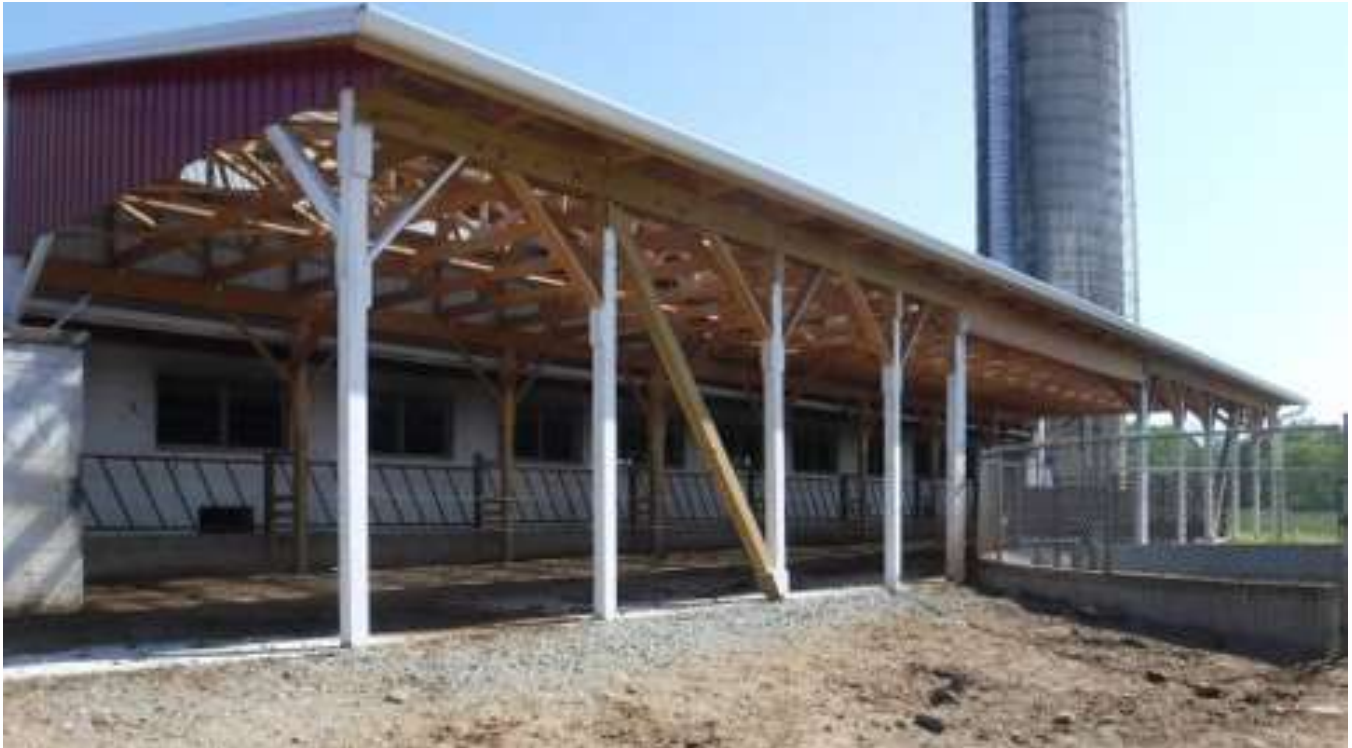
AFTER

- **Riparian Forest Buffer and Streambank Fencing** - Absorb nutrient and sediment runoff, shade stream and cool water temperatures, stabilize streambanks, provides wildlife habitat.
- **Off Stream Watering Facilities** - Keep livestock out of stream for watering purposes.
- **Stabilized Access Road** - Reduce erosion on high traffic areas.
- **Silage Leachate Collection** - Reduce nutrient laden runoff into surface waters.
- **Roofed Barnyard** - Eliminate precipitation from coming in contact with manure and generating nutrient runoff.
