# SR22® PISTOL PRODUCT SAFETY BULLETIN

## PRODUCTS SUBJECT TO THIS SAFETY BULLETIN AND WHO SHOULD SIGN UP:

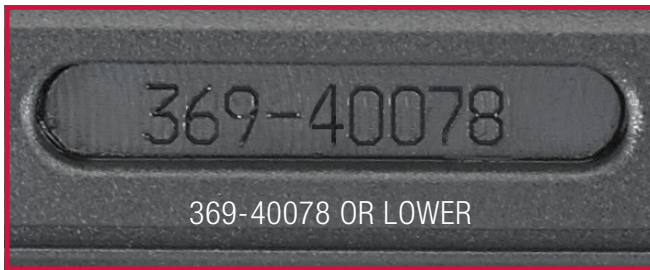
Any SR22 with serial number **369-40078** or lower (including those with a “SS” serial number prefix) is subject to this Safety Bulletin, **IF** it has either: (1) exhibited (or exhibits in the future) a slack single-action trigger; or (2) discharged upon decocking. If you have ever experienced either of these conditions with your SR22 pistol, you should stop using your pistol and **sign up** for the Safety Retrofit.
