May 14, 2021

I inspected Lake Frances today to view the current state of algae control, observe other aquatic plant issues, and to make observations that relate to the long-term management of this water body.

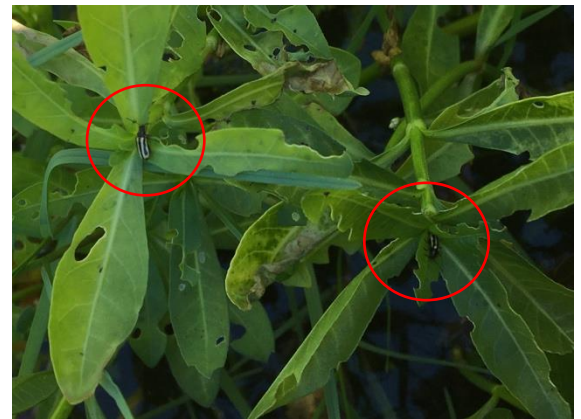
There are several beds of alligator weed (*Alternanthera philoxeroides*) occurring along the shoreline. This is the vine like plant the grows out from the shore with clover-like white flowers. I observed at least a dozen health beds scattered around the lake. However, I did find one bed that had active alligator weed flea beetles (*Agasicles hygrophila*), which should spread and control this problem as the season progresses. Flea beetles are about ¼ inch long with yellow stripes. Their larvae are specialized to eat alligator weed leaves. Like tilapia, flea beetles survive mild winters, but may need to be supplemented in the future following exceptionally cold winters. Some obviously found refuge this past winter and are doing well.

1 Flea beetle on alligator weed. Lake Francis 2021.

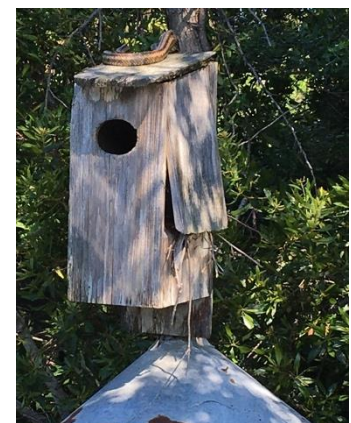
The number of non-native waterfowl appears to have been reduced over time. Efforts to discourage them should continue. I did observe one wood duck nesting box turned into a lunch box. This yellow rat snake had defeated the predator guard and ingested an egg. Trees and bushes should be trimmed annually to prevent snake access.

2 Yellow rat snake with ingested egg. May 14, 2021
