# HomInspect - home inspection services

## \*\*\* Residential Inspection Report \*\*\*

December 23, 2019

1122 15th St  
Your Town, USA

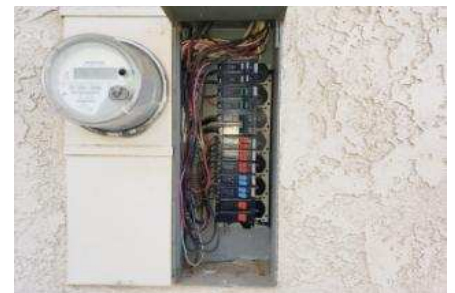
View inside main electrical service panel

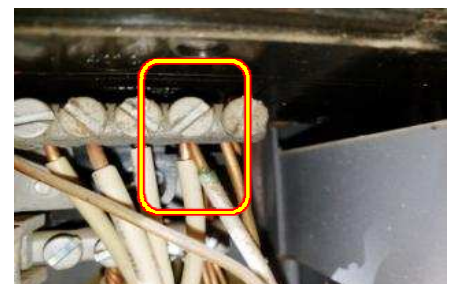
- The masthead insulator grommet was damaged/missing where the main overhead service entrance conductors (SEC) enter masthead. Recommend further evaluation by a qualified electrical contractor and corrective repair as necessary.
- There were neutral (white) wires doubled or bundled together under the same lug (screw), this condition could cause loose connections and overheating. Neutrals should always have a single connection (Unless the manufacturer states otherwise, bus bars are only designed for one current carrying conductor per terminating lug). Recommend further evaluation by a qualified electrical contractor and corrective repair in accordance with accepted practice is recommended.

Neutral (white) wires were doubled or bundled together

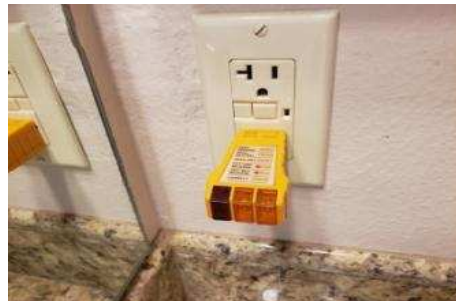
- There were outlets in garage next to the work bench that tested with reverse polarity. This happens when the hot live wire (black or red wire) and neutral wires (white wire) get flipped around at an outlet or switch. Reversed polarity creates a potential shock hazard. Recommend further evaluation and corrective repair in accordance with accepted practice.
- GFCI electrical outlet in the master bath did not respond correctly when tested and should be repaired or replaced as necessary for safe and proper function. A GFCI outlet also known as "Ground fault circuit interrupter device" is to add additional protection against electrical shock or electrocution. It's designed to detect very low levels of electrical current leaks (ground faults), and acts quickly to shut off power, preventing serious shock.

GFCI outlet not responding correctly

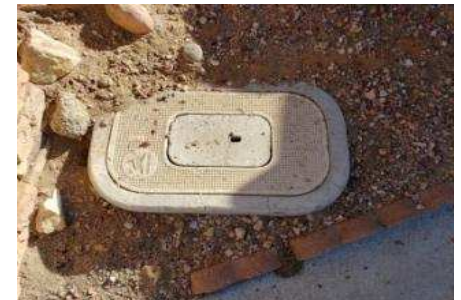
The home water supply pressure exceeded the 80 psi limit considered the maximum allowable by generally-accepted current standards (water pressure tested at 105-115 psi). Excessively high water pressure is likely to cause leaks if not corrected. Recommend a qualified plumbing contractor for corrective action.

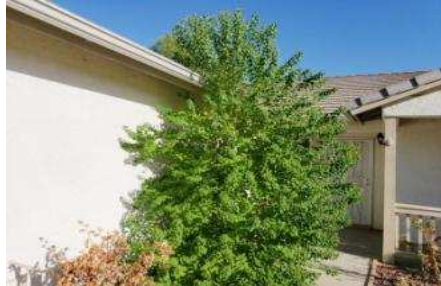
Clear away vegetation as needed

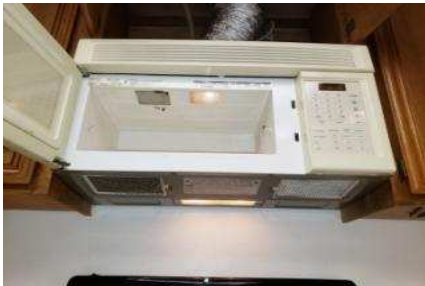
The exhaust vent ducting in the overhead cabinet was using a soft flex ducting. This type of ducting is improper for this type of application and should be a rigid ducting that is designed for this type of use. Recommend corrective repair as necessary in accordance with the manufactures installation instructions.

Fan and light were functional

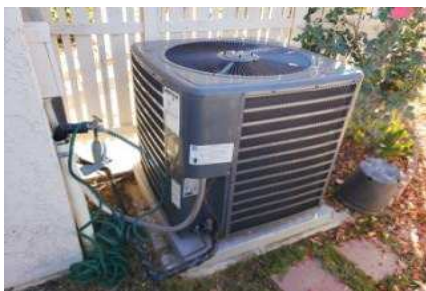
AC compressor was functional

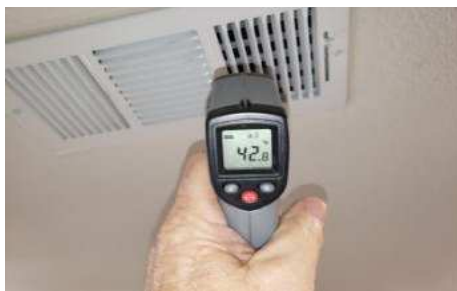
Temperature reading

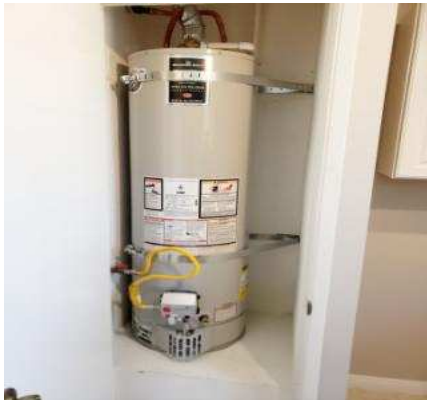
- The water heater TPR (temperature pressure relief valve) discharge pipe has a positive slope or runs uphill. This condition can cause water to be trapped in the discharge pipe and could cause the TPR valve to fail. This TPR valve is a very important safety device. Also noted the TPR piping material (PVC) used was improper. Recommend corrective repair as necessary to properly configure the discharge pipe that meets current standards.
- It is recommended in accordance with current standards to install a drain pan below the water heater to protect against potential water leakage and damage concerns.

TPR pipe improper/runs uphill

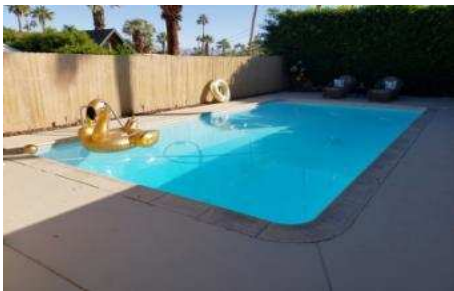
**Further Comments:** No concerns observed

View of decking

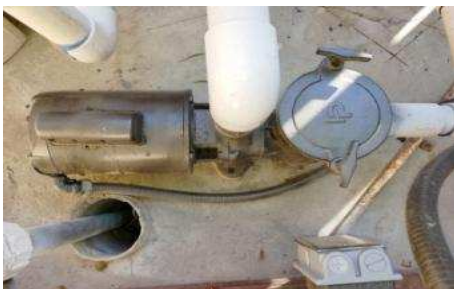
**Further Comments:** No concerns observed

Pump was functional

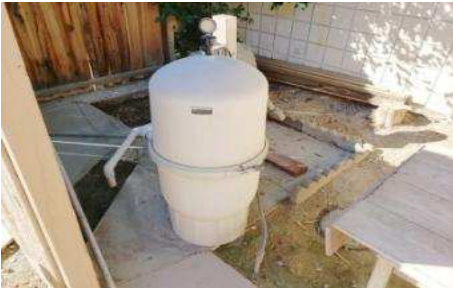
Further Comments: No concerns observed

Filter

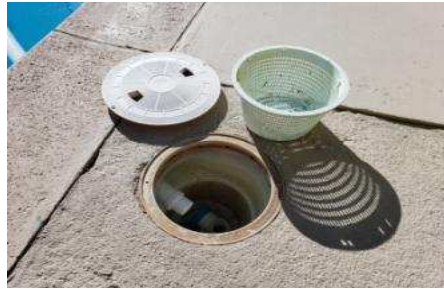
Skimmer and basket

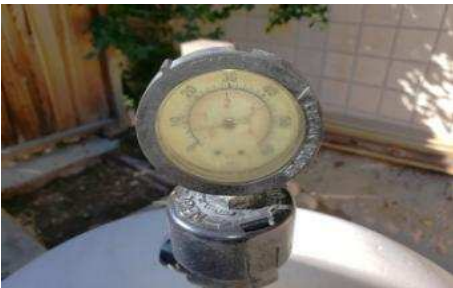
Further Comments: No concerns observed

Pressure gauge on filter
