# HomInspect - home inspection services

## \*\*\* Residential Inspection Report \*\*\*

December 23, 2019

1122 15th St  
Your Town, USA

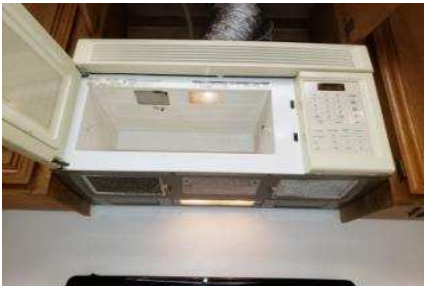
- The exhaust vent ducting in the overhead cabinet was using a soft flex ducting. This type of ducting is improper for this type of application and should be a rigid ducting that is designed for this type of use. Recommend corrective repair as necessary in accordance with the manufactures installation instructions.

The exhaust vent ducting in the overhead cabinet was using a soft flex ducting. This type of ducting is improper for this type of application and should be a rigid ducting that is designed for this type of use. Recommend corrective repair as necessary in accordance with the manufactures installation instructions.

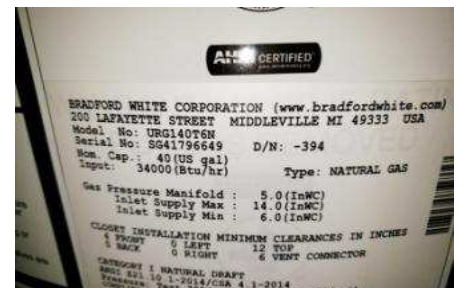
Data tag

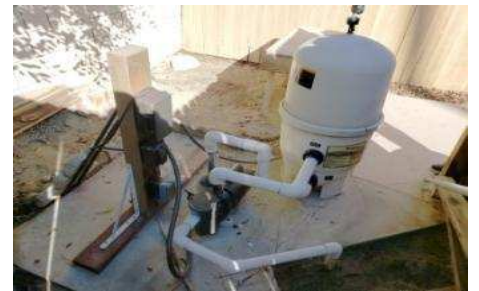
**Further Comments:** The pool equipment (pump) does not appear to be properly bonded. Metal parts of electrical equipment associated with the pool water circulating system should be properly bonded to the equipotential bonding grid in accordance with equipment instructions. Recommend a qualified pool contractor to evaluate and any corrective action that may be needed.

Bonding wire was missing

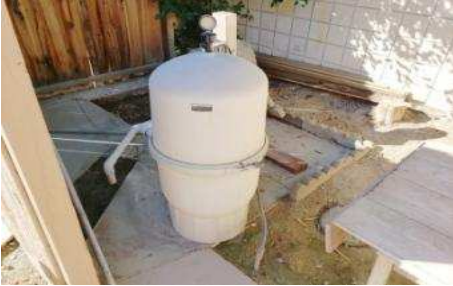
Filter

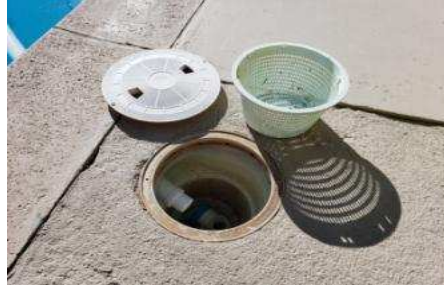
Skimmer and basket

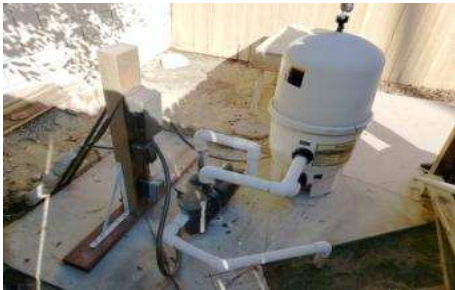
**Material:** PVC piping

**Further Comments:** No concerns observed

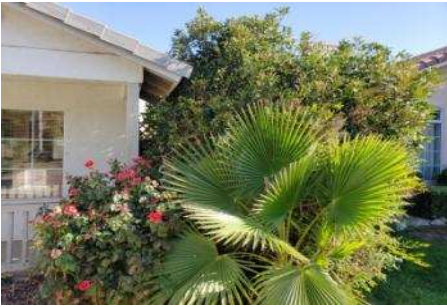
Vegetation was close to or in contact with structure

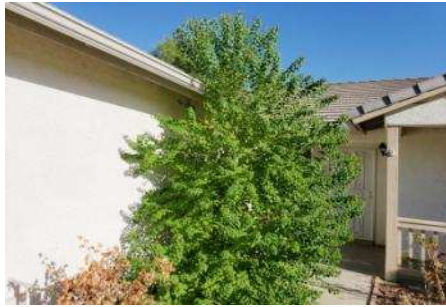
Vegetation was close to or in contact with structure

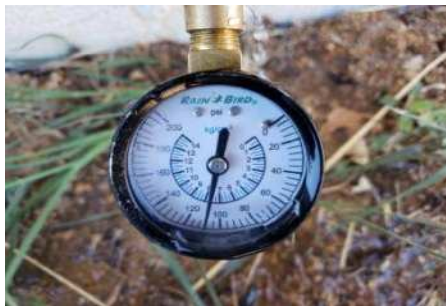
Water pressure reading
