All-Star Inspections

All-Star Home Inspection Report

**123 Easy Street
Cleveland, OH 44102**

Inspected on Wed, Apr 10 2019 at 1:00 PM

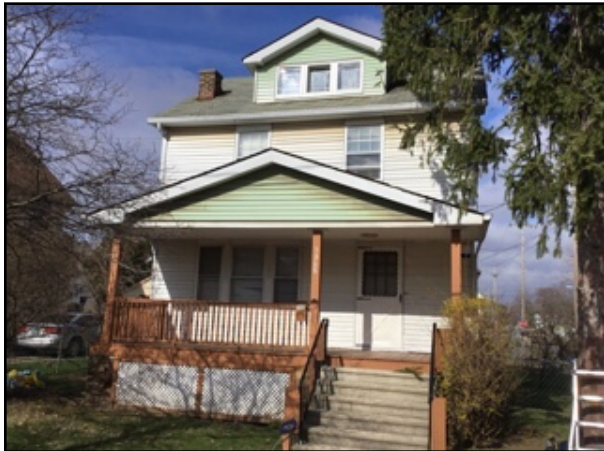
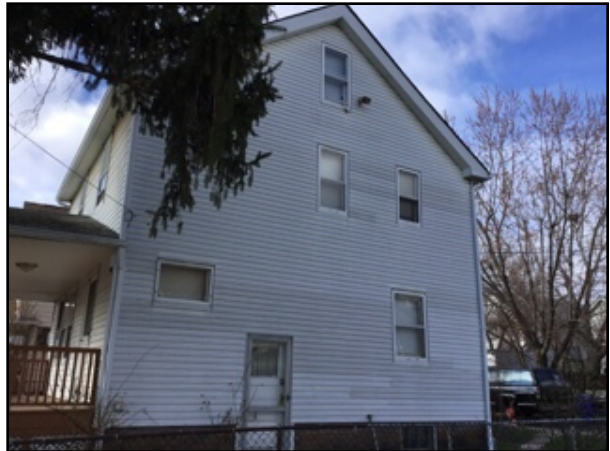
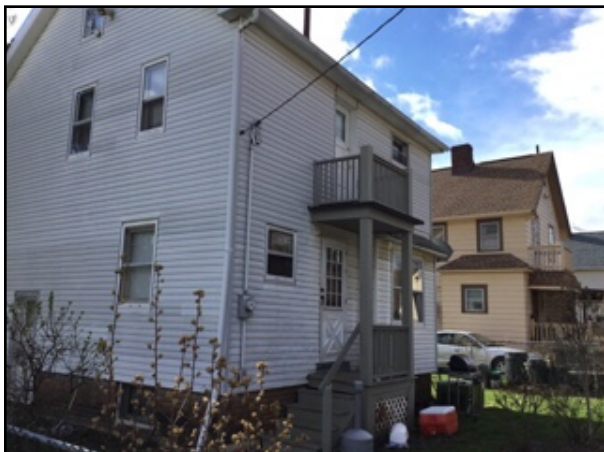
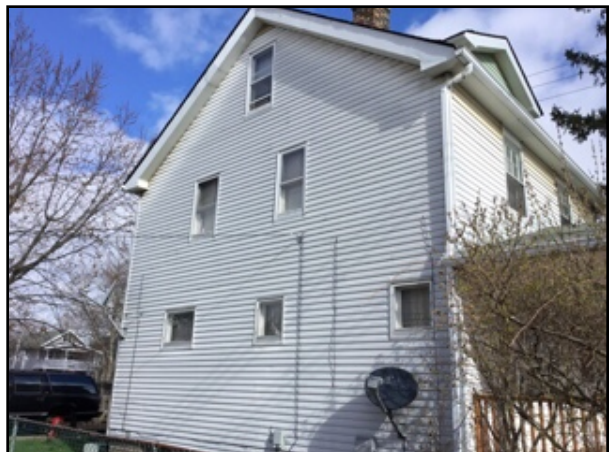
Comment 1:
For Information: General pictures of exterior of house.

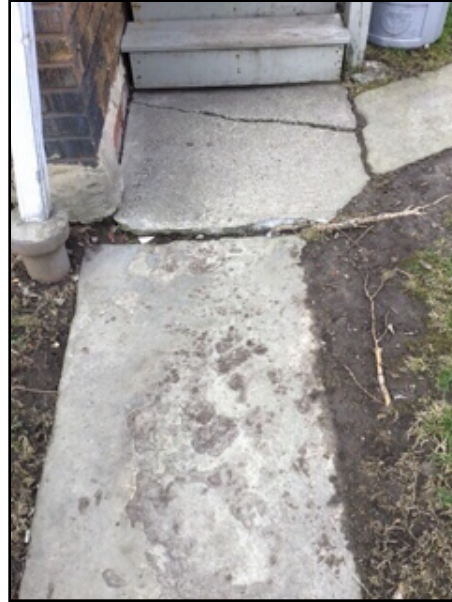
Figure 4-2

Cracking and settling at service walks around house creating potential trip hazards. Safety Hazard. Recommend repairs.

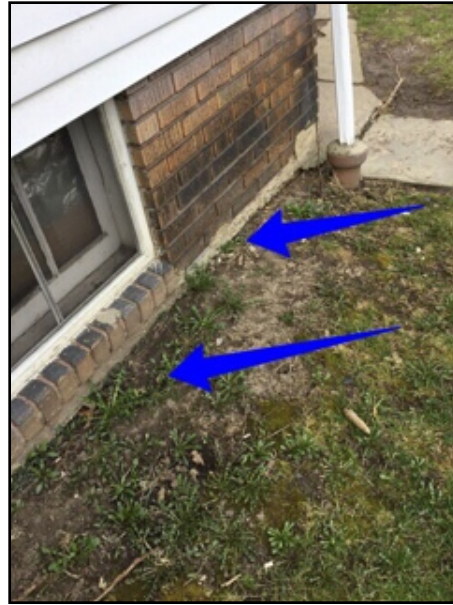
Figure 5-2

Negative soil grades present at several areas around house. Recommend adding additional hard-packed topsoil around the foundation to prevent moisture intrusion along foundation walls.

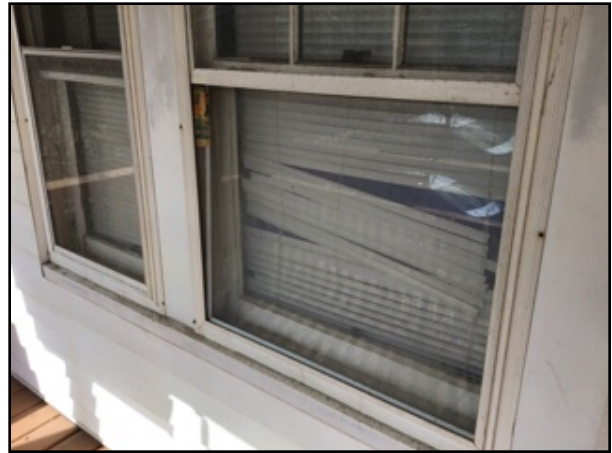
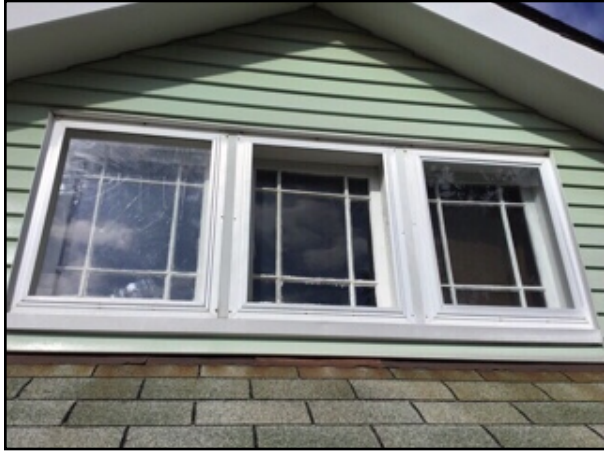
Figure 6-2

Storm window panes out of place or missing at several of the storm windows. Recommend repairs.

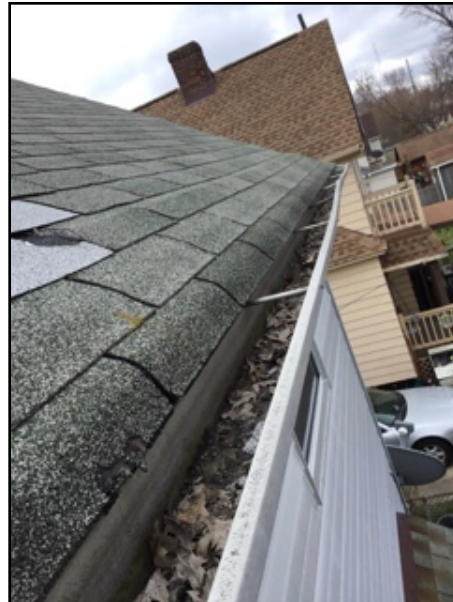
Figure 11-2

Gutters need cleaned out. Recommend cleaning out gutters to ensure proper water drainage.

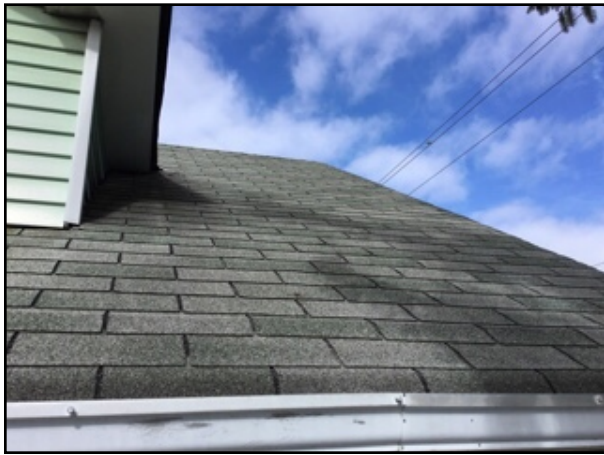
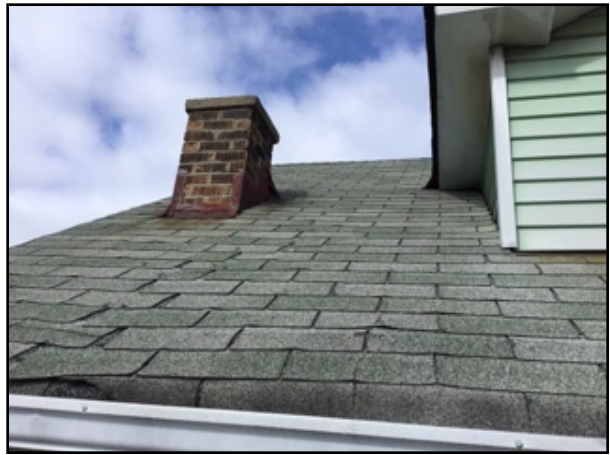
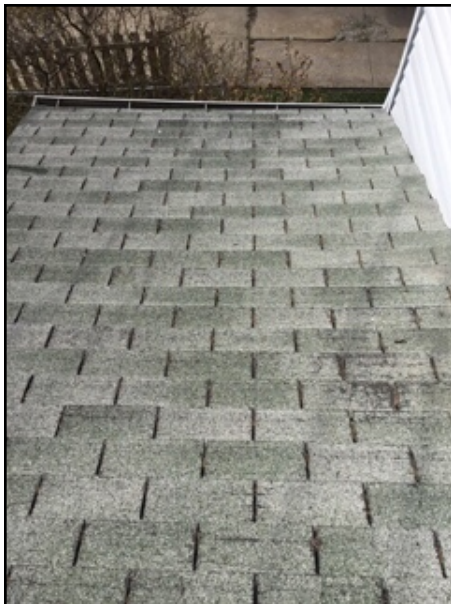
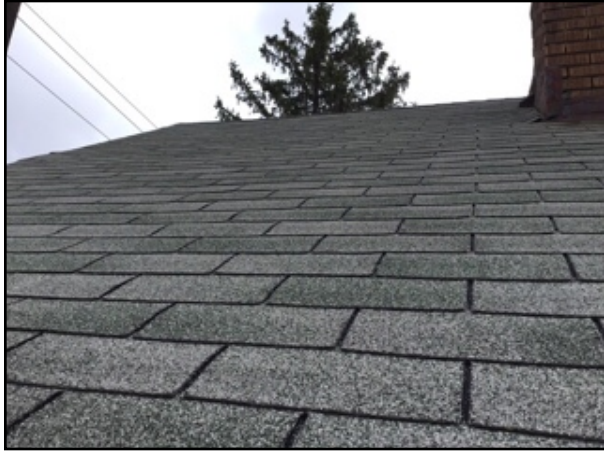
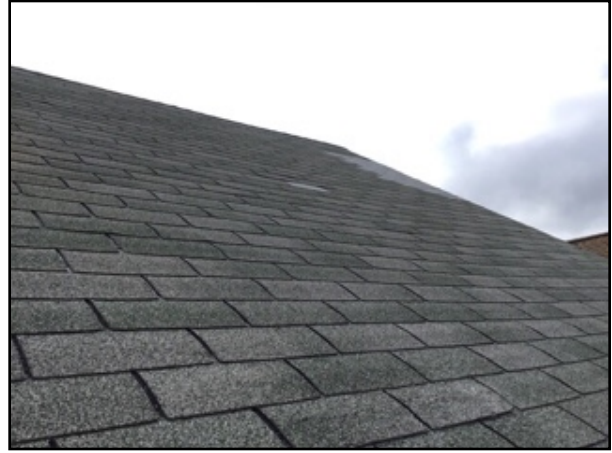
Comment 13:
For Information: General pictures of roof.

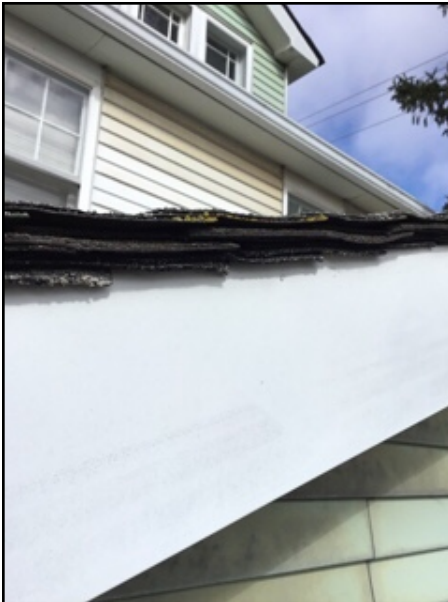
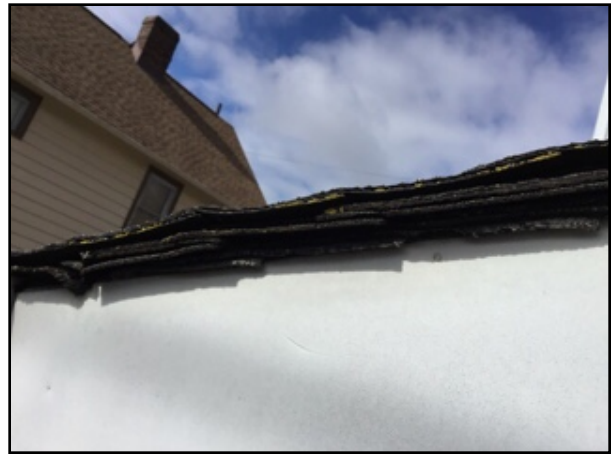
For Information: 3 layers of roofing material present at roof.

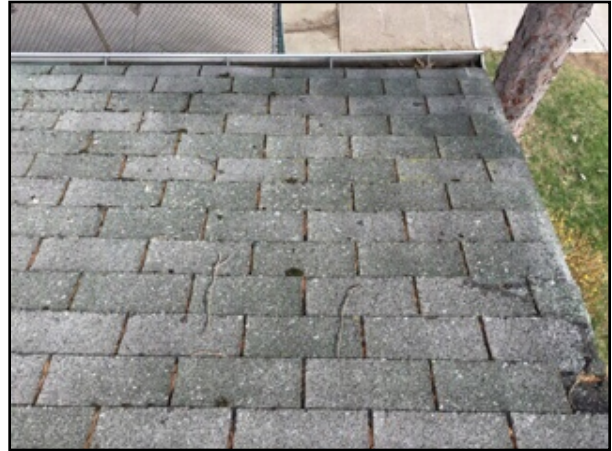
Figure 15-2

**Comment 15:**
Moss, algae, and lichen developing at front porch roof. Recommend treating affected areas to prevent premature deterioration of roofing shingles.

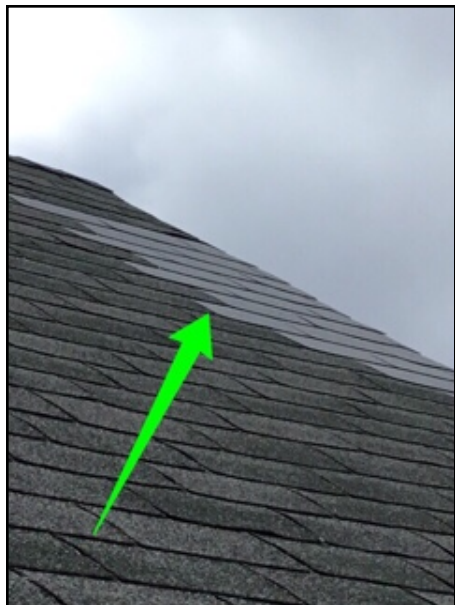
Figure 18-1

For Information: Previous repaired area of roofing at rear roof.

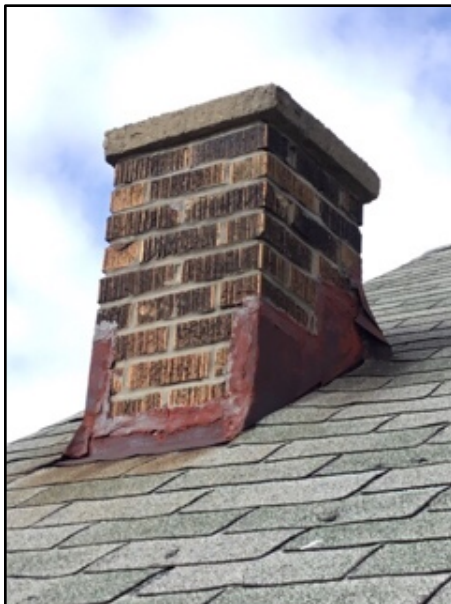
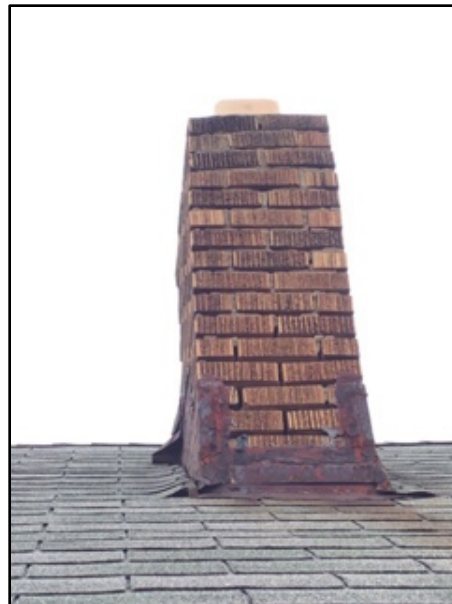
Comment 19:
For Information: General pictures of chimneys.

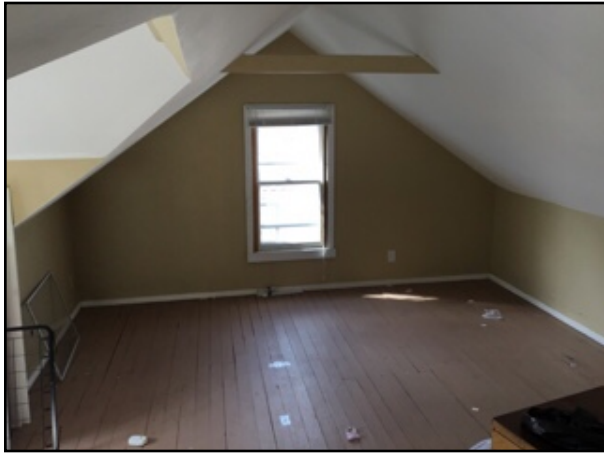
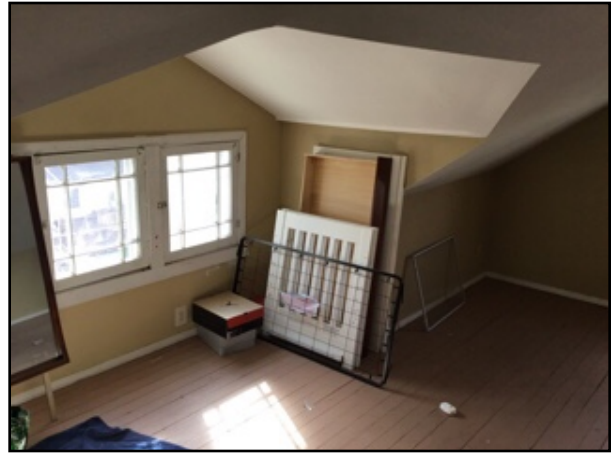
For Information: General pictures of finished attic space.

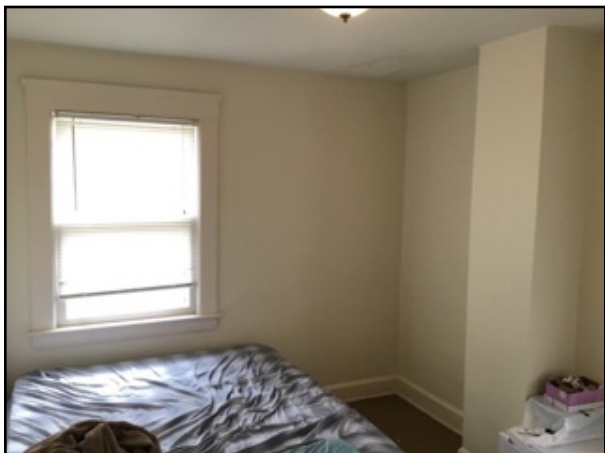
Figure 25-1

Comment 25:
For Information: Front Corner Bedroom.

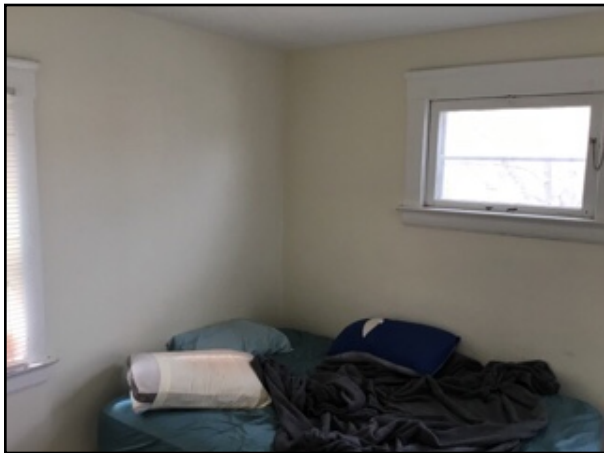
Comment 28:
For Information: Rear Corner Bedroom.

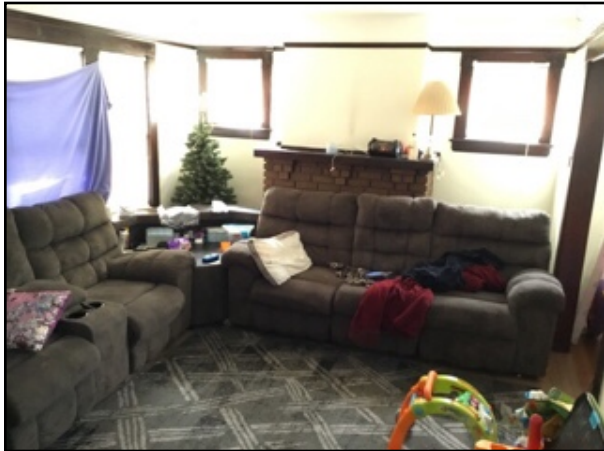
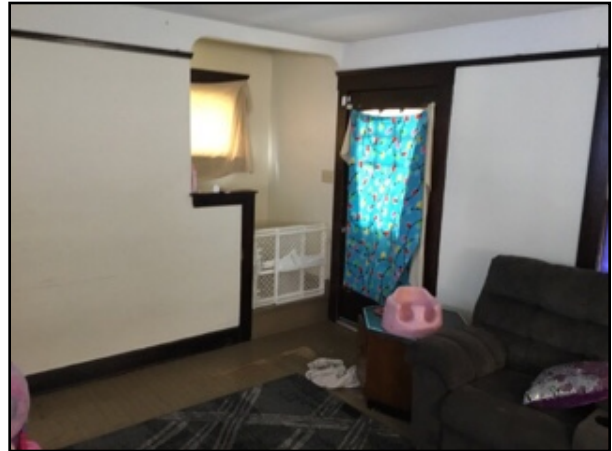
Comment 29:
For Information: Living Room.

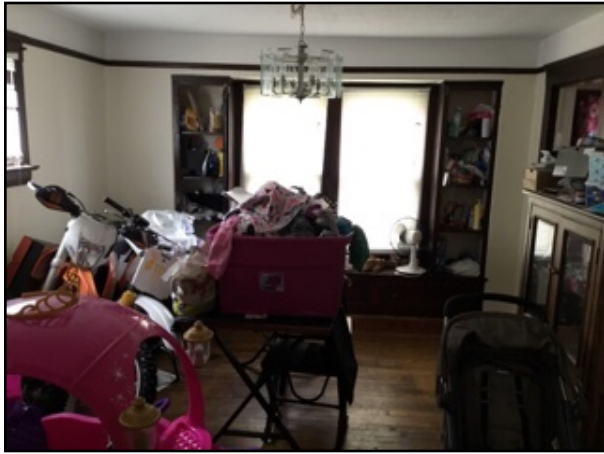
Figure 30-1

Comment 30:
For Information: Dining Room.

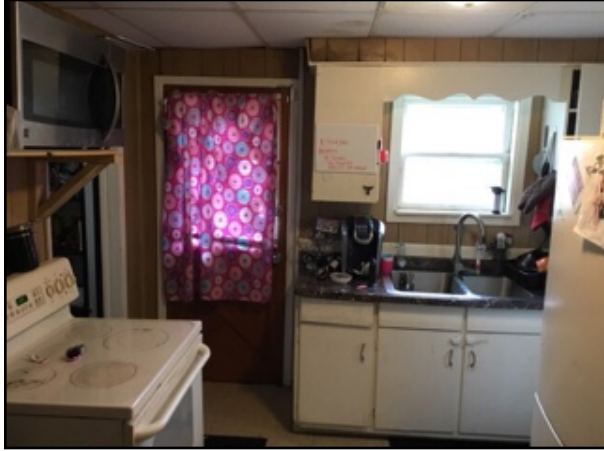
Figure 31-1

Comment 31:
For Information: Kitchen.

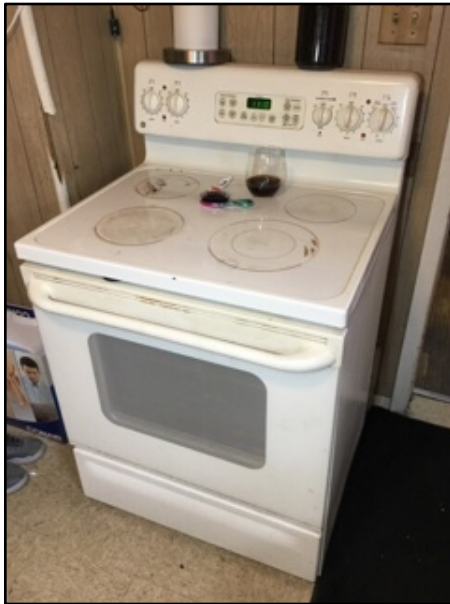
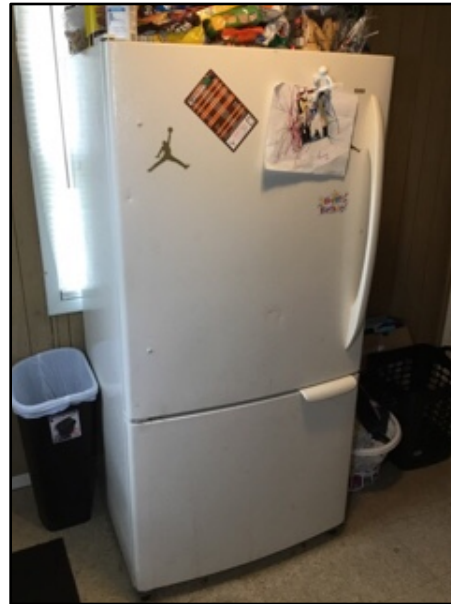
For Information: Appliances present at time of inspection (owned by tenant).

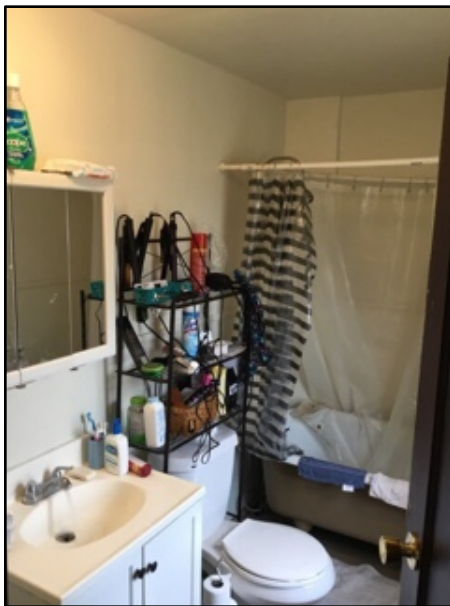
Figure 36-1

Comment 36:
For Information: Bathroom.

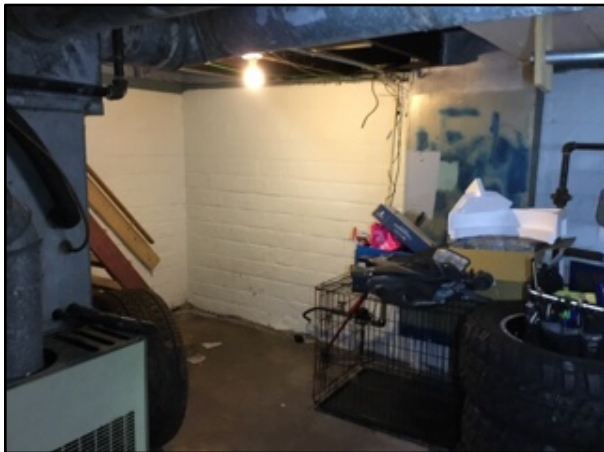
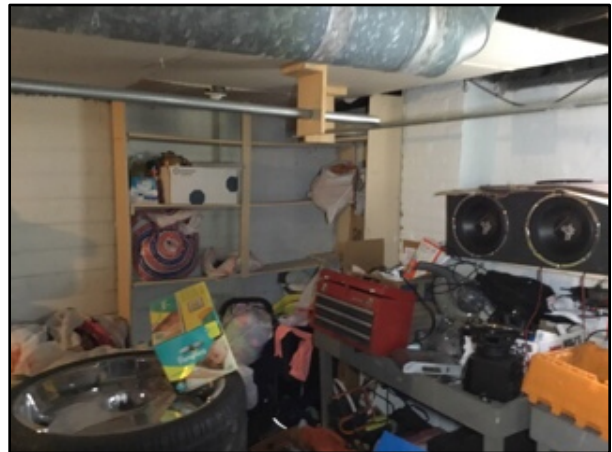
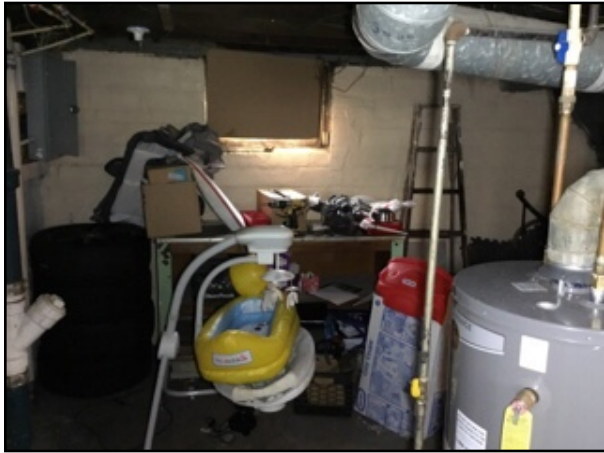
Comment 42:
For Information: General pictures of basement.

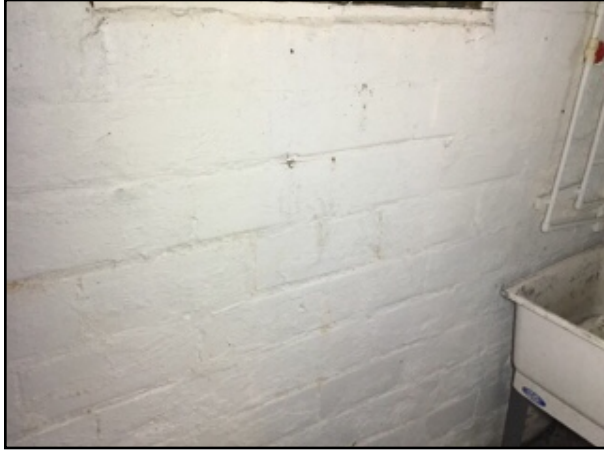
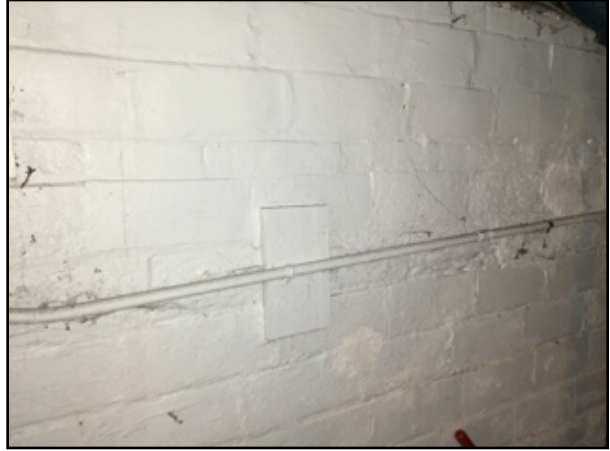
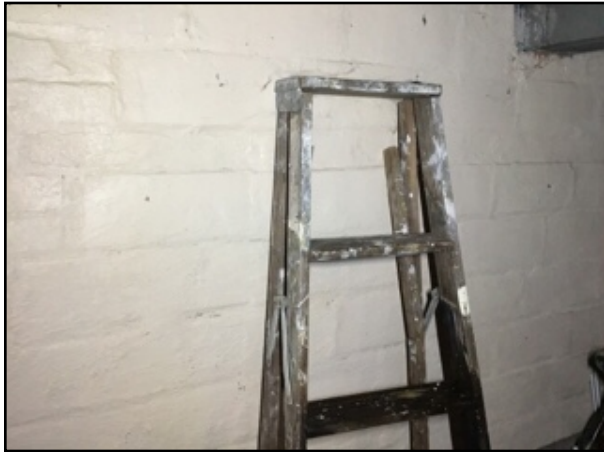
For Information: General pictures of interior foundation walls.

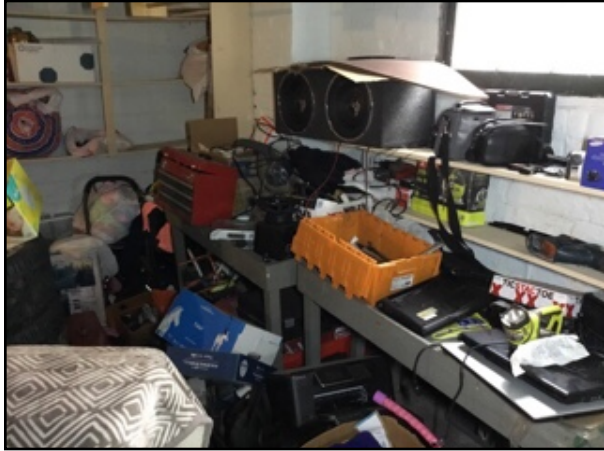
Figure 44-1

For Information: Interior foundation walls partially covered due to owner's belongings.

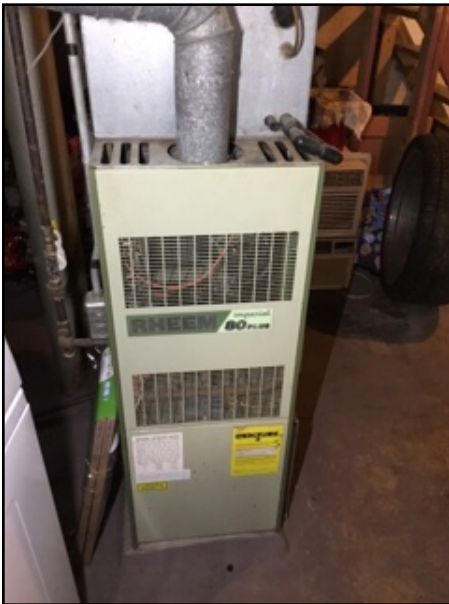
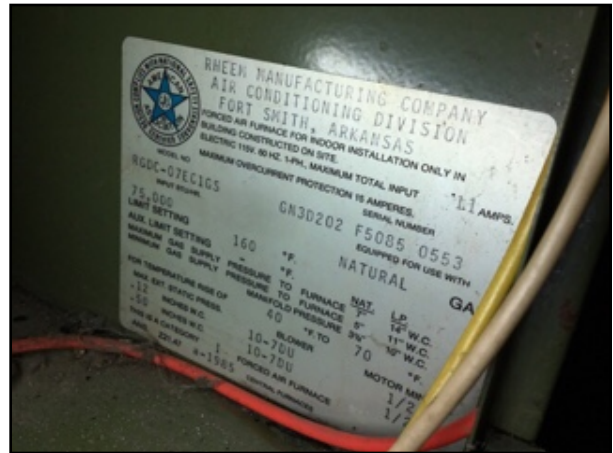
For Information: Furnace and manufacturer's data label.

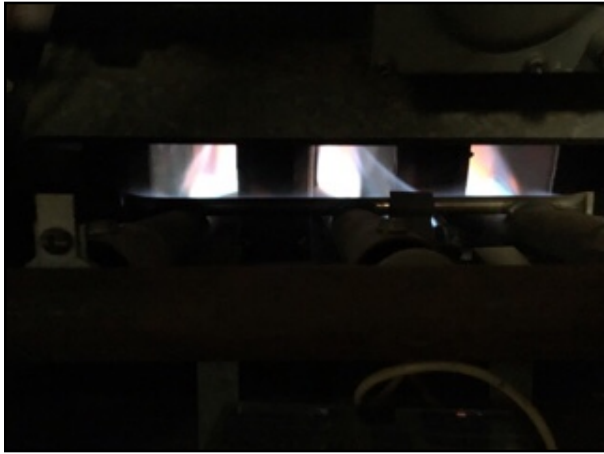
Figure 48-1

**Comment 48:**
For Information: Furnace operation was satisfactory at time of inspection.

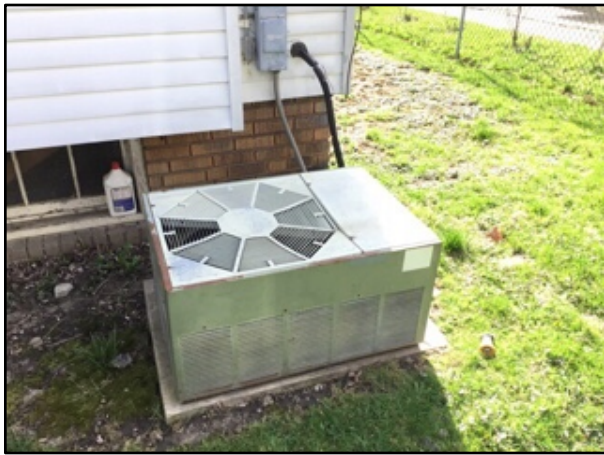
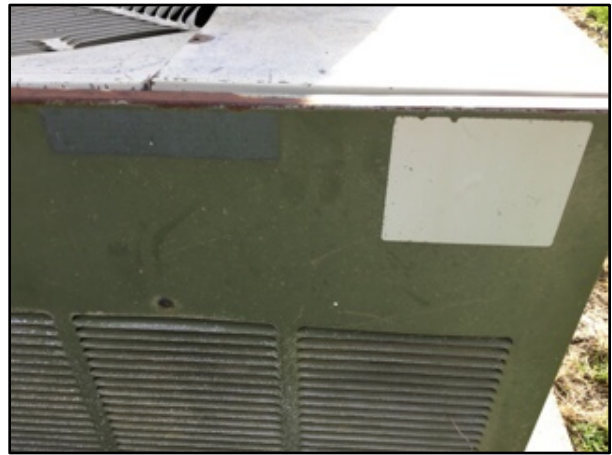
**Comment 50:**
For Information: A/C unit and manufacturer's data labels (not legible).

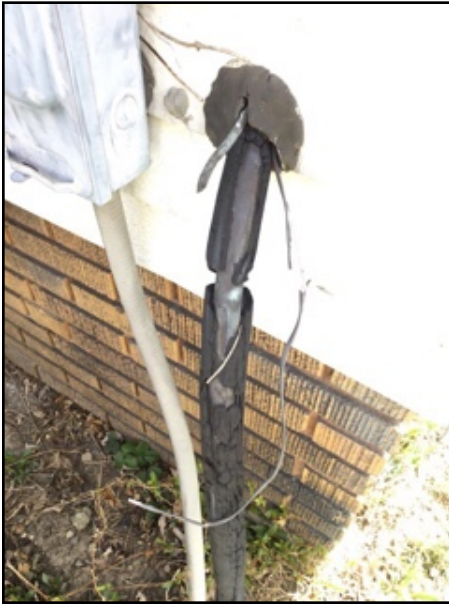
Figure 51-1

**Comment 51:**
For Information: A/C unit is no longer properly connected to evaporator coil at furnace.

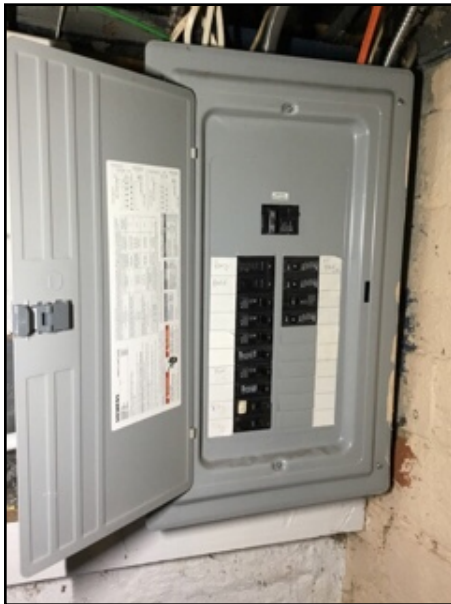
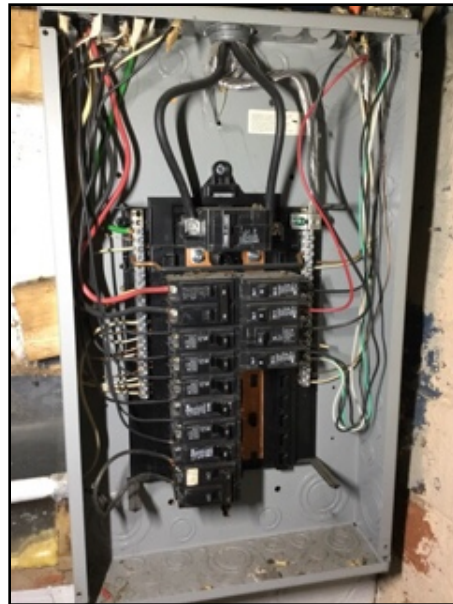
Comment 52:
For Information: Electrical Panel.

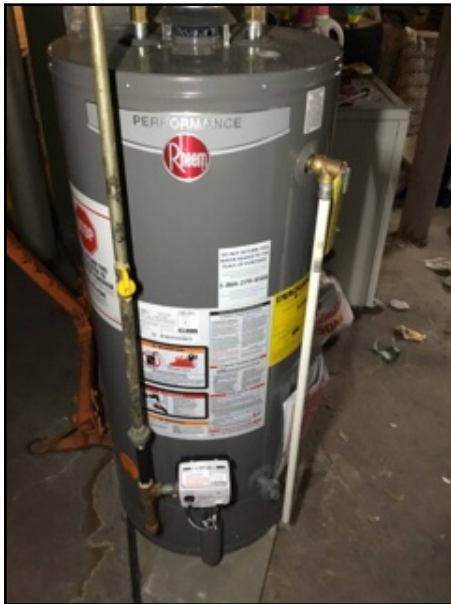
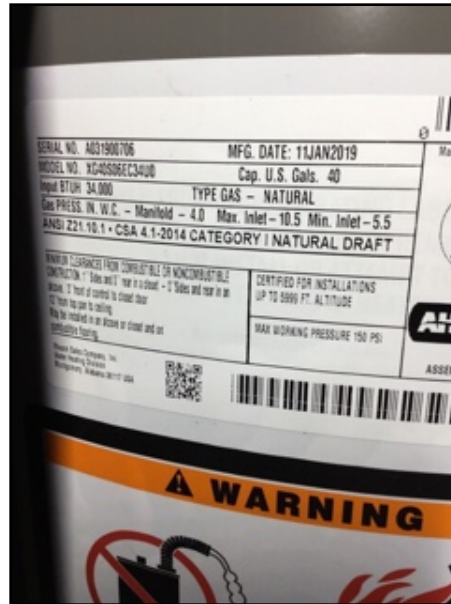
For Information: Water heater and manufacturer's data label.

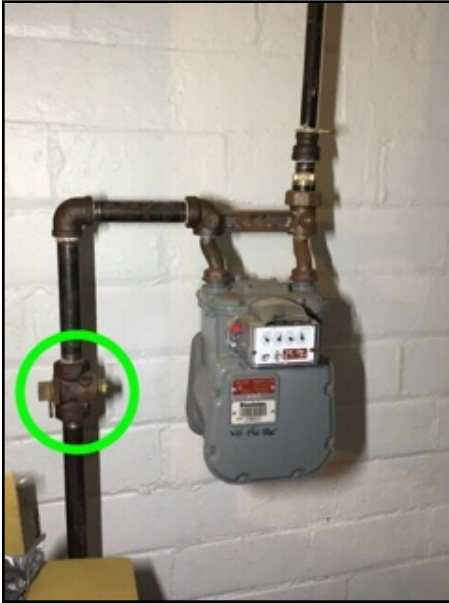
Figure 56-1

For Information: Main gas meter and shutoff.

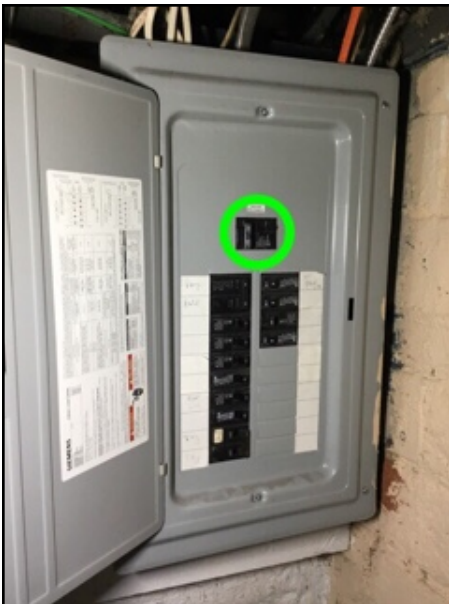
Figure 57-1

For Information: Main electrical shutoff.
