**456 Sample Report Ln
Houston, TX 77095**

PROPERTY INSPECTION REPORT FORM

Jane Smith <i>Name of Client</i>	07/04/2022 <i>Date of Inspection</i>
456 Sample Report Ln, Houston, TX 77095 <i>Address of Inspected Property</i>	
John Tatum <i>Name of Inspector</i>	Professional Inspector # 9459 <i>TREC License #</i>
 <i>Name of Sponsor (if applicable)</i>	 <i>TREC License #</i>

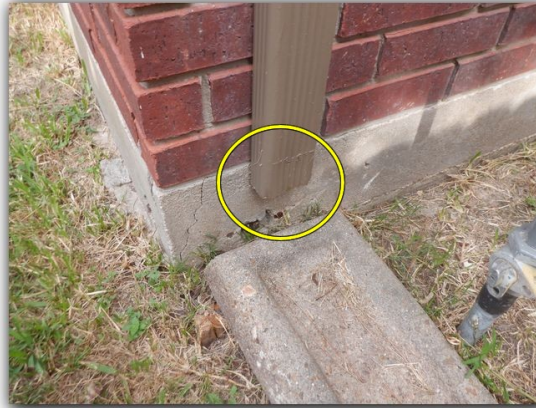
Multiple areas of damaged and / or dented gutter / downspouts were observed.

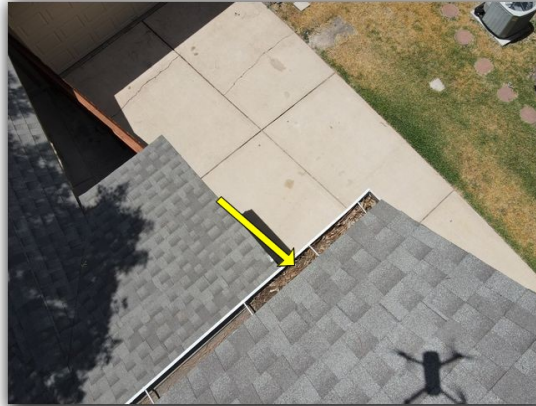
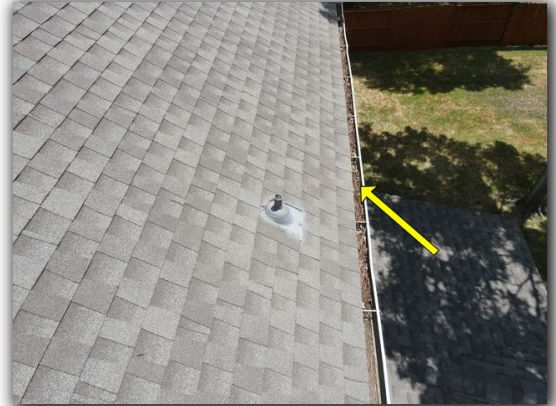
Full of debris and/or holds standing water.

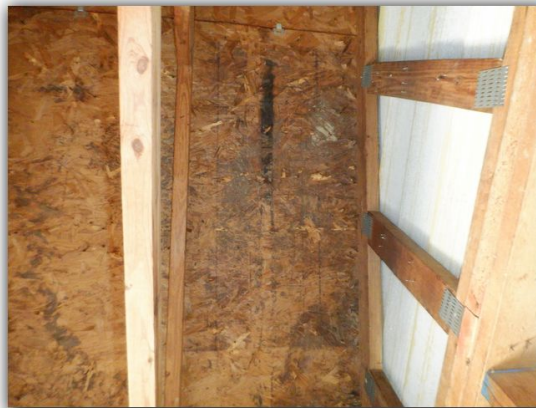
Water stain(s) observed in attic at numerous areas in the garage and house.

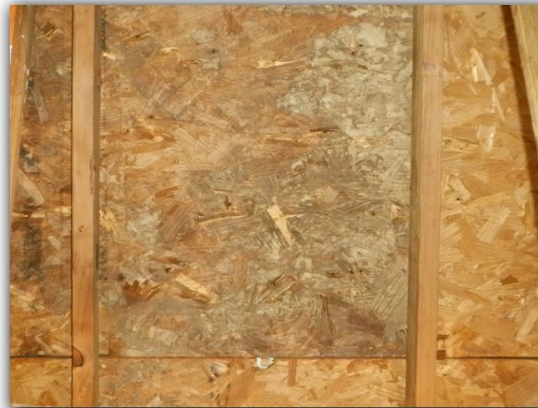
Evidence of previous (possibly current) rodent activity in attic.

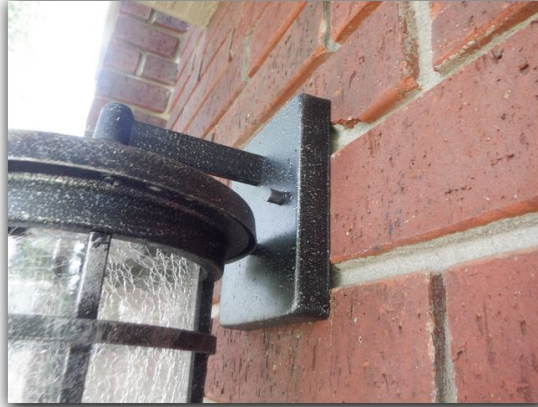
Need sealing / caulking around all holes and exterior siding penetrations on top and both sides, (leave bottom open) to prevent water entry. Including but not limited to dryer, bath and range top vents, light fixtures, etc. Need sealing / caulking around all holes and exterior siding penetrations on top and both sides, (leave bottom open) to prevent water entry. Including but not limited to dryer, bath and range top vents, light fixtures, etc.

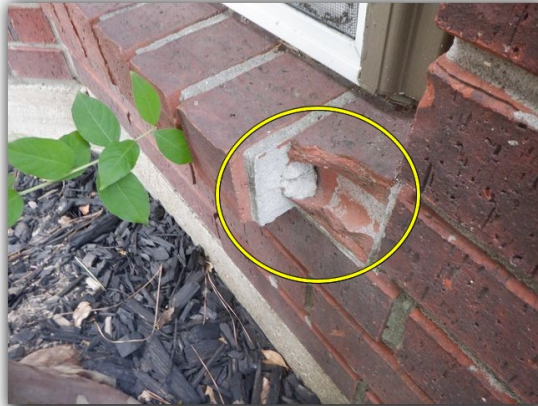
Damaged exterior brick window ledge was observed at the northeast corner.

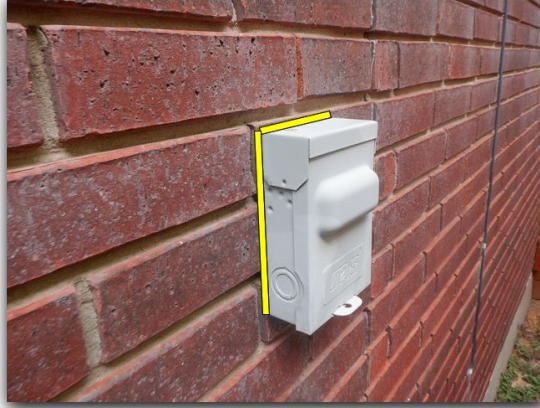
Recommend caulking around electrical disconnect box(s) of A/C unit(s) to prevent water entry behind disconnect(s).

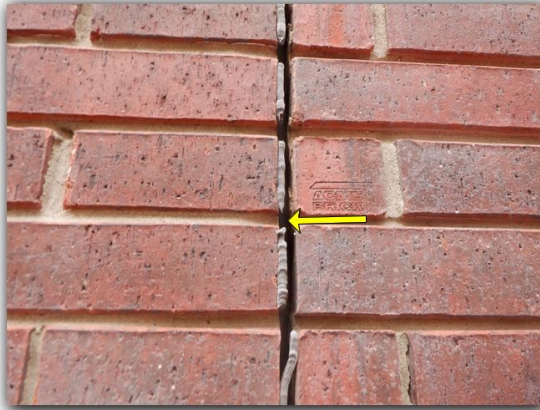
Expansion joint(s) and / or inside corners in brick veneer need caulking. Ensure any mortar present in expansion joint is first removed before sealing.

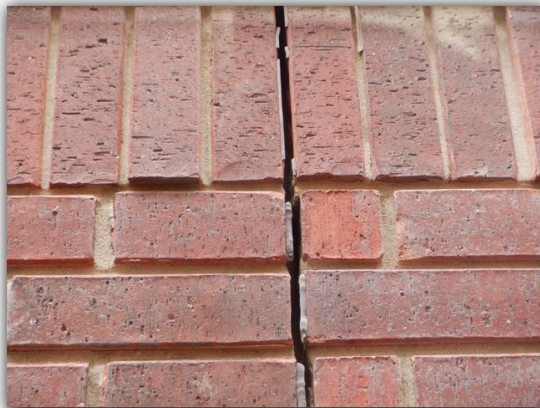
Uneven separation of expansion joint was noted between the upper and lower wall at the east exterior.

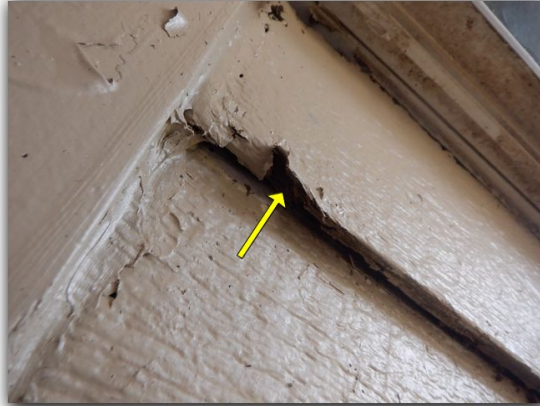
Synthetic wood siding observed on house, it is common industry knowledge that this siding has a tendency to rot easily if not kept well sealed / painted and that most manufactures of this type of product are / have been involved in some type of class action lawsuit.

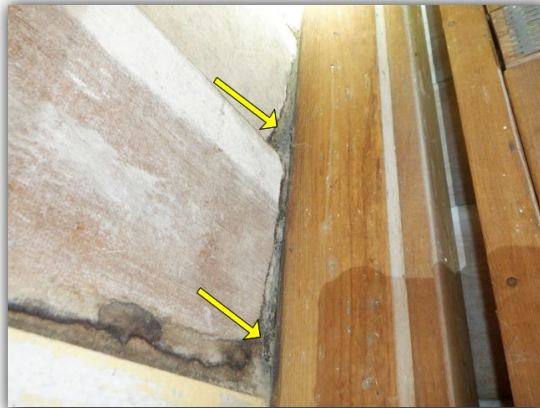
Evidence of possible wood destroying insect damage observed in the garage; Final determination of structurally significant damage to wood members cannot be determined without removal of wall covering {interior sheetrock or exterior siding}.

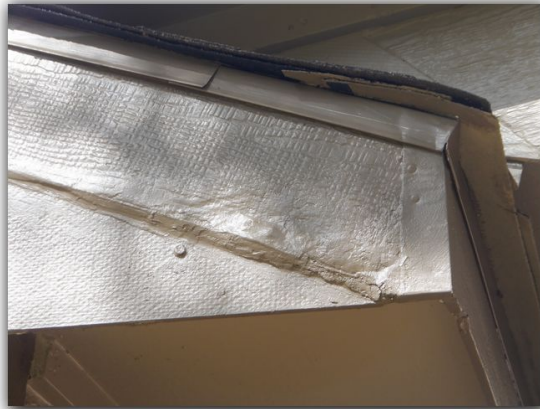
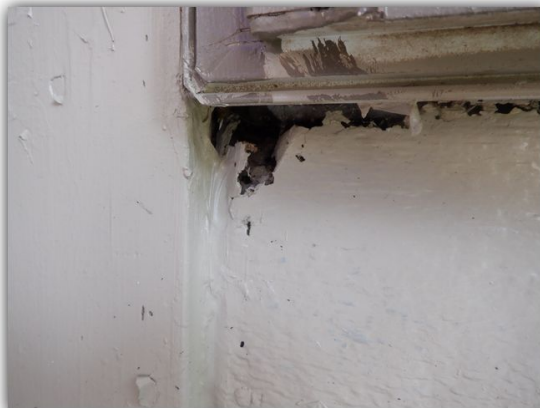
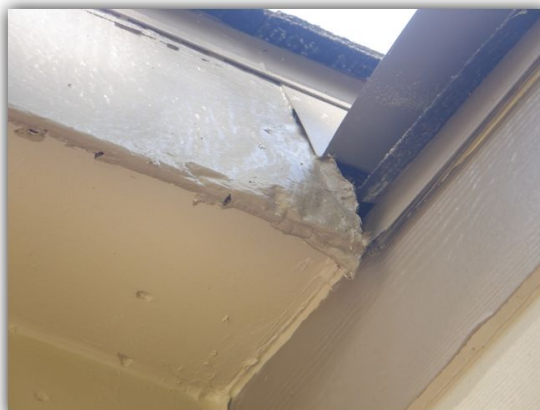
Wood rot observed on areas of house / garage.

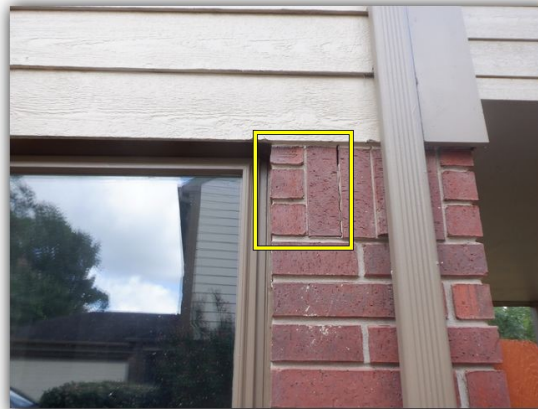
Loose bricks were present at the upper corner of a window at the west exterior.

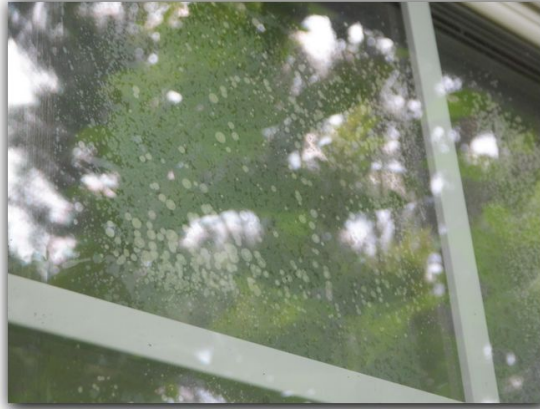
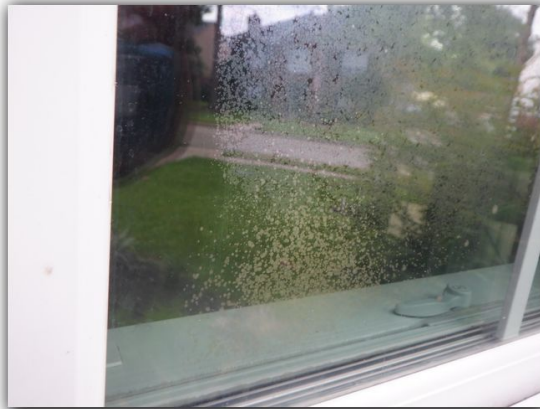
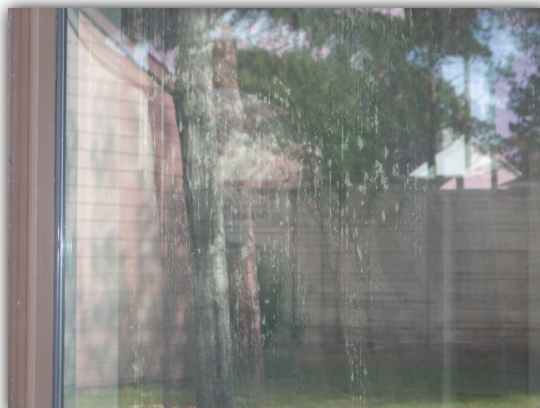
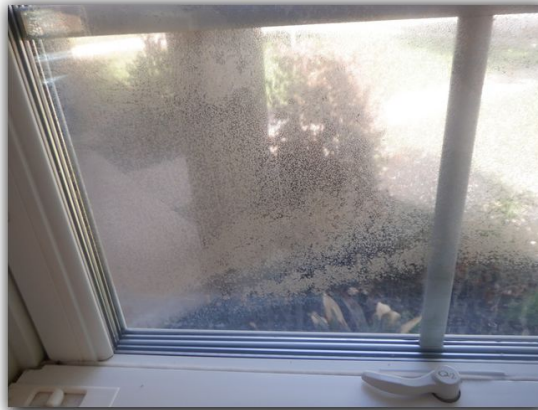
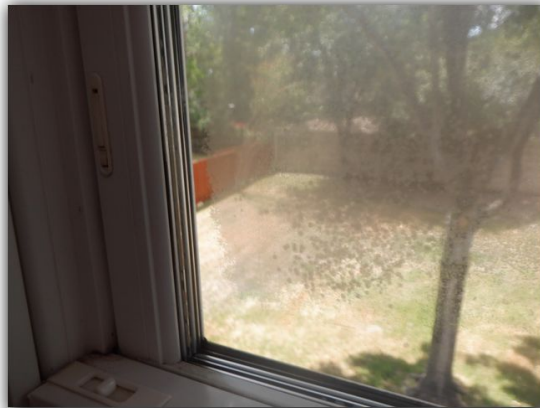
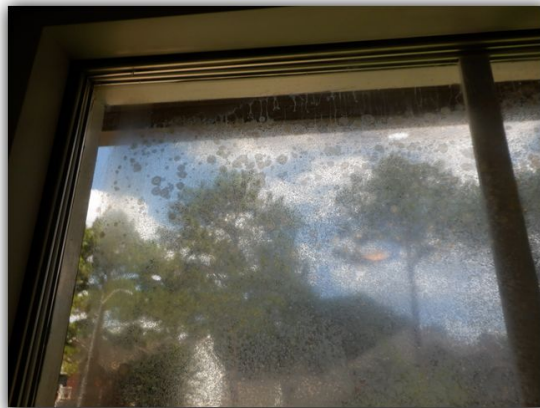
Double pane window vapor seals appear broken, including but not limited to, (Kitchen, Living Room, Formal Living Room, Dining Room, Breakfast Room, All Bedrooms, 2nd Floor Hall Bathroom)

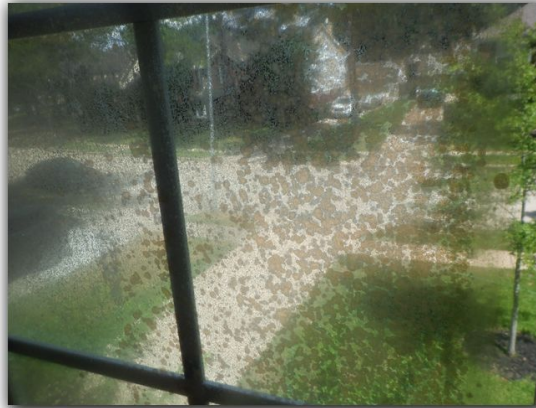
Multiple screens are missing and/or damaged.

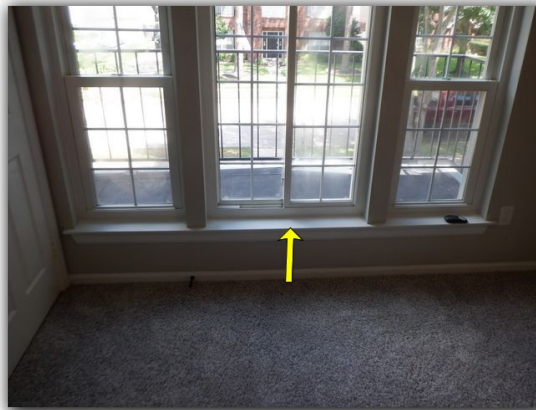
Windows at one or more 2nd floor rooms were a potential fall hazard for small children due to their low height above the floor; did not observe fall protection outside the window. Ref IRC R613.2 Window Sills: In dwelling units, where the opening of an operable window is located more than 72 inches above finished grade or surface below, the lowest part of the clear opening of the window shall be a minimum of 24 inches above the finished floor of the room in which the window is located. Glazing between the floor and 24 inches shall be fixed or have openings through which a 4-inch diameter sphere cannot pass.

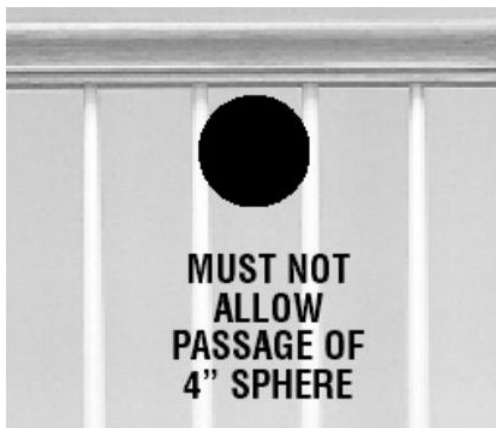
Space between railings does not comply with current industry standard, (code) UBC 421.1.1 & CABO D105.2.1. Requires spacing between intermediate rails do not allow passage of an object four inches in diameter. Recommend covering large openings in stair rails with temporary type nylon netting if small children are present in house to prevent injury.

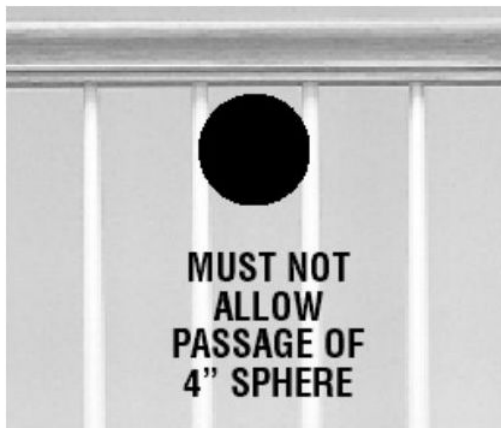
Space between railings does not comply with current industry standard, (code) UBC 421.1.1 & CABO D105.2.1. Requires spacing between intermediate rails do not allow passage of an object four inches in diameter. Recommend covering large openings in stair rails with temporary type nylon netting if small children are present in house to prevent injury.

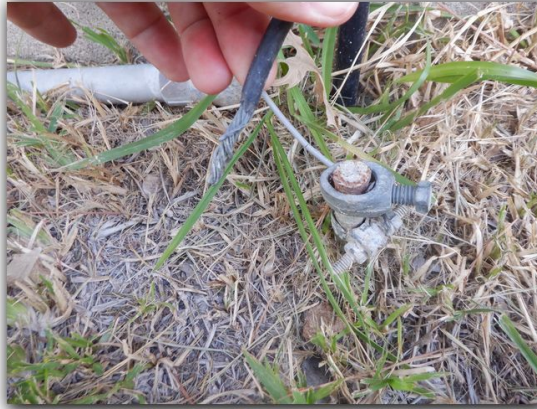
Ground clamp and/or wire not secured to ground rod below service meter.

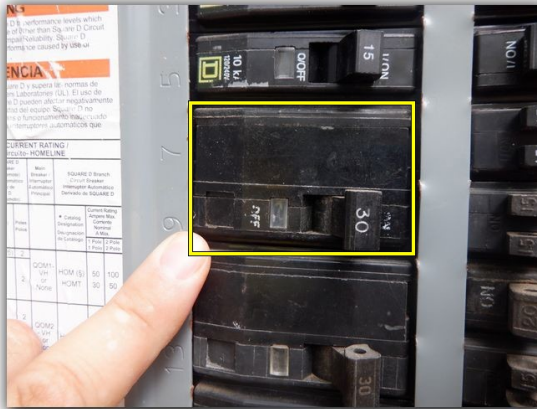
Breakers are oversized per data plates on sides of A/C units.

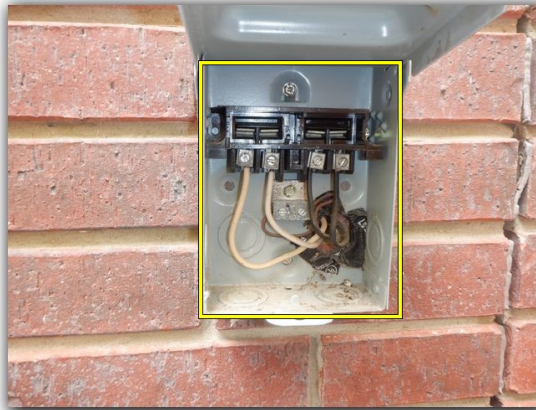
A/C unit electrical disconnect wiring reversed, line / load connections are backwards.
Live electrical wiring to wrong side of electrical disconnect when power turned off at disconnect will result in shock hazard, repair. (Northern disconnect)

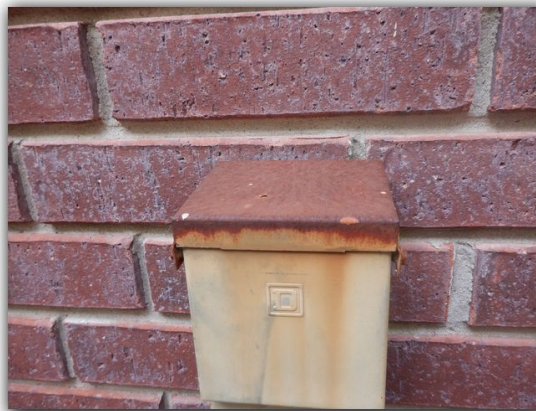
The southern A/C disconnect box was observed to be rusted / damaged.

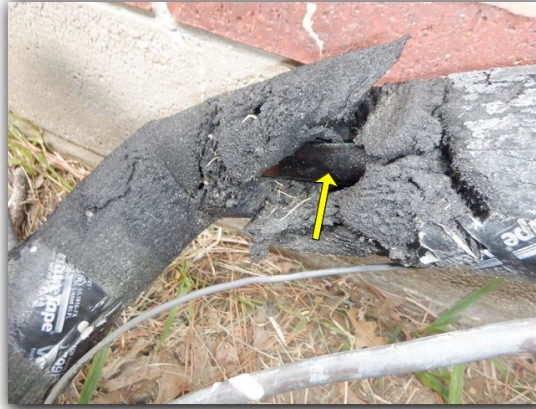
Section of suction line insulation missing or deteriorated near condenser.

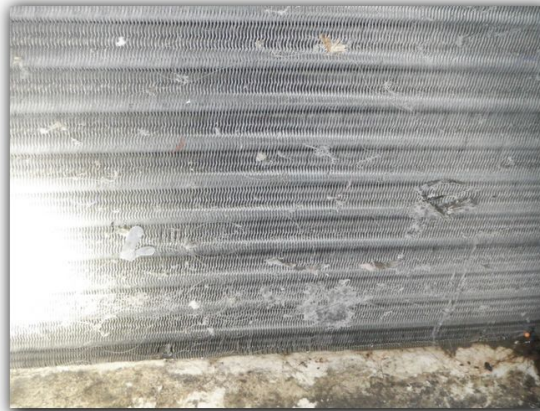
Coils are dirty, needs cleaning. Dirty coils reduce air flow thru the system and create high head pressures at the compressor, thereby unduly stressing and reducing life span of system components.

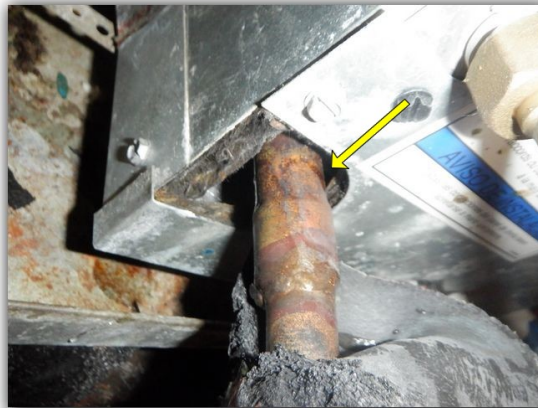
Excessive air loss at evaporator coil around drain and Freon line connections.

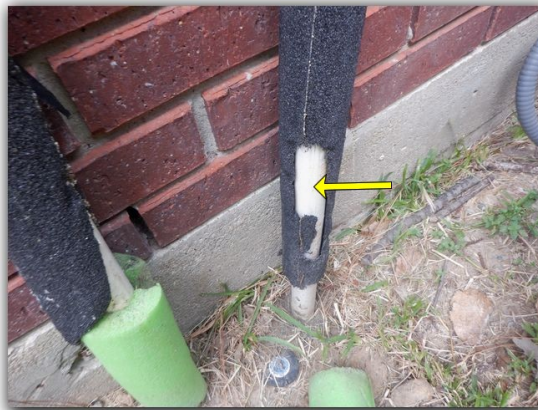
Recommend insulating exterior water line(s) to prevent freeze damage.

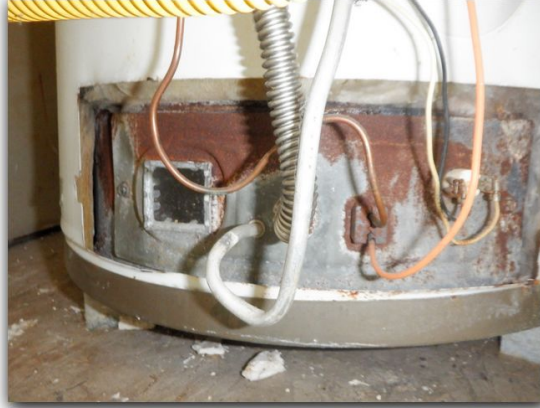
Corrosive damage was observed around the lower burner compartment.

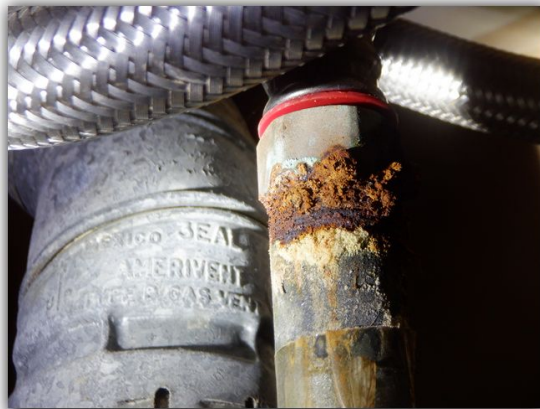
Corrosion observed at shut off valve and/or connections on top of water heater.

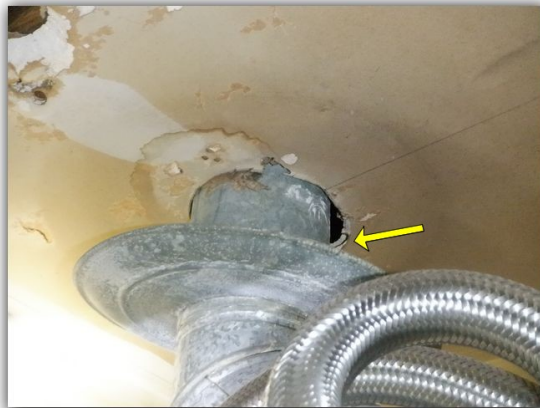
Vent collar not secured around vent pipe at ceiling and/or is missing.

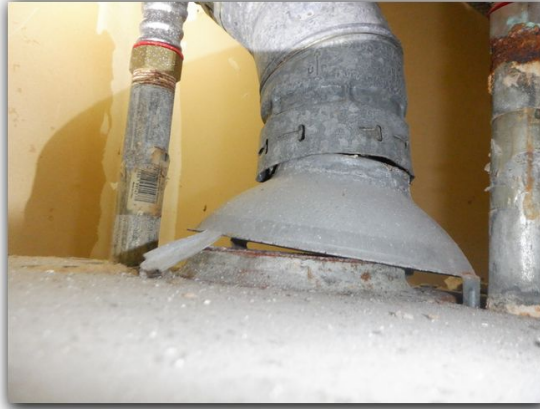
Improperly vented, vent pipe not properly aligned at top of water heater allowing products of combustion (bad gas) to vent into house/attic.

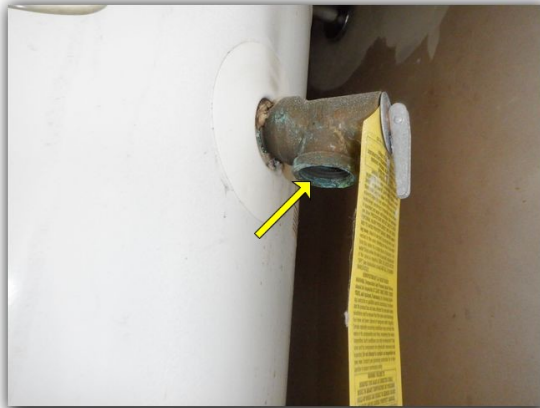
Drain line not connected to T&P valve, hazardous condition exists.

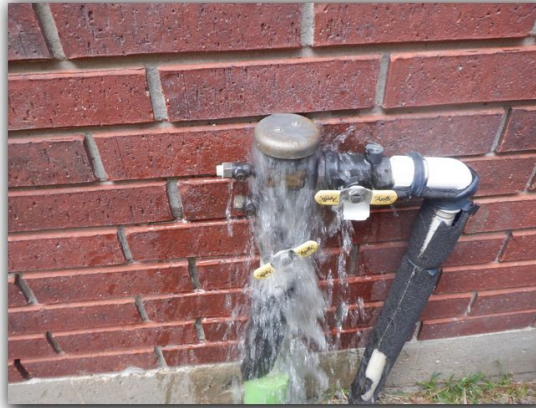
The sprinkler back flow preventer was damaged / could not be turned on. Sprinkler system could not be operated / inspected.
