**123 Sample Report St
Houston, TX 77005**

PROPERTY INSPECTION REPORT FORM

John Smith <i>Name of Client</i>	08/02/2022 <i>Date of Inspection</i>
123 Sample Report St, Houston, TX 77005 <i>Address of Inspected Property</i>	
John Tatum <i>Name of Inspector</i>	Professional Inspector # 9459 <i>TREC License #</i>
 <i>Name of Sponsor (if applicable)</i>	 <i>TREC License #</i>

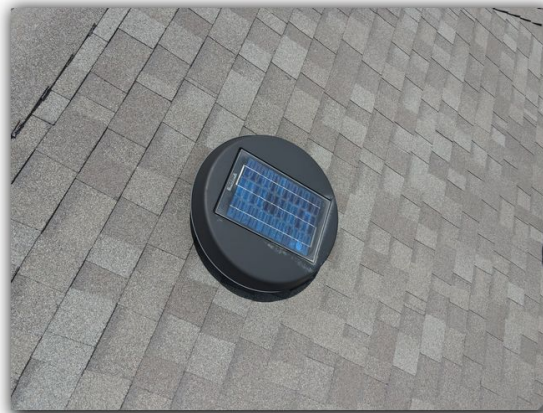
The solar powered roof vent operation could not be confirmed.

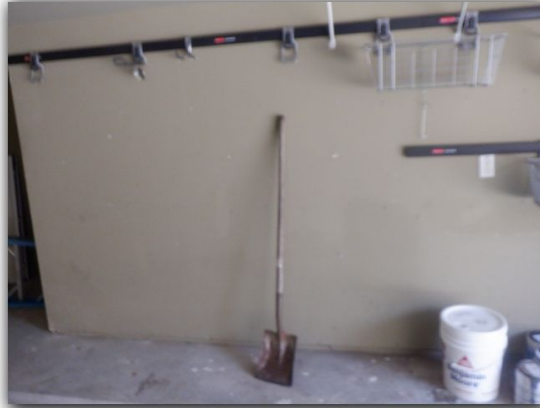
Recommend repairing holes / openings in garage walls and / or ceiling to serve as fire stopping to comply with current code and help protect house.

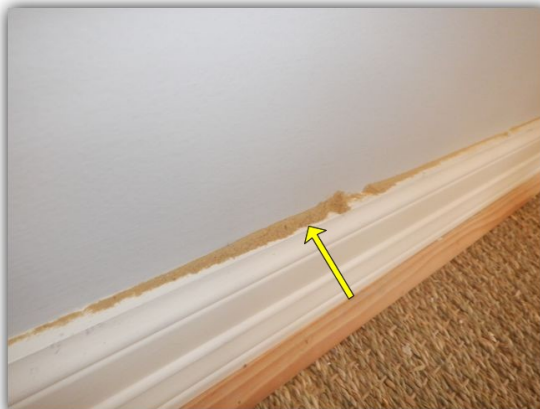
Saw dust was present along the base board in the room over the garage. Recommend inquiry of the seller.

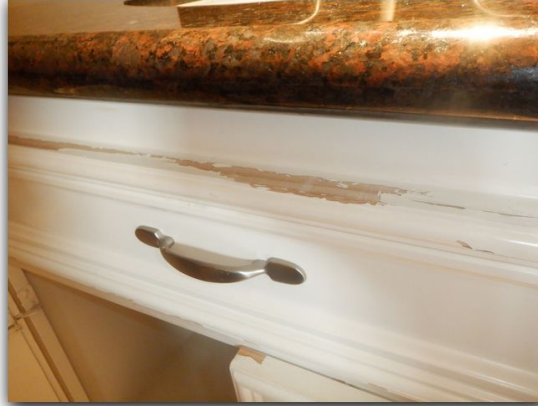
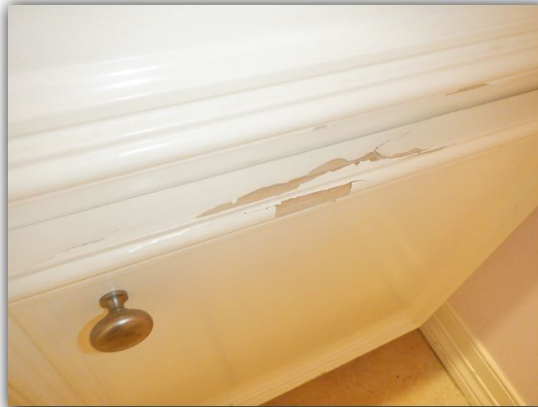
Peeling paint was observed to the cabinetry in multiple bathrooms.

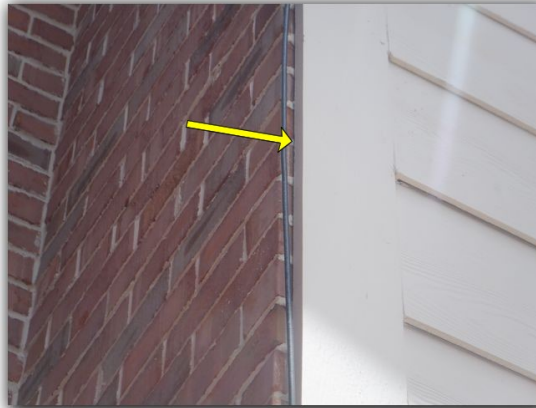
Caulking missing and/or deficient around vertical trim boards may allow wind driven rain entry.

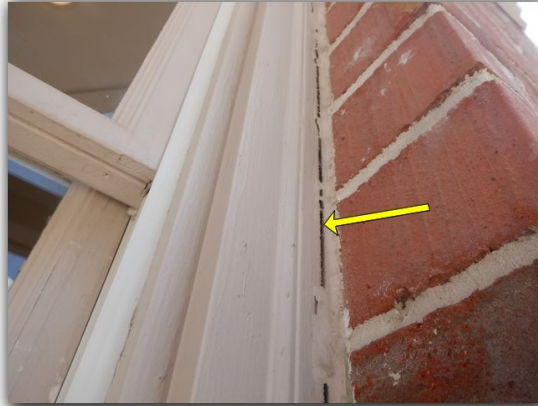
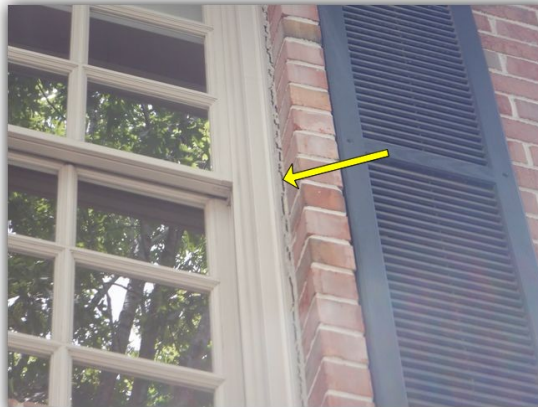
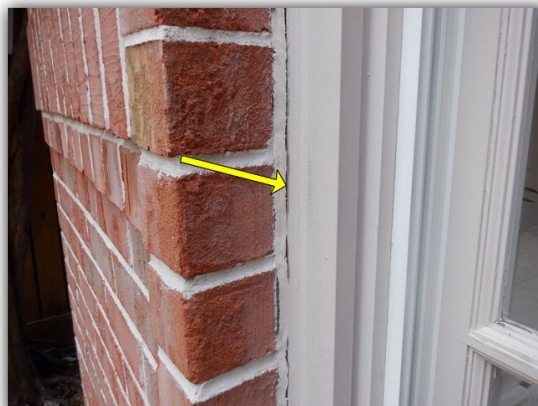
Caulking deficient around one or more windows, will allow water penetration during heavy / wind driven rains.

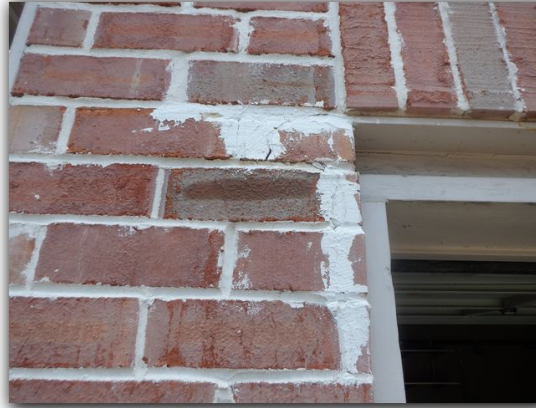
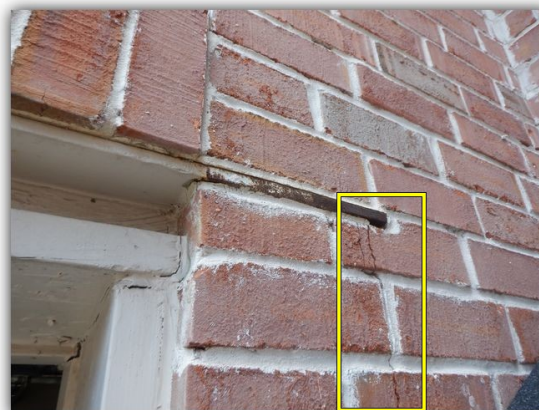
Cracks at upper corners of windows is typical due to not enough space left at ends of steel lintel at time of construction to allow for expansion of metal.

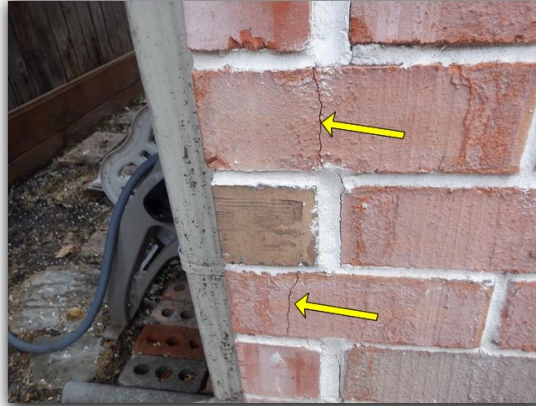
Cracks in brick veneer and/or repairs, one or more locations, Recommend buyer take photographs of cracks, their location, and width [ruler across the crack] with a high resolution camera that has a date stamp for future reference. Including but not limited to the following location(s): (Northwest corner)

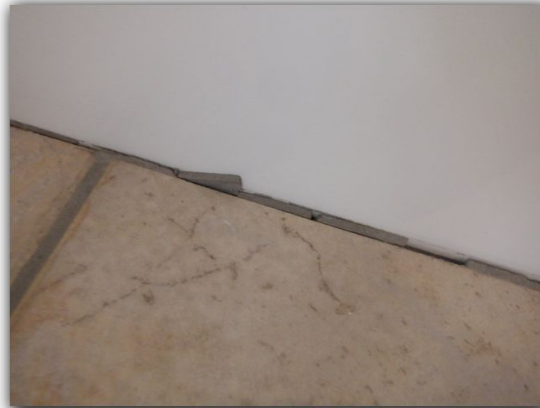
Multiple grout deficiencies were observed in the dining room.

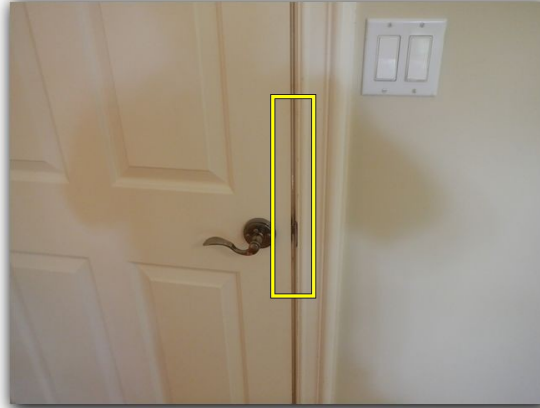
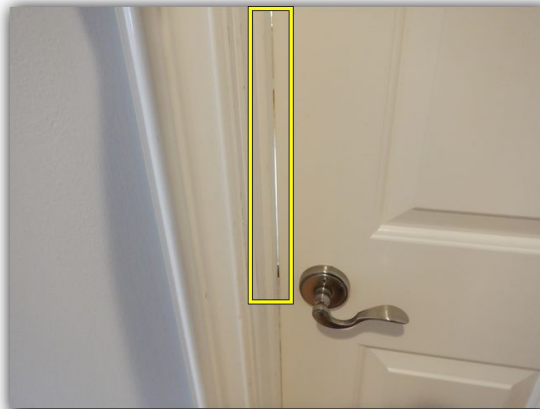
Gapping was present between the door and frame to the Northeast bedroom.

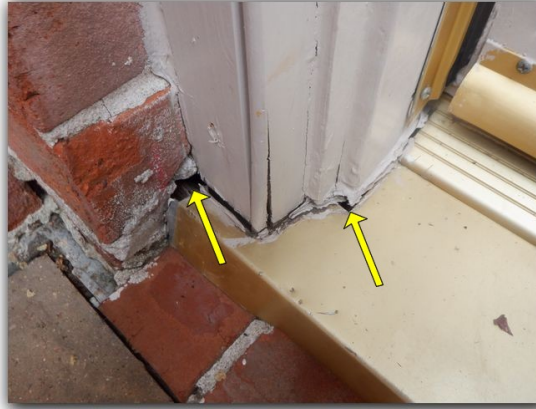
The northwest exterior door threshold was loose and very poorly sealed / will allow water entry.

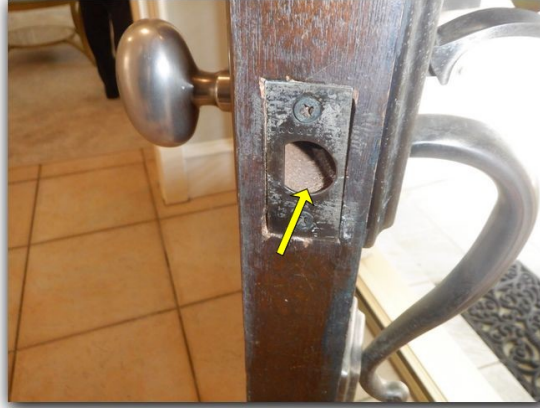
The front door was missing the latching hardware / would not latch.

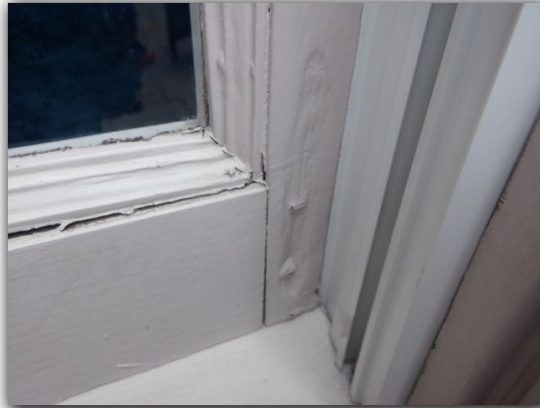
Wood rot of window frame/jambs observed at numerous locations.

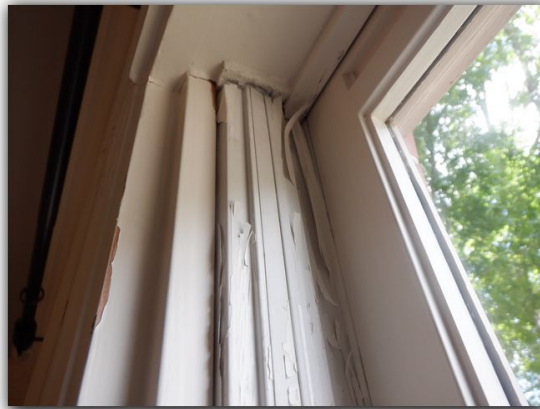
The paint was observed to be peeling heavily at the dining room windows.

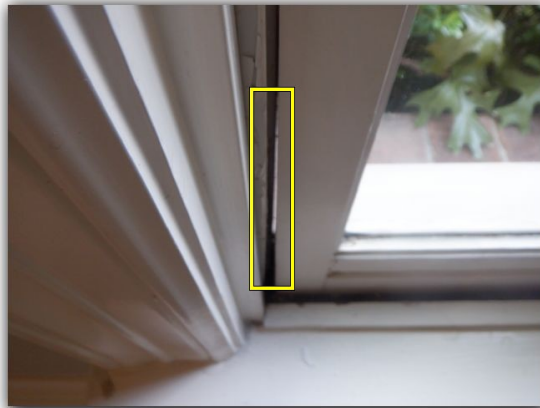
A gap was present between the window and frame at the southern dining room window.

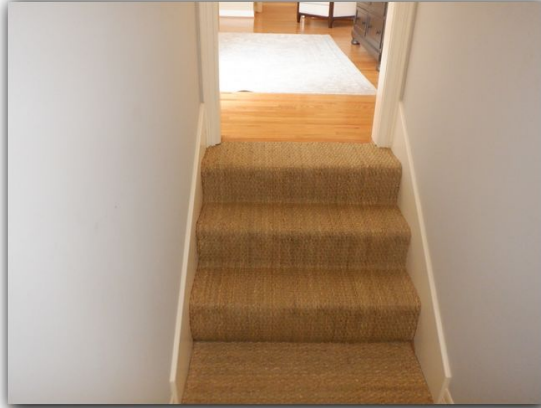
Stair steps having 3 or more risers should have a handrail for safety.

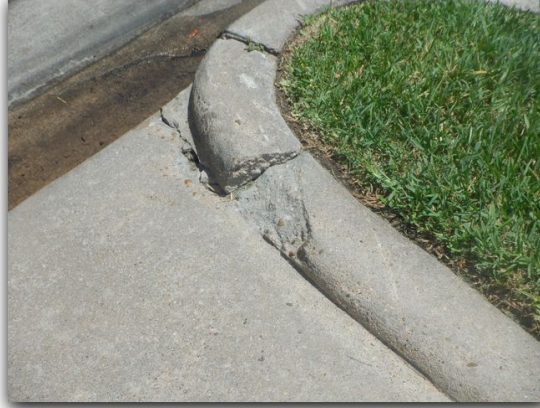
The concrete curb was observed to be damaged at the end of the driveway.

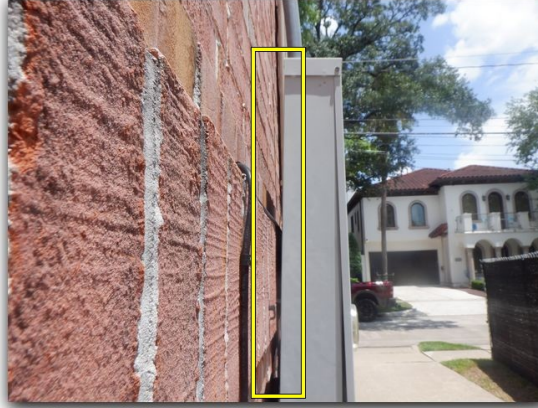
The electric panel was pulling away from / is not adequately secured to the wall.

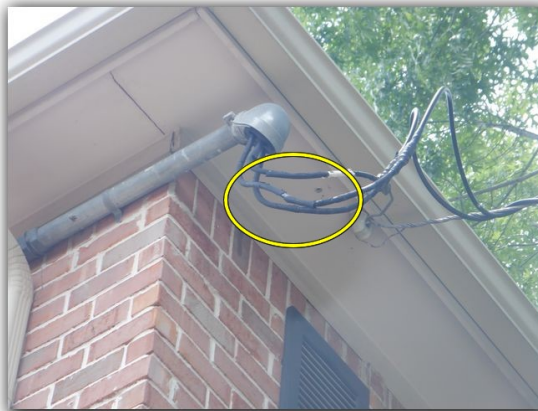
Electrical wiring insulation is damaged on service drop. Recommend evaluation by Center Point.

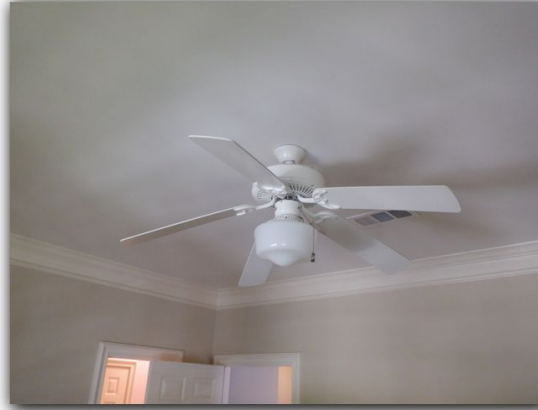
The fan blades were loose in the northeast bedroom and in the living room.

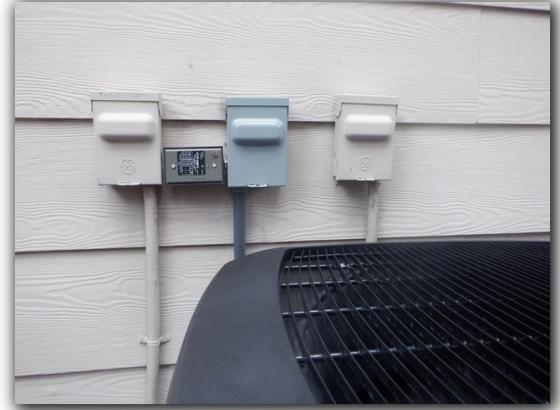
Code requires minimum clearance to electrical service panels to be 36" in front of and 30" from side to side. (A/C disconnects)

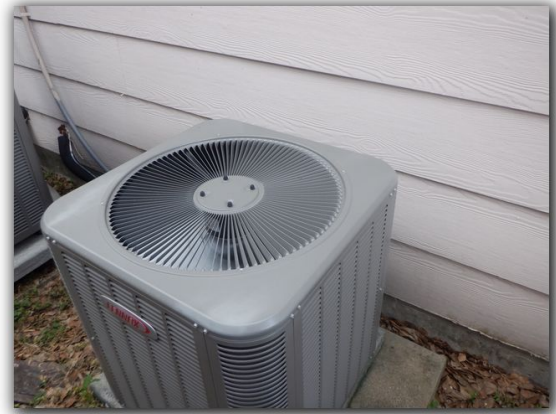
Condenser coil location requirements

Buyers note; Keep walls/fences/decks a minimum of 2 feet away from sides of A/C unit and a minimum of 4 feet over unit to allow proper air flow across coils and/or proper access to unit for servicing.

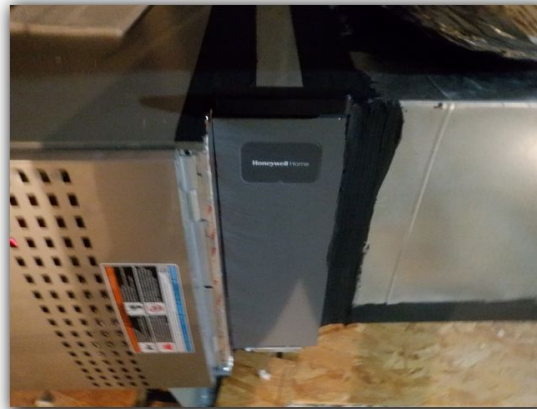
Media air filter(s) located in attic that requires changing/cleaning every 6 months, recommend checking guide for proper maintenance information.

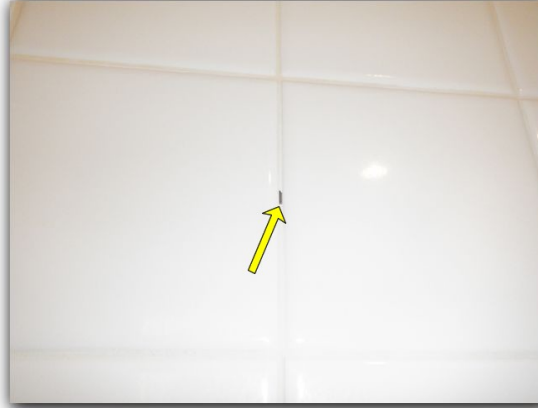
Minor grout deficiencies were present in the tub of the room over the garage.

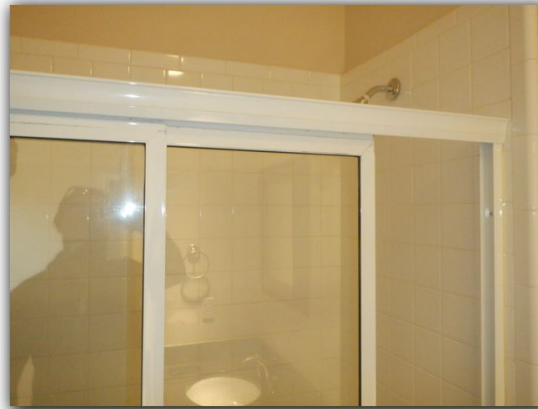
The bathtub sliding glass door framing was very loose and the doors were off the tracks in the 2nd floor middle south bathroom.

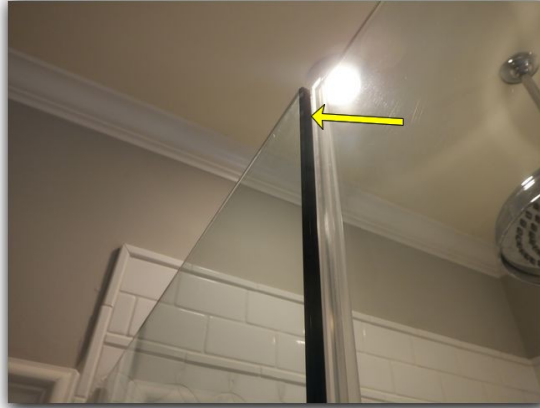
Shower door needs adjustment to operate/close properly. (Master bathroom shower)

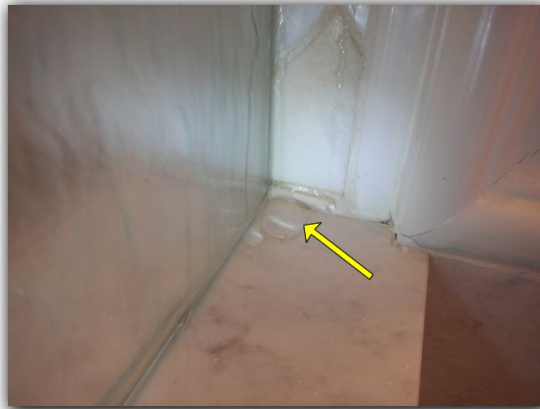
Shower door lower weather stripping loose and / or damaged, results in possible water leaking from base of door, needs repair / replacement. (Master shower)

The master shower enclosure needs to be re-sealed / currently leaks.

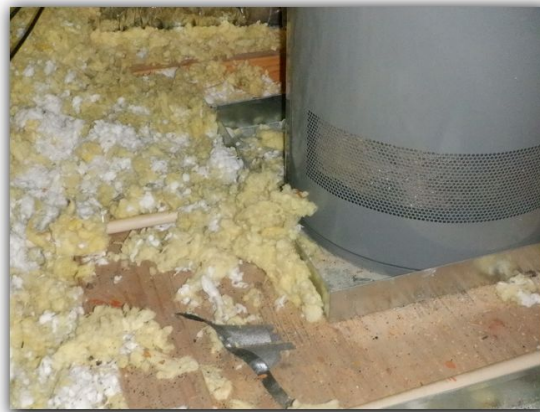
Insulation / debris in drain pan needs to be removed to prevent clogging of drain line.

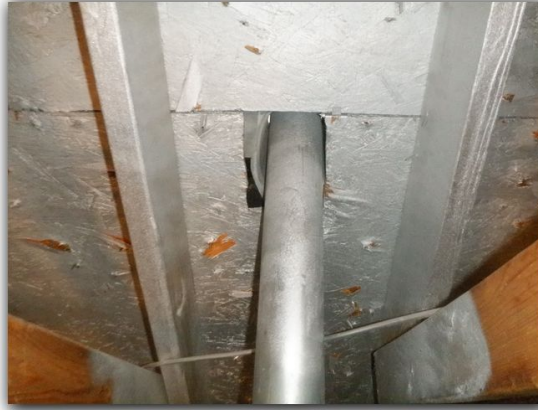
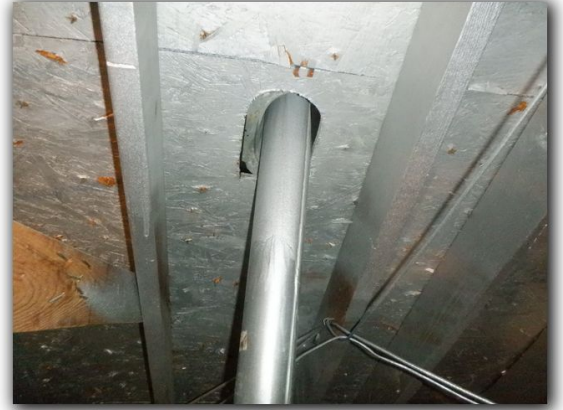
Vent pipe(s) is (are) not properly secured (strapped) in place.

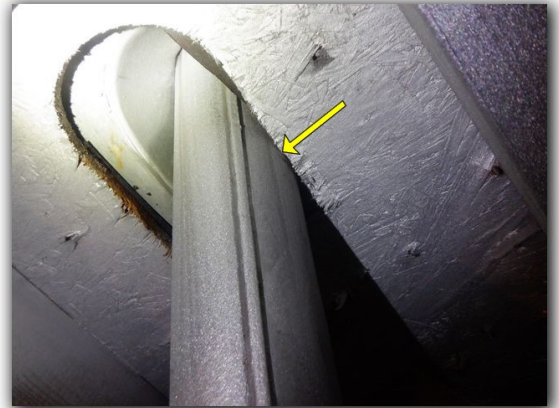
Exhaust vent pipe is in contact or does not have required minimum 1" clearance from combustible material, [wood roof decking].

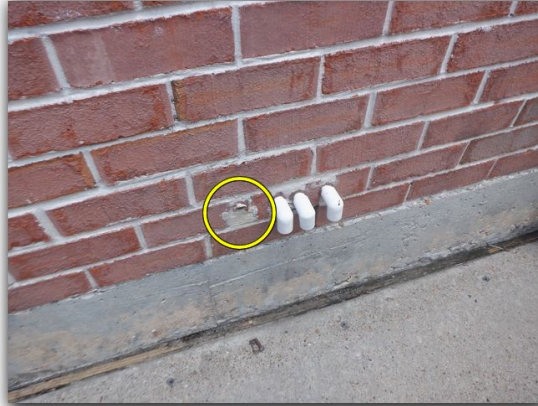
The drain line termination for the water heater drain pan drain line or temperature and pressure relief valve drain line was damaged at the southern exterior.

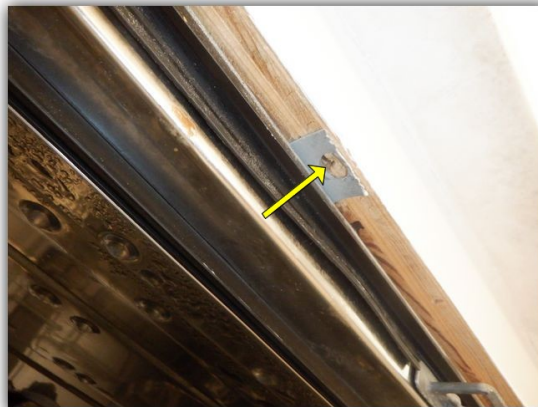
Not fully secured to underside of kitchen counter top.

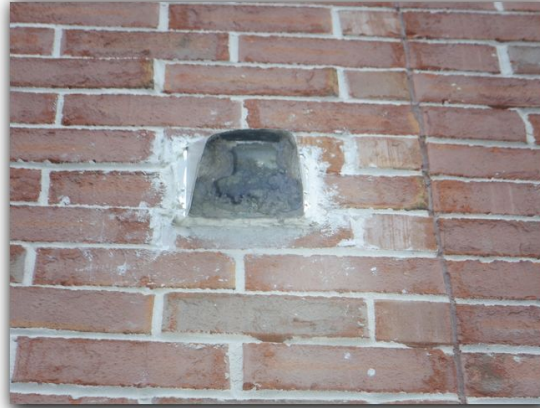
Dryer vent contains lint buildup. Recommend cleaning dryer vent to reduce drying time and risk of fire hazard.

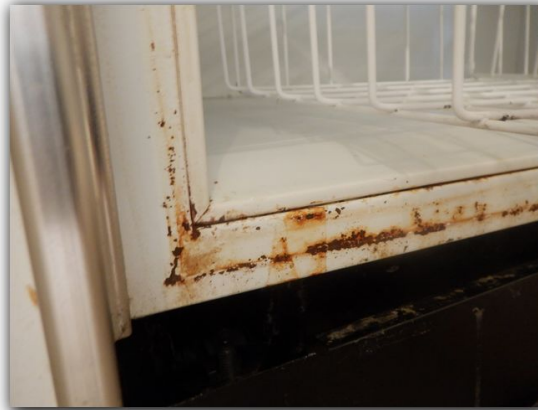
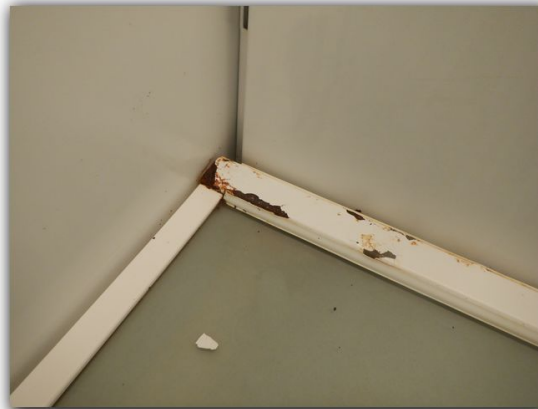
Heavy corrosive damage is present on the interior of the refrigerator / freezer.

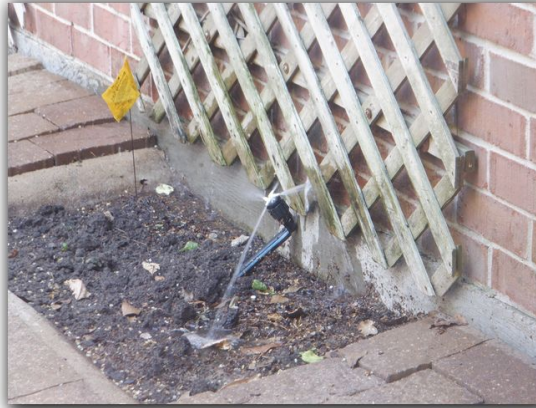
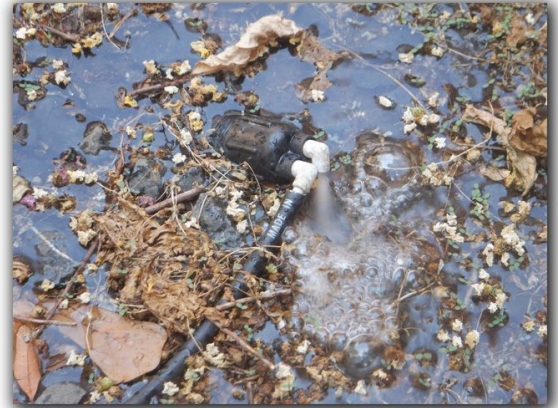
One or more spray heads need adjustment for proper yard cover and reduced over spray on house.

Zone 3 was off, but when operated, it appears that multiple heads are intended for potted plants.
