**Pier & Beam Sample report
Houston, TX 77008**

PROPERTY INSPECTION REPORT FORM

John Doe <i>Name of Client</i>	10/13/2022 <i>Date of Inspection</i>
Pier & Beam Sample report, Houston, TX 77008 <i>Address of Inspected Property</i>	
John Tatum <i>Name of Inspector</i>	Professional Inspector # 9459 <i>TREC License #</i>
 <i>Name of Sponsor (if applicable)</i>	 <i>TREC License #</i>

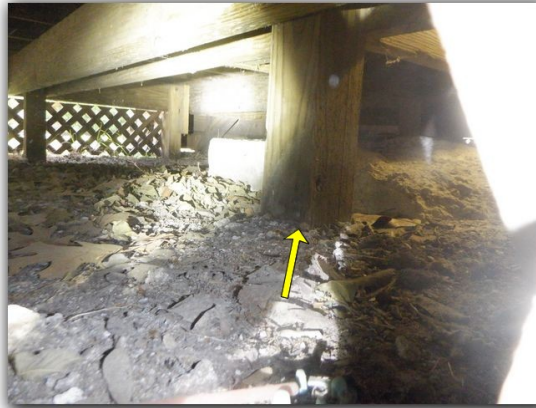
Earth wood contact in some areas, conducive condition to termite activity and wood rot.
(Below the porches)

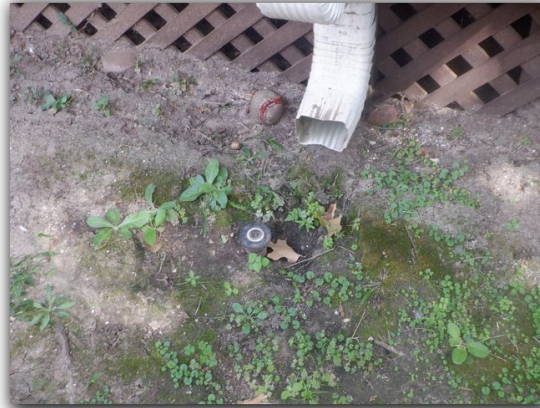
Downspouts need splash blocks at bottoms to prevent soil erosion.

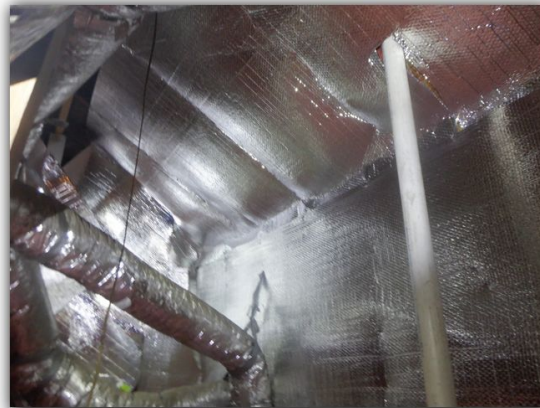
The majority of the attic framing was not visible due to radiant barrier sheeting.

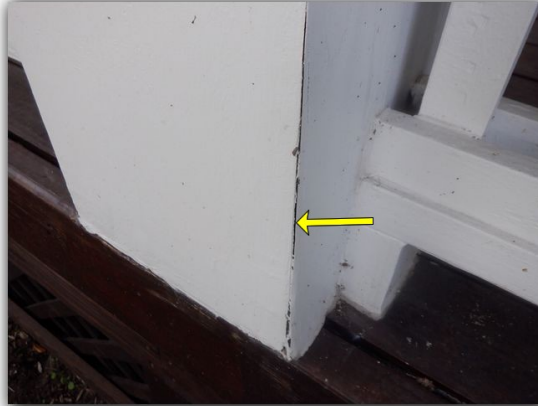
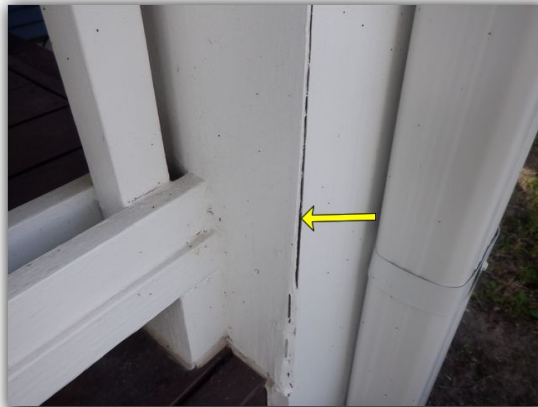
Caulking missing and/or deficient around vertical trim boards may allow wind driven rain entry.

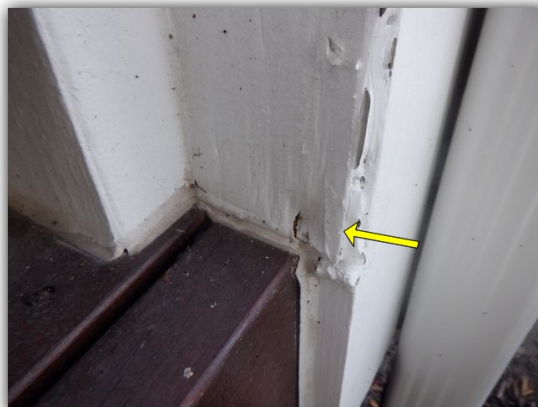
Wood rot / damage observed bottom/base of one or more wood columns.

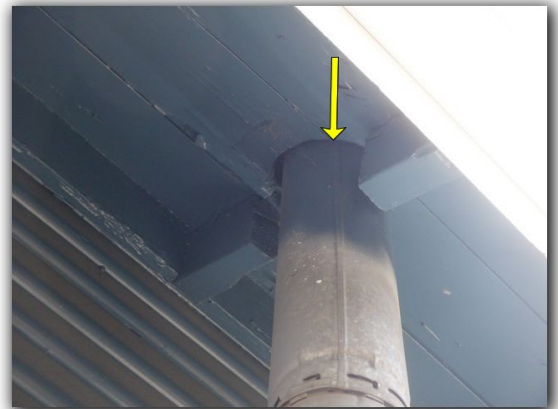
Vent clearances

Exhaust vent pipe is in contact with combustible material, [wood roof decking]. Current industry standards (code) require 1" clearance for double wall vent pipe.

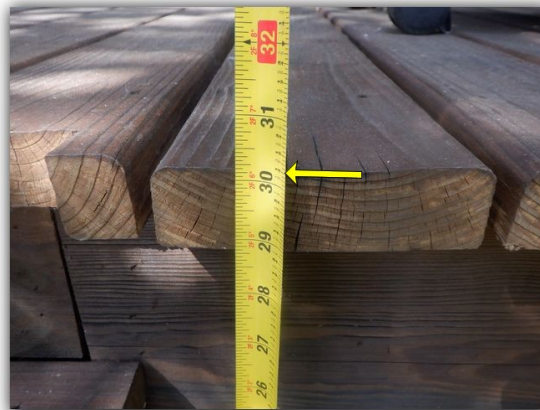
Exterior porch/patio(s) at or greater than 30 inches above ground should have proper guardrail height of 36 inches. Ref. CABO 315.1 IRC R312.1.

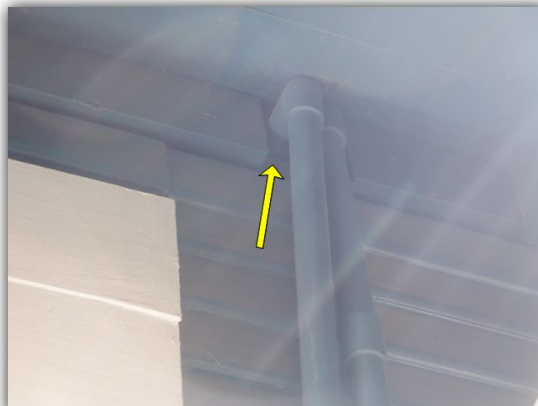
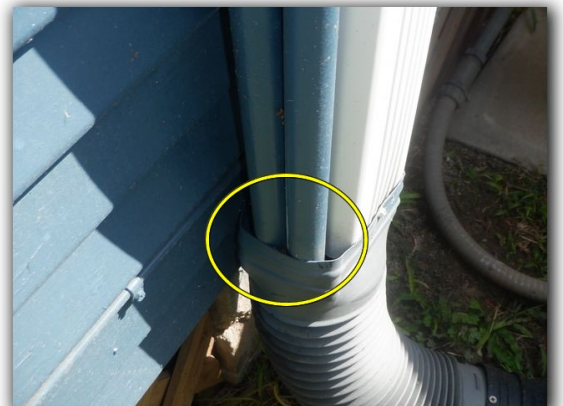
The secondary drain line for the A/C does not properly terminate over a door or window as is currently required.

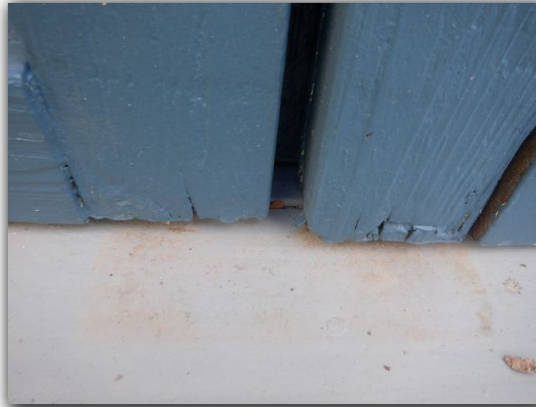
Wood rot was observed around the perimeter of the backyard shed.
