SENTINEL
INSPECTION GROUP

**456 Your Street
Houston, TX 77084**

PROPERTY INSPECTION REPORT FORM

Jane Smith <i>Name of Client</i>	10/29/2022 <i>Date of Inspection</i>
456 Your Street, Houston, TX 77084 <i>Address of Inspected Property</i>	
John Tatum <i>Name of Inspector</i>	Professional Inspector # 9459 <i>TREC License #</i>
 <i>Name of Sponsor (if applicable)</i>	 <i>TREC License #</i>

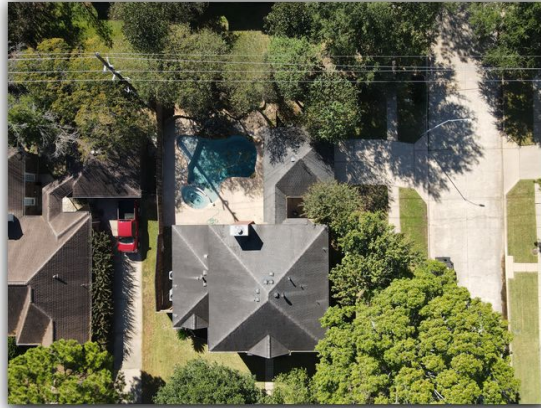
Older roof, nearing end (last 1/3 to 1/4) of serviceable life. Observed Brittle, cracked, curled ends, and/or excessive granular loss of shingles.

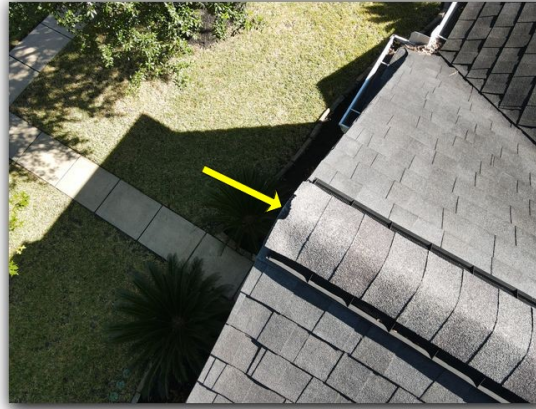
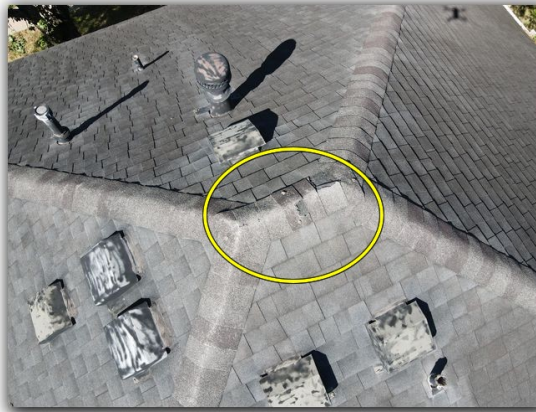
Areas that need immediate attention, including but not limited to; (e.g., torn/damaged shingles, etc.)

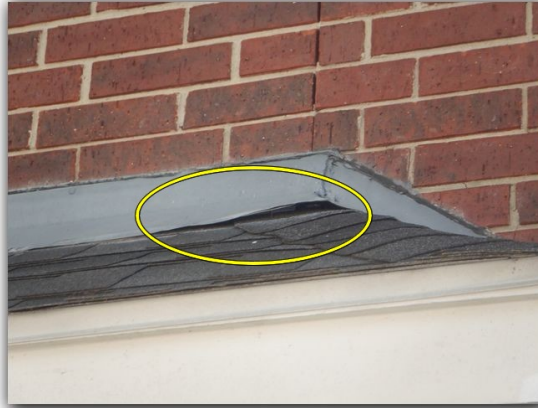
Lower side of flashing is not sealed down at one or more locations where roof meets vertical wall, wind driven rains will cause water penetration.

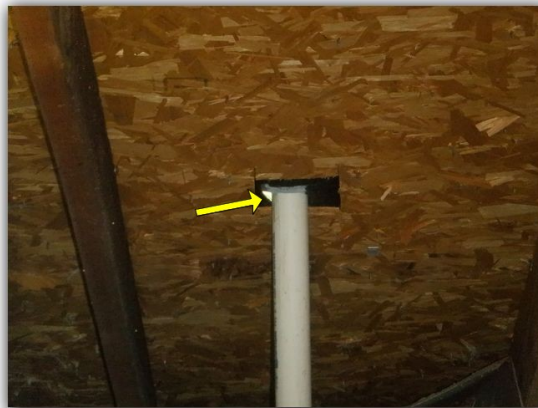
Roof water penetration observed at the following location(s): (Around multiple drain waste vents in the attic)

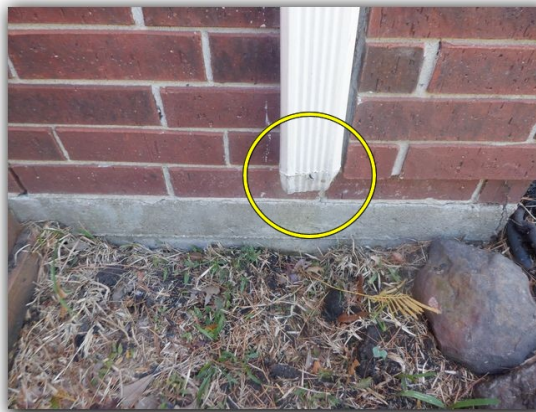
One or more downspouts were observed to be damaged.

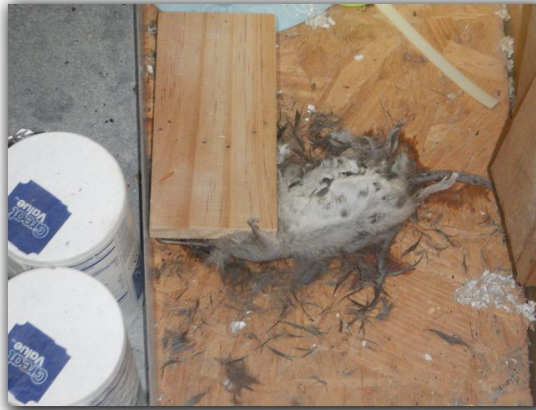
Evidence of previous (possibly current) rodent activity in attic.

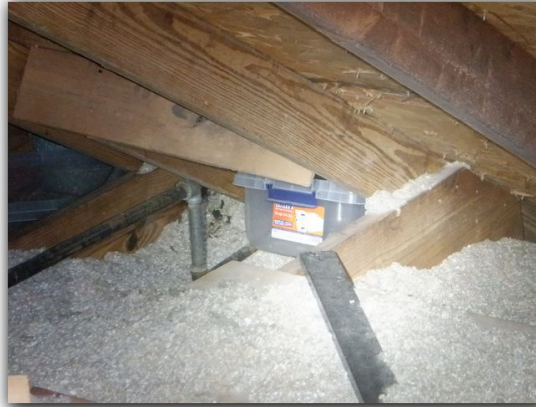
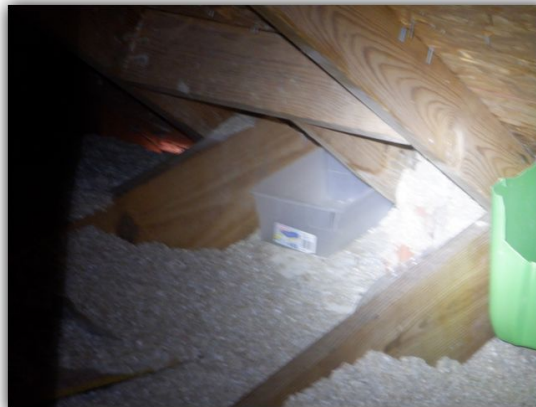
Observed bucket(s) in attic, possibly used for roof leak in the past or currently in use. Recommend inquiry of seller.

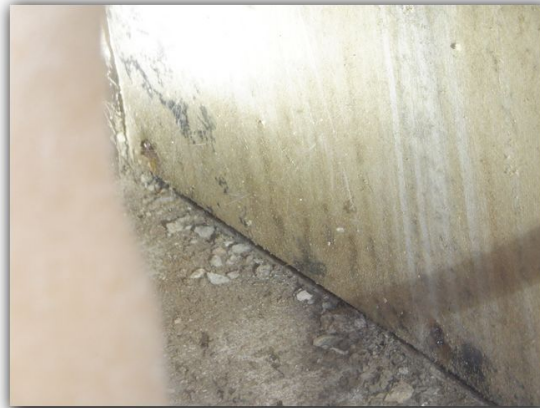
Observed possible micro-organism growth (Below the master bathtub) which may be a concern due to increased awareness of environmental issues associated with molds. Recommend removal of all sheetrock containing visible mold growth plus an additional 2 feet surrounding area. *This company does not inspect for and is not qualified to render opinions on any type on environmental or other bio-hazards. If this is a concern or potential concern, Sentinel Inspection Group recommends contacting a qualified professional of your choice for further information / investigation.*

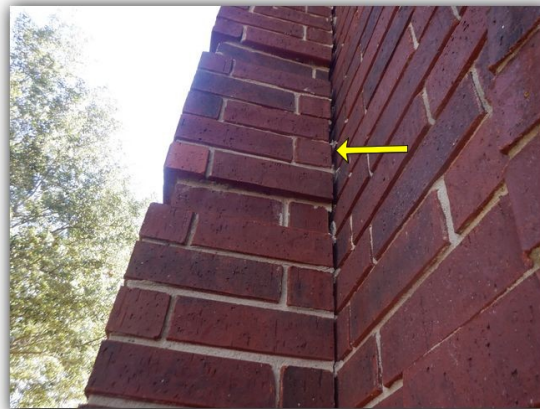
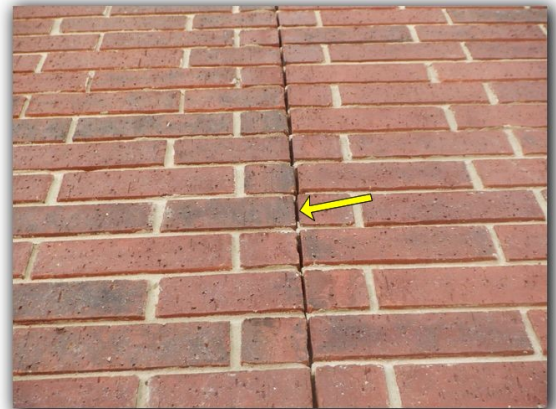
Expansion joint(s) and / or inside corners in brick veneer need caulking. Ensure any mortar present in expansion joint is first removed before sealing.

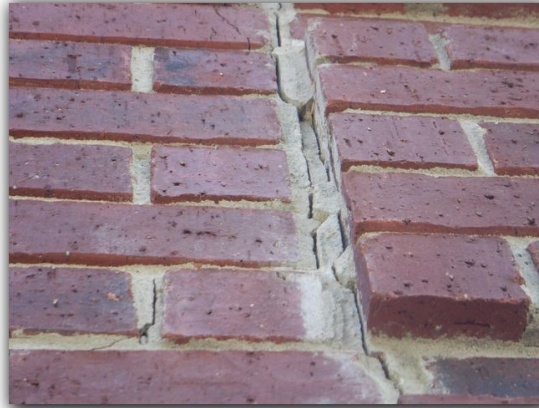
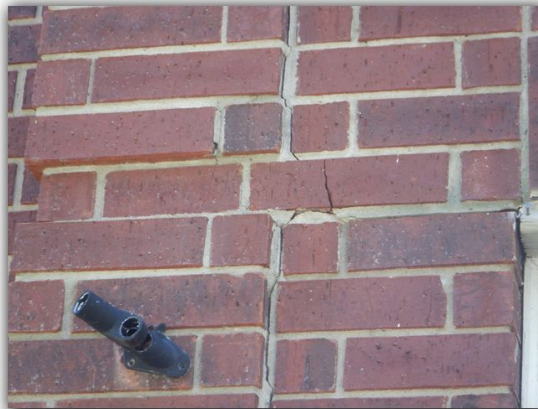
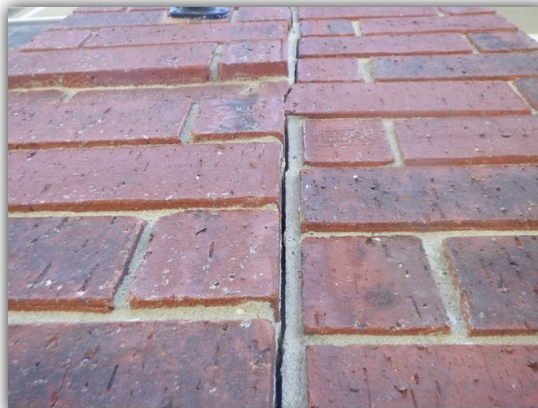
Cracks in brick veneer and/or repairs, one or more locations, Recommend buyer take photographs of cracks, their location, and width [ruler across the crack] with a high resolution camera that has a date stamp for future reference.

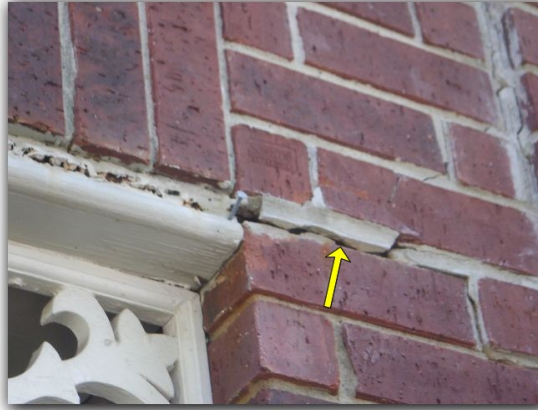
Cracks at upper corners of windows is typical due to not enough space left at ends of steel lintel at time of construction to allow for expansion of metal.

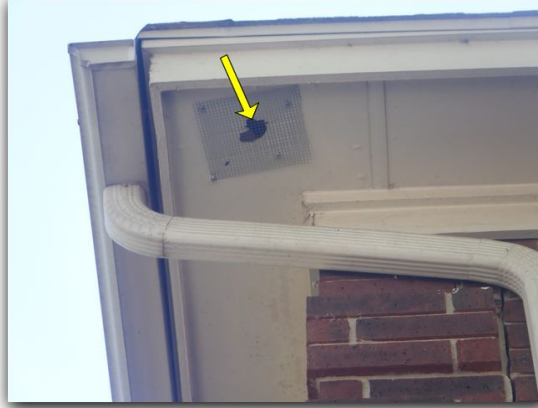
Soffit damage was observed at multiple locations of the west exterior.

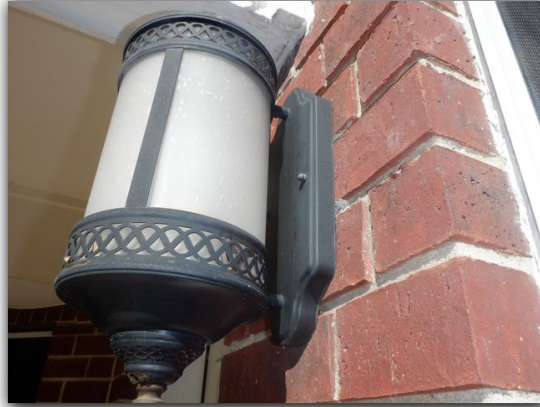
Need sealing / caulking around all holes and exterior siding penetrations on top and both sides, (leave bottom open) to prevent water entry. Including but not limited to dryer, bath and range top vents, light fixtures, etc. Need sealing / caulking around all holes and exterior siding penetrations on top and both sides, (leave bottom open) to prevent water entry. Including but not limited to dryer, bath and range top vents, light fixtures, etc.

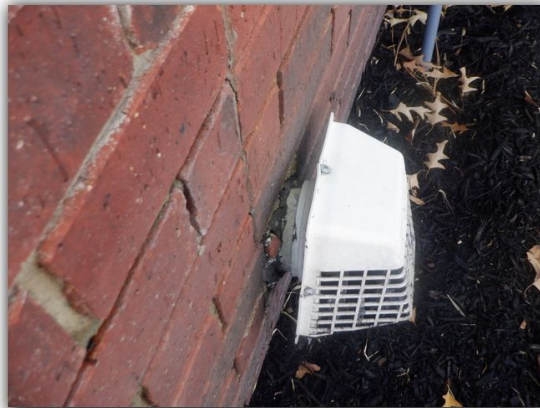
The dryer vent was not properly flush and sealed at the exterior wall.

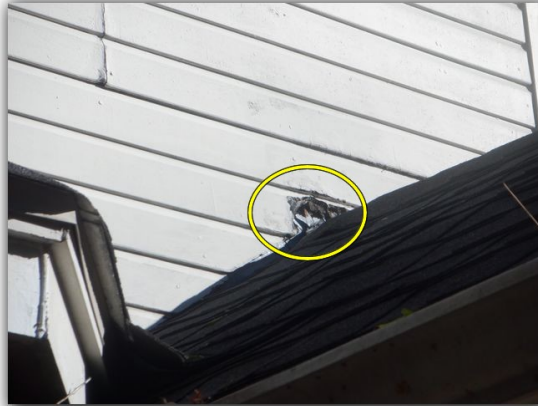
Synthetic wood siding observed on house, it is common industry knowledge that this siding has a tendency to rot easily if not kept well sealed / painted and that most manufactures of this type of product are / have been involved in some type of class action lawsuit.

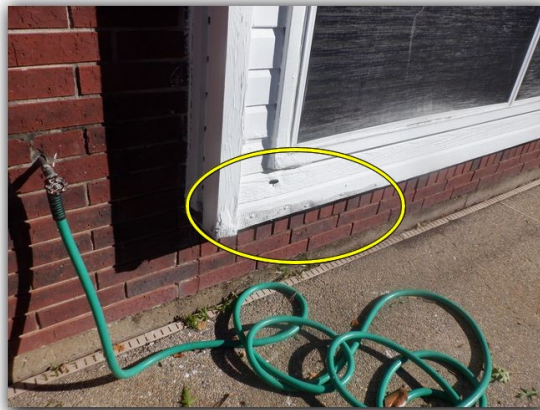
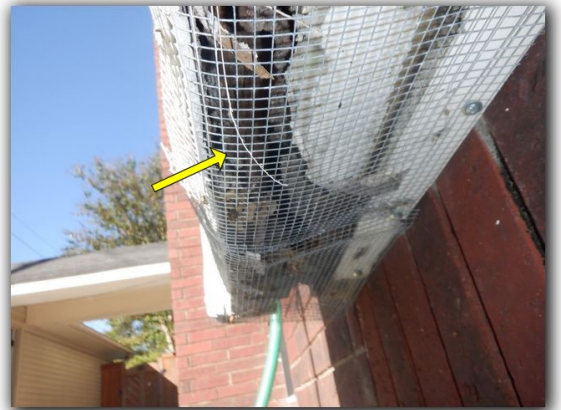
The underside of the southeast dormer was rotted out.

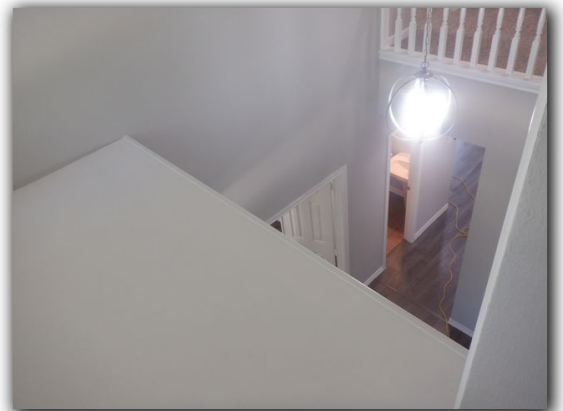
A latch / lock should be placed on the door to the area above the front entry from the 2nd floor northwest bedroom to prevent child entry to the area and possible serious injury.

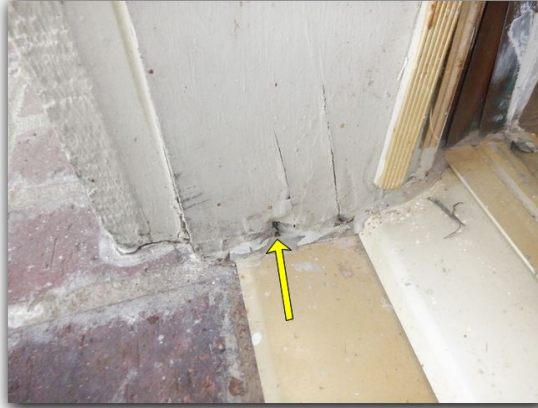
Wood rot of lower door and/or jamb; (Front door)

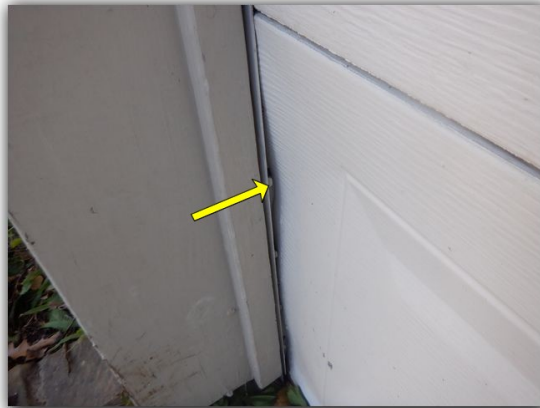
Denting / Damage was observed to the garage door.

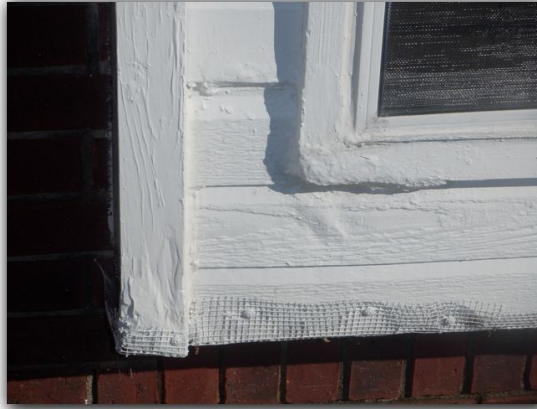
Wood rot of window frame/jambs observed at one or more locations.

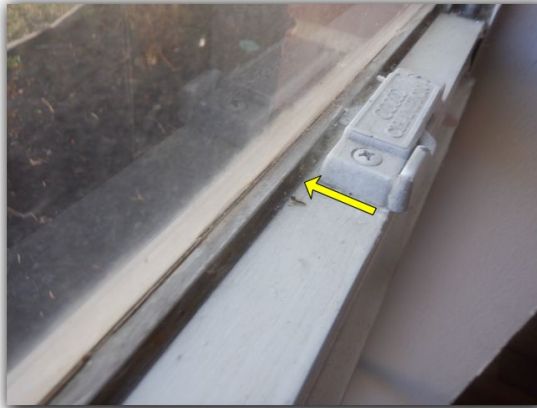
Many windows were observed to be improperly sealed shut. Buyer's note; bedroom(s) without operational / operable window and/or 2nd means of emergency egress is a RECOGNIZED FIRE/SAFETY HAZARD. Does not comply current life safety codes.

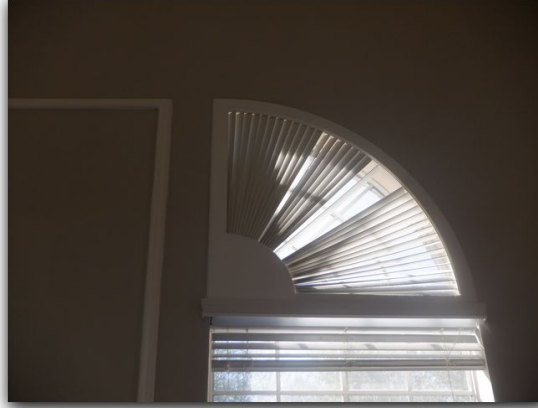
Multiple window blinds were observed to be damaged.

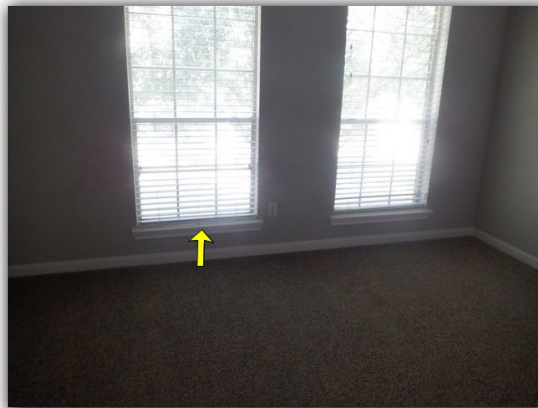
Windows at one or more 2nd floor rooms were a potential fall hazard for small children due to their low height above the floor; did not observe fall protection outside the window. Ref IRC R613.2 Window Sills: In dwelling units, where the opening of an operable window is located more than 72 inches above finished grade or surface below, the lowest part of the clear opening of the window shall be a minimum of 24 inches above the finished floor of the room in which the window is located. Glazing between the floor and 24 inches shall be fixed or have openings through which a 4-inch diameter sphere cannot pass.

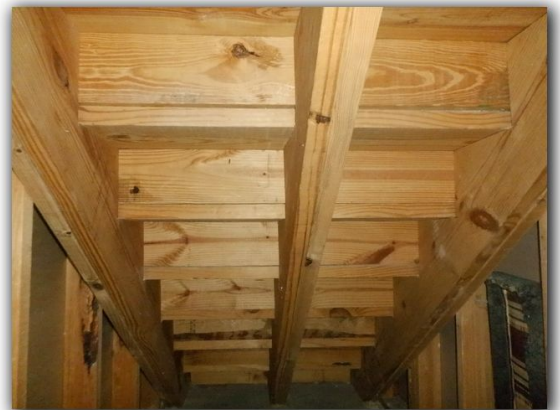
Bottom side of stairs is not properly fire stopped.

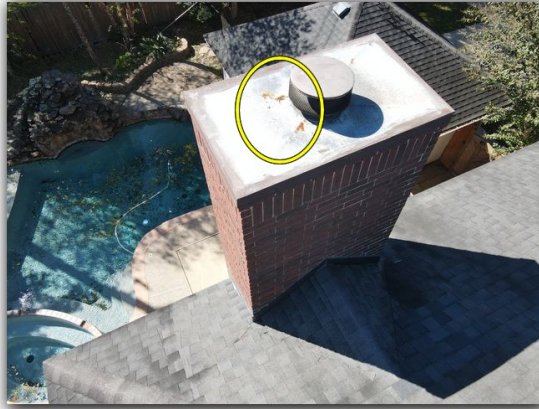
Recommend cleaning and painting corrosion on chimney cap.

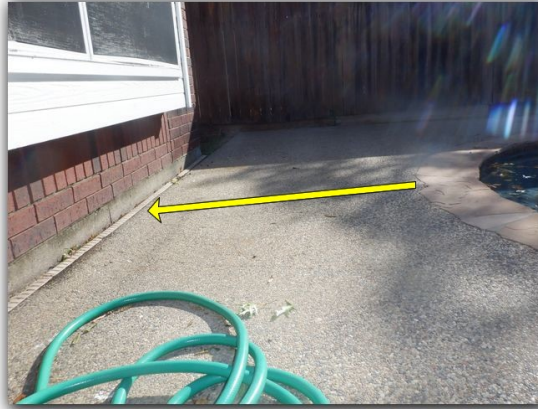
Exterior patio improperly slopes towards house. This condition tends to encourage water penetration during heavy rains.

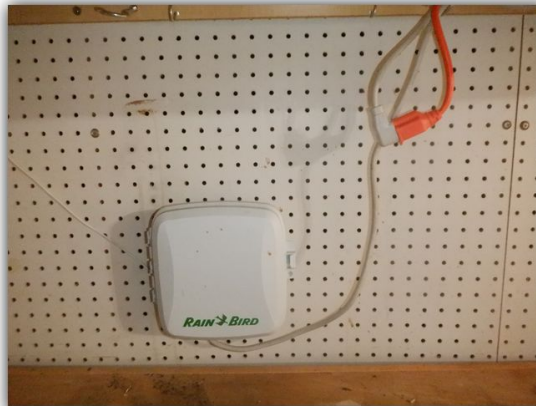
Extension cord wiring used improperly as permanent wiring; (To the sprinkler control panel)

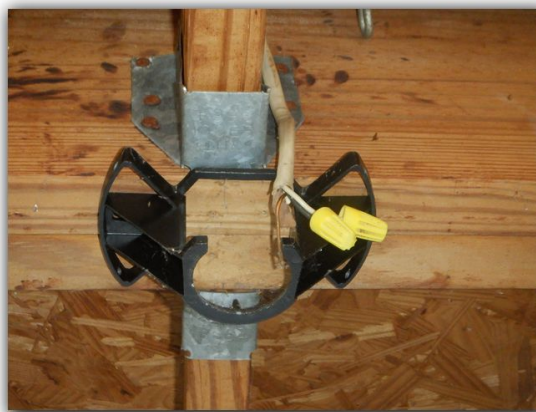
Wire improperly terminated, including but not limited to the following location; (Garage)

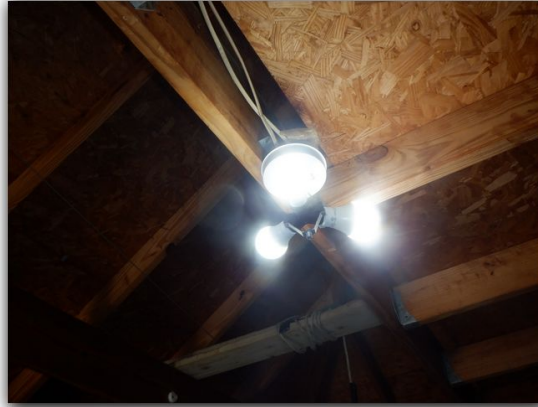
Light diffuser / globe cracked, damaged or missing; (Garage)

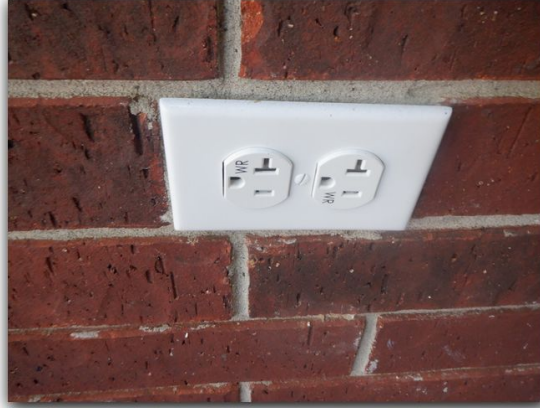
Exterior outlet damaged, missing weather proof cover, (Front porch)

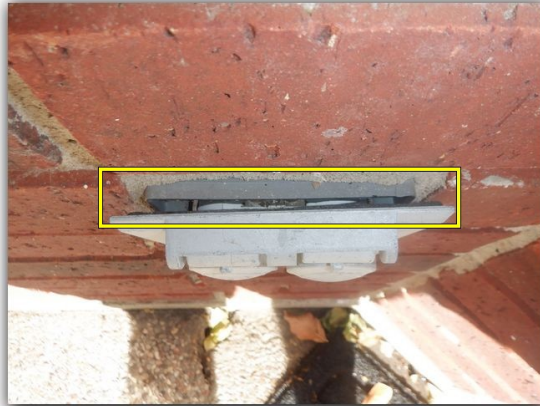
Exterior outlet(s) not sealed well against rain water entry.

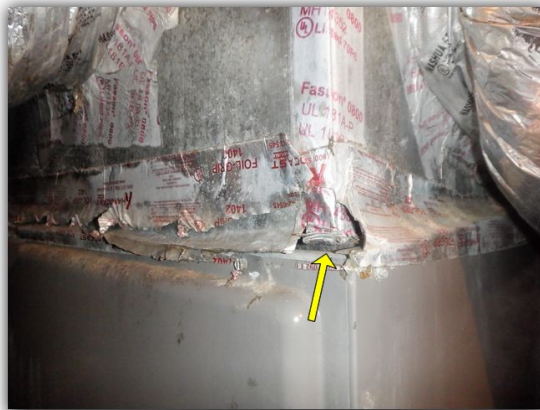
Excessive air loss around transition/coil/heater/plenum.

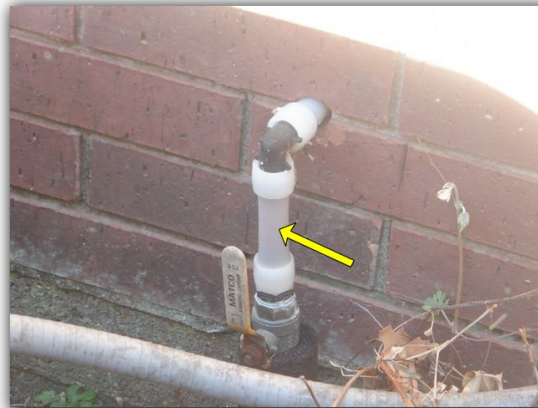
Recommend insulating exterior water line(s) to prevent freeze damage.

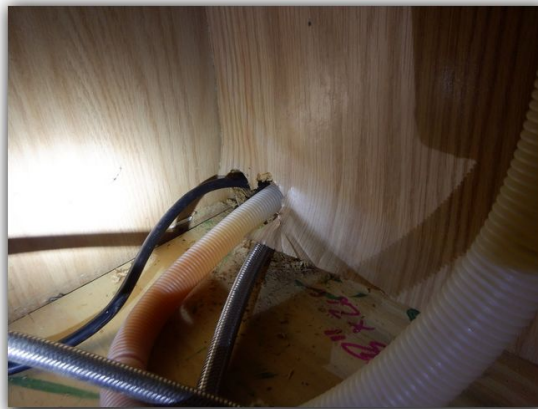
Water damage and loose decking were observed below the kitchen sink.

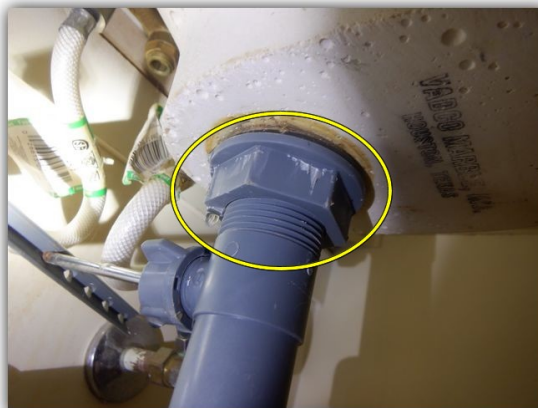
Large water leak below sink, (Left master bathroom sink)

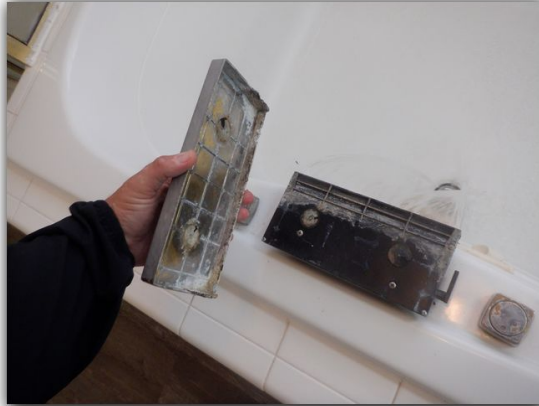
The master bathtub faucet was observed to be damaged.

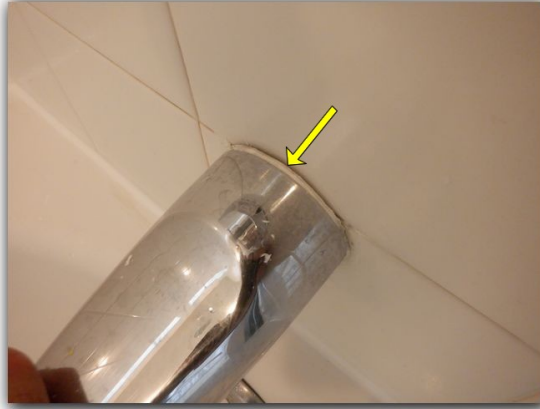
Recommend caulking around all tub/shower faucets and spouts to prevent water entry behind wall.

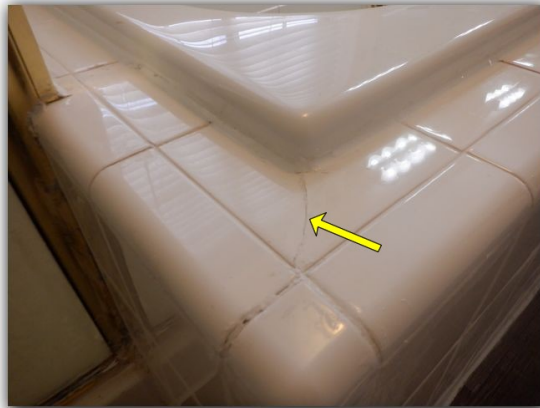
Observed cracked/loose tiles; (Master bathtub)

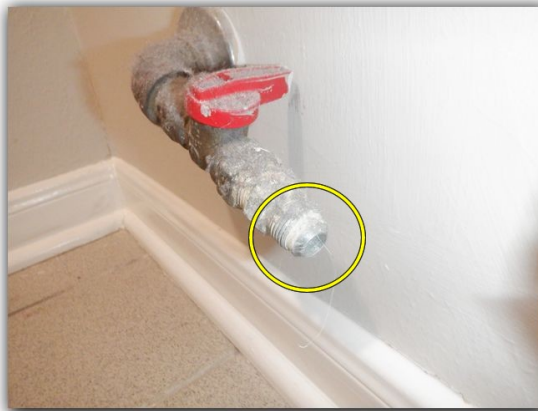
Uncapped gas valve at laundry room. Gas line needs to capped if not used.

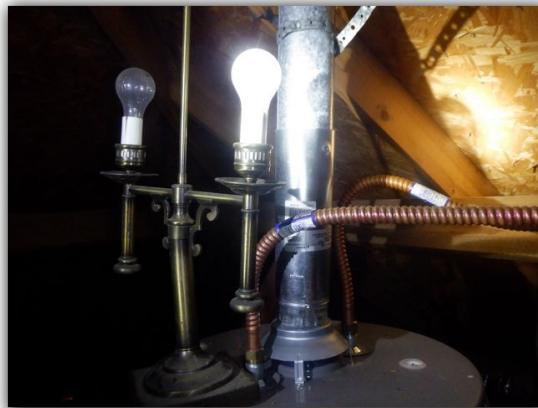
Vent pipe connection(s) improper, inside out / upside down, does not fully contain products of combustion in duct.

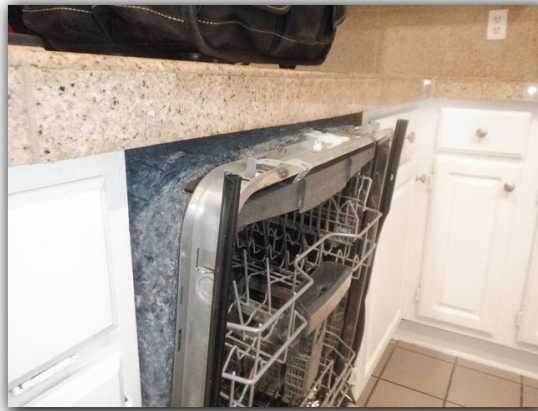
Not secured to underside of kitchen counter top.

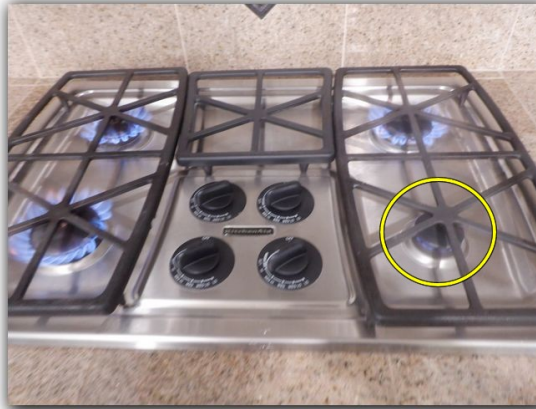
The flame was very low for the front right burner, even when set at high.

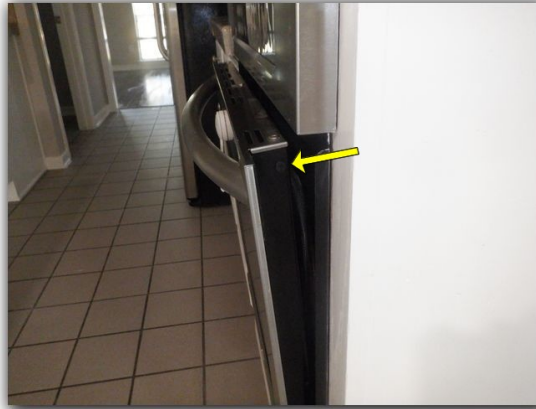
The oven hinges were worn, which is preventing full closure of the door. Accuracy of temperature could not be checked / tested as the oven would not properly function without physically holding the door shut.

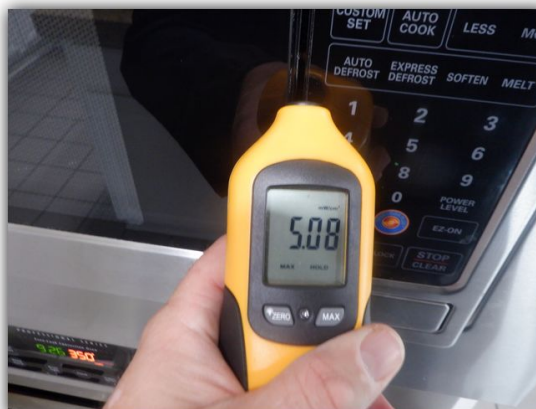
The door of the microwave did not appear to properly close. It door is simply touched while microwave is running, the microwave shuts off. Recommend further evaluation and repairing or replacing as necessary.

The microwave door is not properly sealed / has higher than normal leakage.

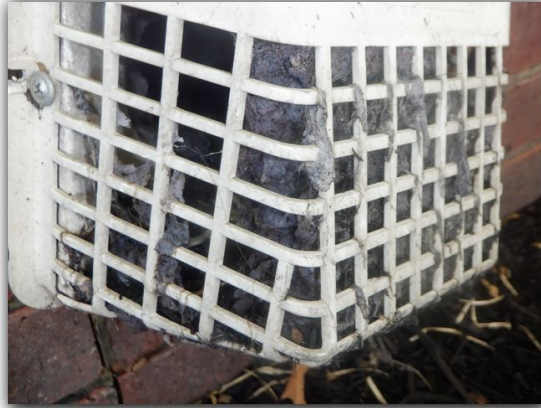
Dryer vent contains lint buildup. Recommend cleaning dryer vent to reduce drying time and risk of fire hazard.

Recommend periodic cleaning of the dryer vent ductwork to reduce the risk of fire.

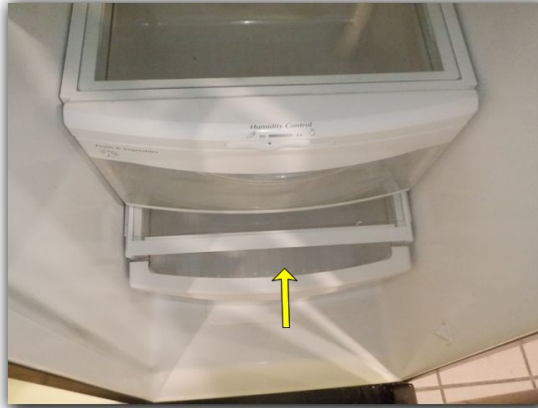
The refrigerator light did not function at the time of inspection.

Multiple areas of minor damage and missing components were observed in the refrigerator / freezer.
