PROPERTY INSPECTION REPORT FORM

John Doe <i>Name of Client</i>	10/30/2022 <i>Date of Inspection</i>
123 Your Street, Houston, TX 77030 <i>Address of Inspected Property</i>	
John Tatum <i>Name of Inspector</i>	Professional Inspector # 9459 <i>TREC License #</i>
 <i>Name of Sponsor (if applicable)</i>	 <i>TREC License #</i>

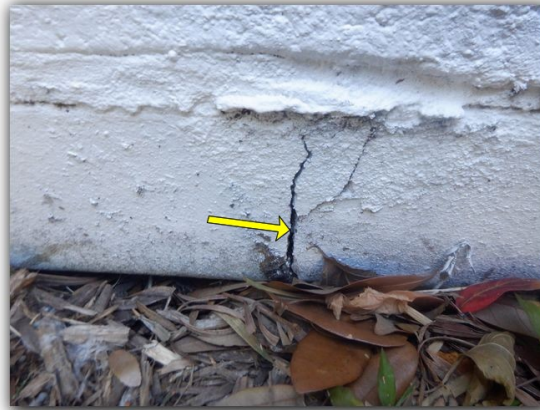
One or more cracks found in perimeter grade beam of house.

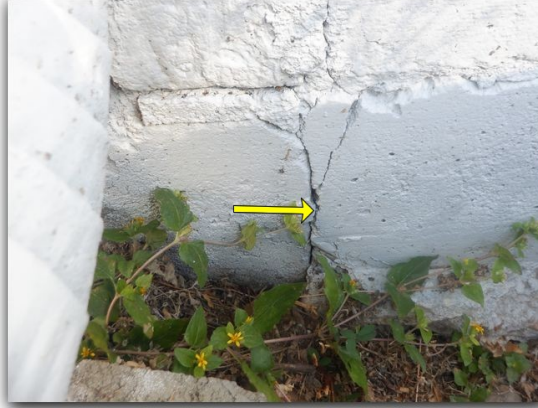
Observed addition to original house foundation. "Cold joints" where the two slab abut each other is a location for wood destroying insect to enter house unseen.

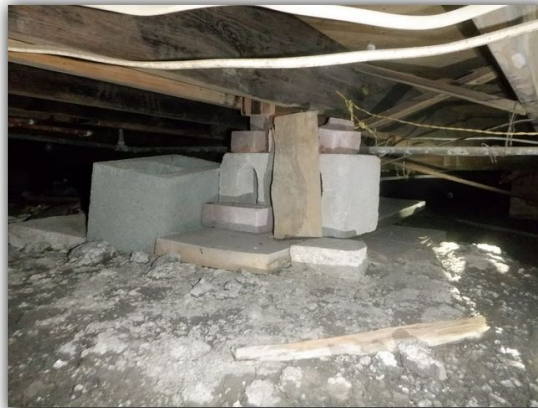
Spalling (i.e., corner pops) at one or more corner(s). Corner spalling is common to slab foundations and does not affect the structural integrity of the foundation.

An amateurish pier was present at the southwest corner of the house. Recommend replacing with a proper pier and making access to inspect the remaining framing and support piers.

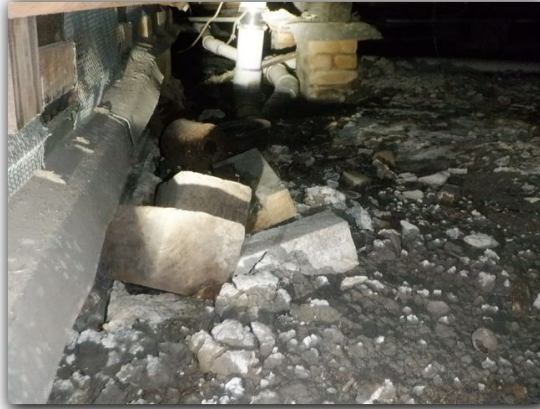
Recommend removal of debris / junk from below house.

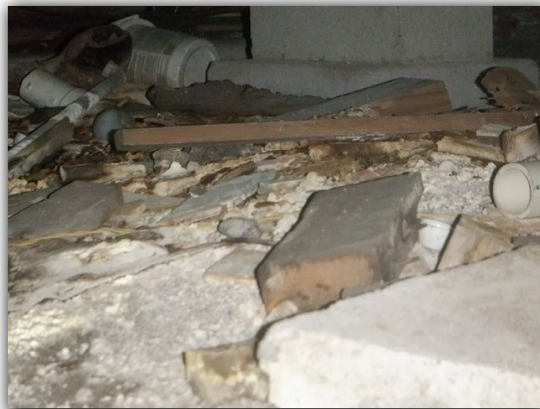
Scrap wood below house is considered a conducive condition for termites, recommend removal of all scrap wood below house.

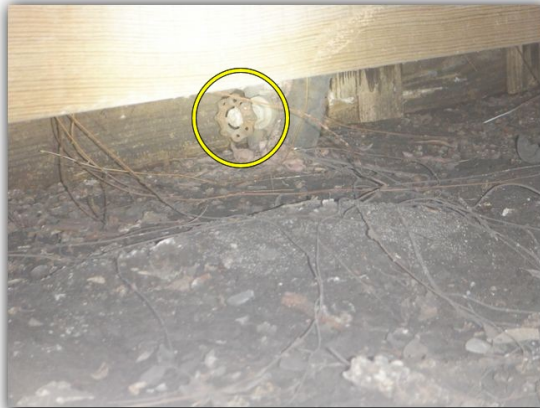
What appears to be a water shutoff was observed to be in an inaccessible area below the pool house foundation.

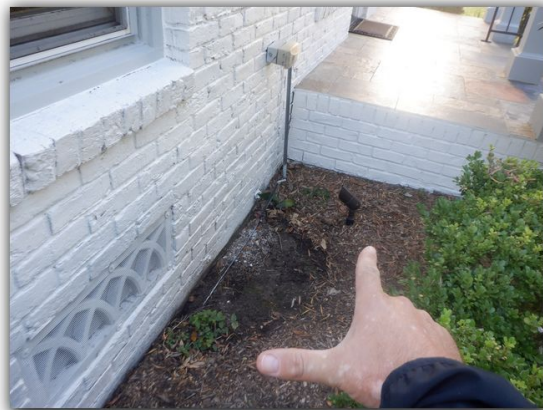
Depressions in soil near foundation are detrimental to good foundation maintenance, recommend filling in depressions.

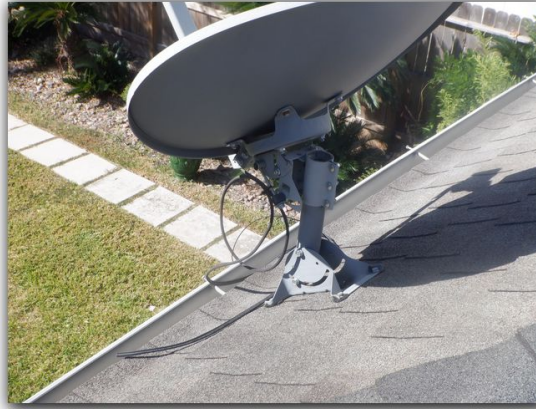
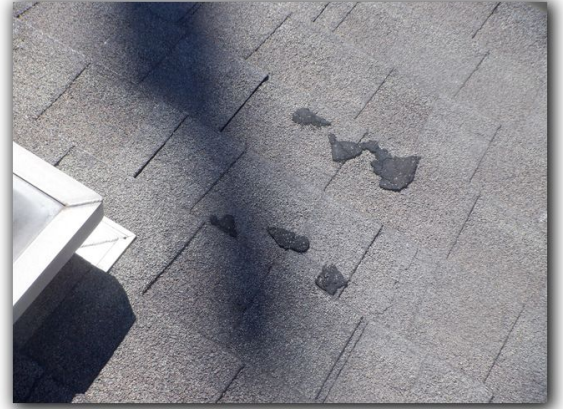
Buyer's note: Satellite dish bracket attachments can be more susceptible to water penetration.

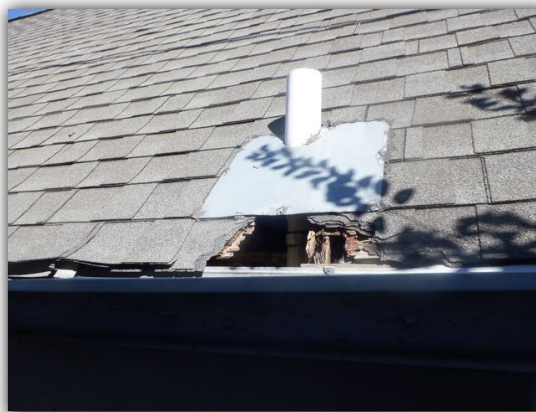
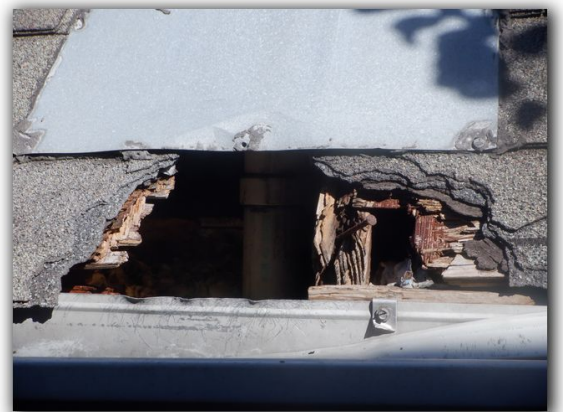
A very large hole was present in the roof at the back of the pool house. Per the neighbor, Raccoons are currently living in this space.

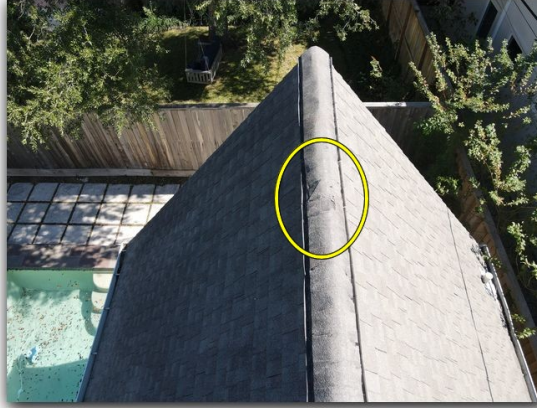
Substantial roof damage was present at the ridge of the pool house.

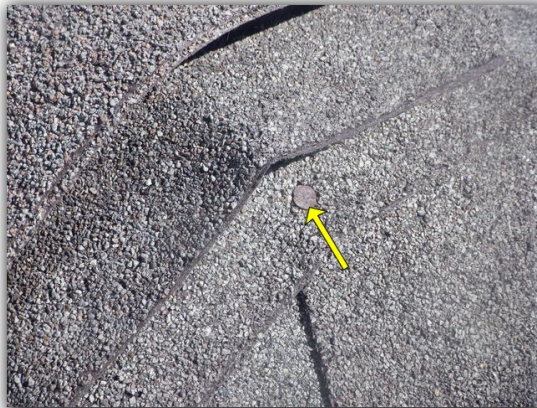
Exposed staples / nail heads / fasteners observed on roof, all exposed fasteners should be sealed to prevent water entry.

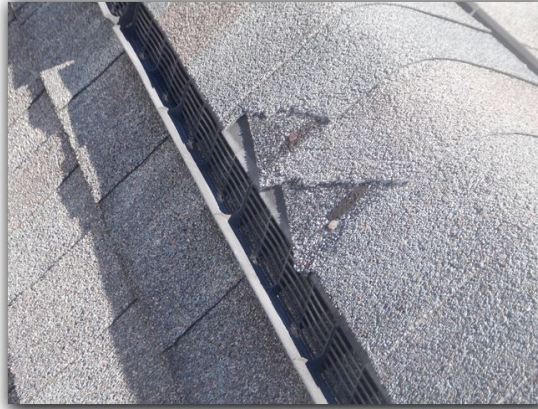
Multiple areas of damaged roofing were present on the house.

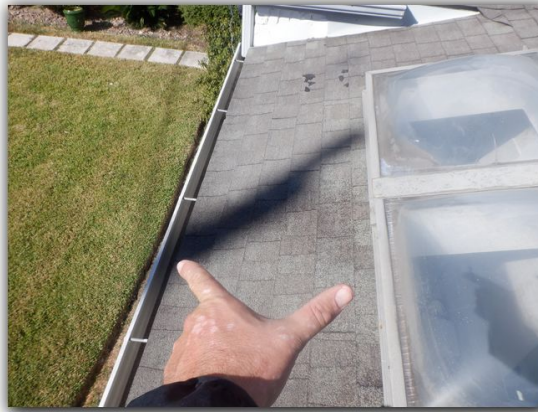
Area(s) of soft/spongy and/or rotted roof decking observed while walking on roof.

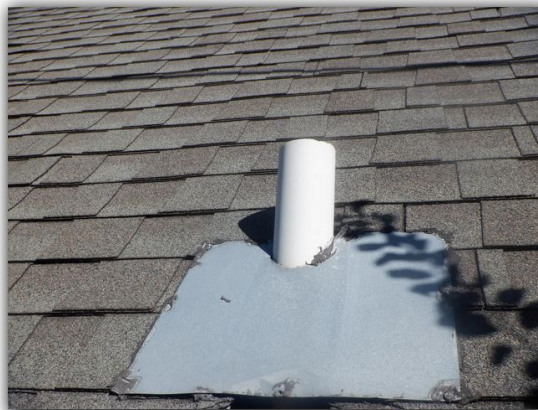
Improper flashing was present around the drain waste vents on the pool house roof.

Roof water penetration observed at the following location(s): (Damaged roofing on the pool house.)

Possible from improper & damaged areas of flashing on drain waste vents.

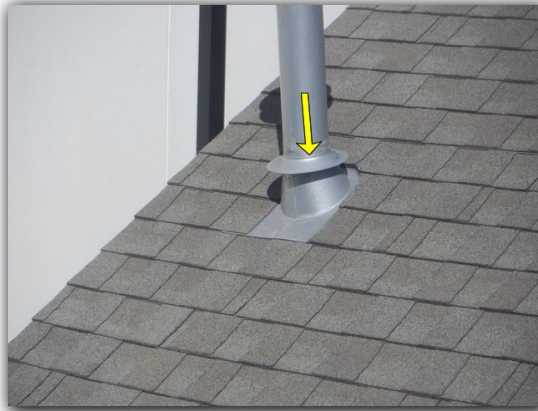
Storm collar needs caulking on all house and water heater vent pipes.

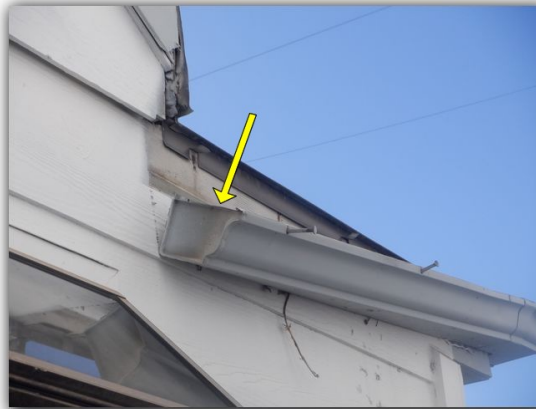
Damaged / Loose gutters were present at the north and west exteriors.

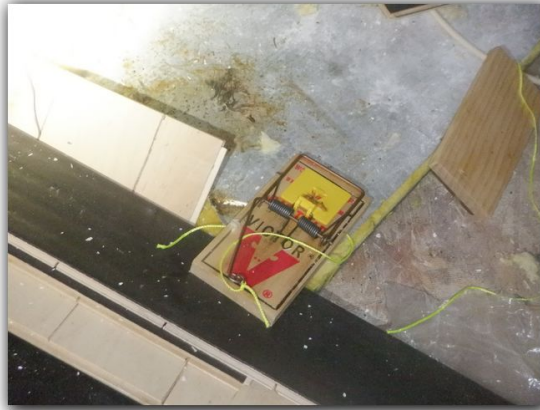
Evidence of previous (possibly current) rodent activity in attic.

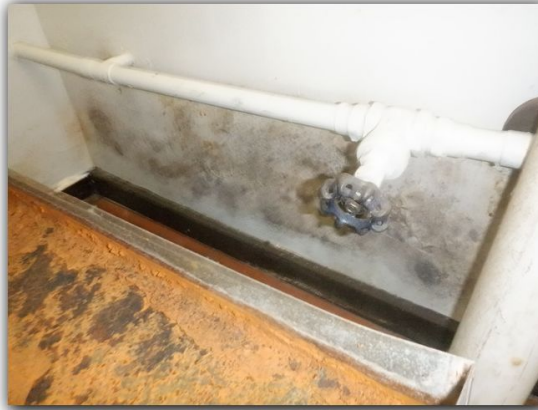
Observed possible micro-organism growth (Pool house HVAC closet) which may be a concern due to increased awareness of environmental issues associated with molds. Recommend removal of all sheetrock containing visible mold growth plus an additional 2 feet surrounding area. *This company does not inspect for and is not qualified to render opinions on any type on environmental or other bio-hazards. If this is a concern or potential concern, Sentinel Inspection Group recommends contacting a qualified professional of your choice for further information / investigation.*

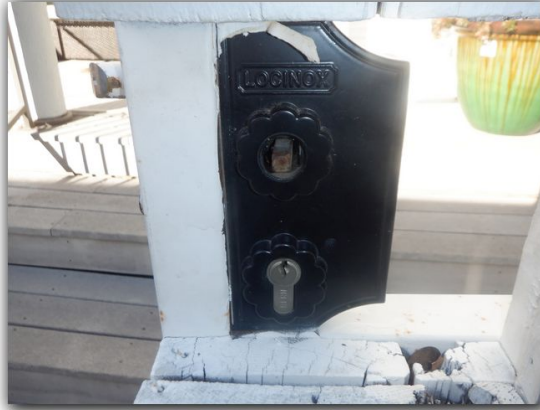
The driveway gate latch was damaged / did not function properly.

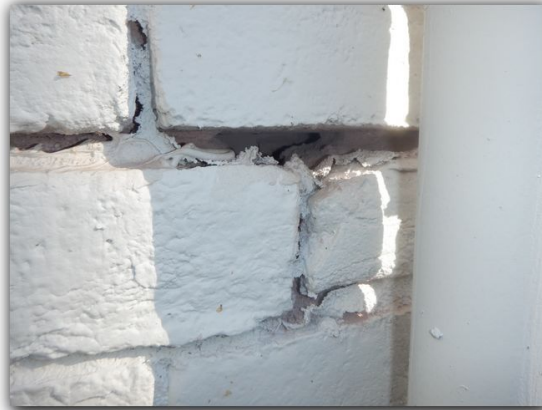
Mortar joints between brick ends is deficient in areas, indication the brick layer might not have properly "struck" the bricks (used enough mortar), recommend re-pointing areas where voids in mortar are present.

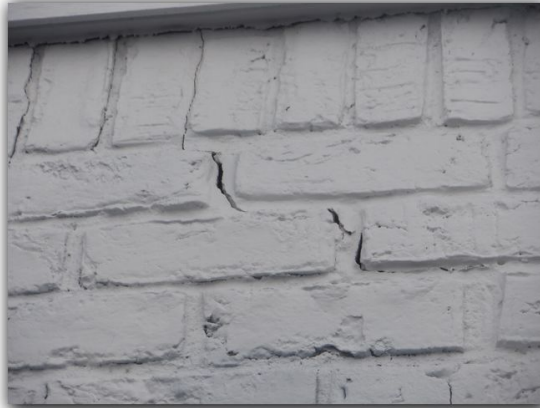
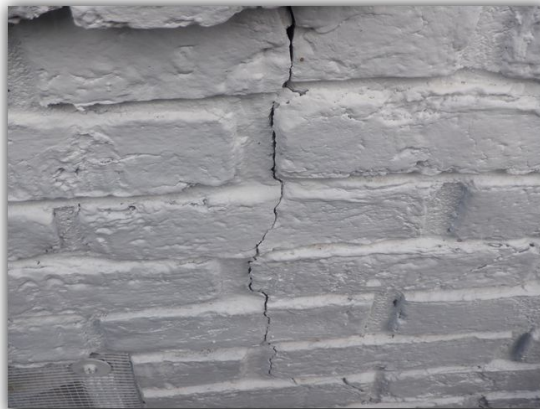
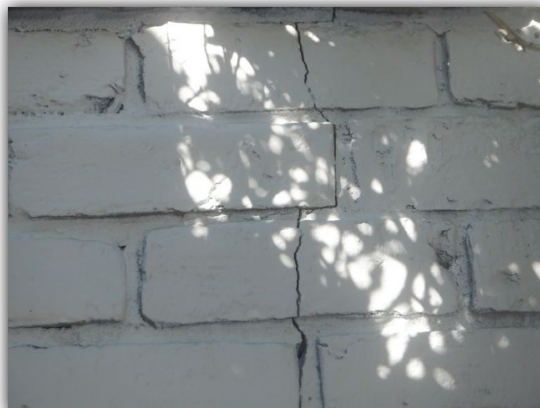
Cracks in brick veneer and/or repairs, one or more locations, Recommend buyer take photographs of cracks, their location, and width [ruler across the crack] with a high resolution camera that has a date stamp for future reference.

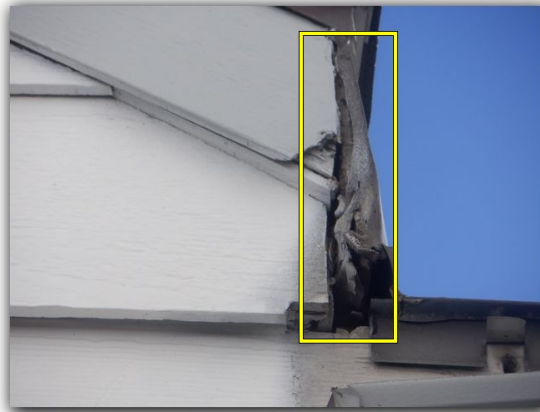
The fascia at the southwest corner needs to be properly flashed or sealed to prevent water entry.

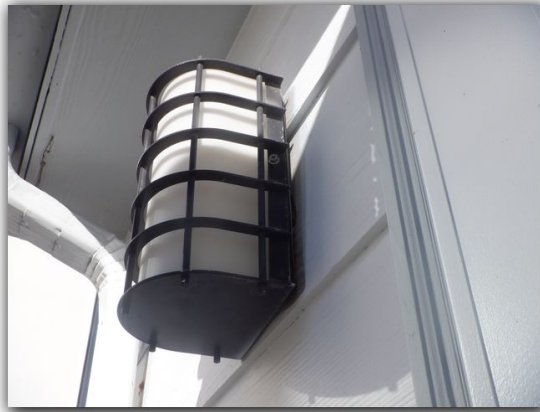
Need sealing / caulking around all holes and exterior siding penetrations on top and both sides, (leave bottom open) to prevent water entry. Including but not limited to dryer, bath and range top vents, light fixtures, etc. Need sealing / caulking around all holes and exterior siding penetrations on top and both sides, (leave bottom open) to prevent water entry. Including but not limited to dryer, bath and range top vents, light fixtures, etc.

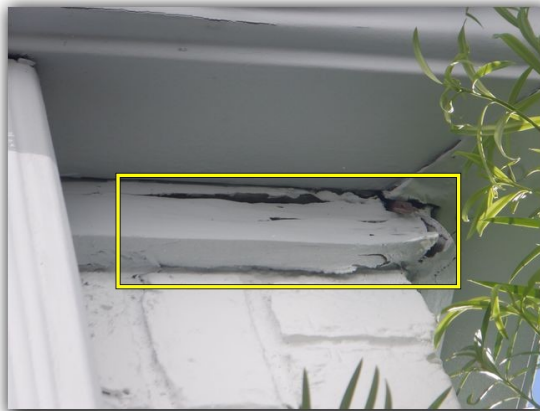
Wood rot observed on areas of house / garage.

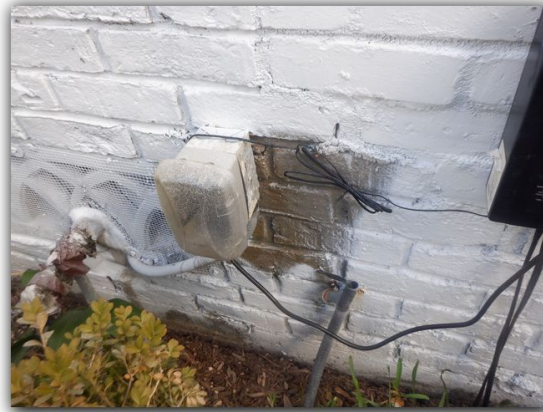
A portion of the brick at the northwest corner was not painted to match.

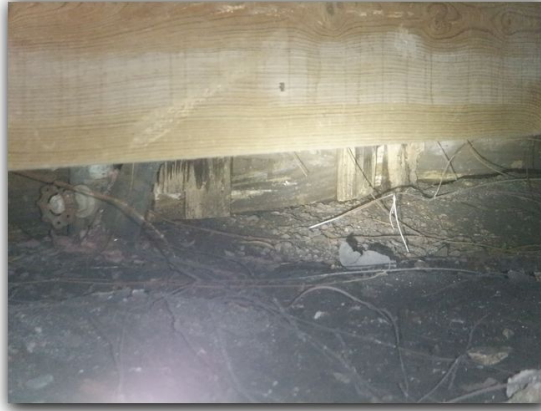
Earth wood contact in some areas, conducive condition to termite activity and wood rot.
(Around the perimeter of the pool house)

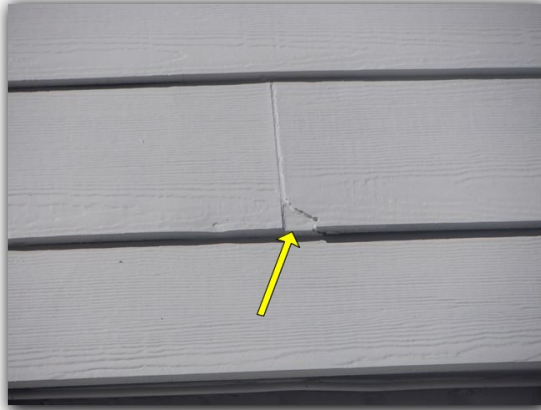
Multiple areas of minor cement board were observed around the house.

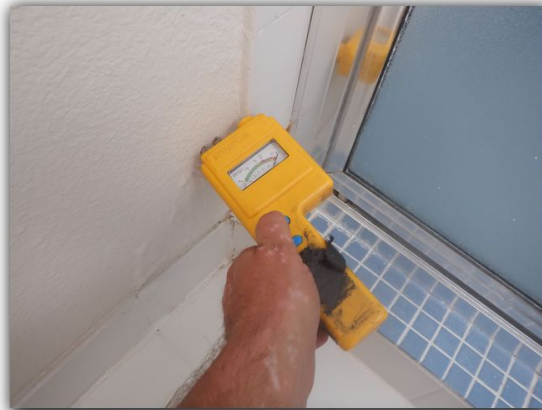
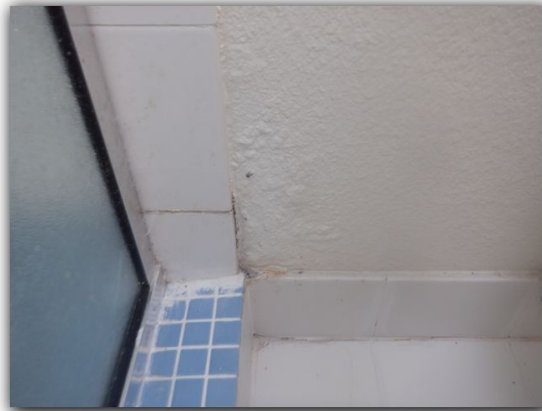
Water penetration observed at the following location(s): (Both sides of the 1st floor master bathroom shower enclosure.)

Possible from exterior window frames not properly caulked / sealed.

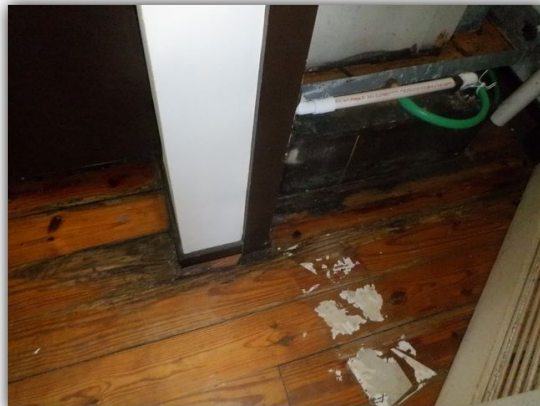
Water damage was present on the wood flooring in the pool house near the HVAC closet and at the west exterior door.

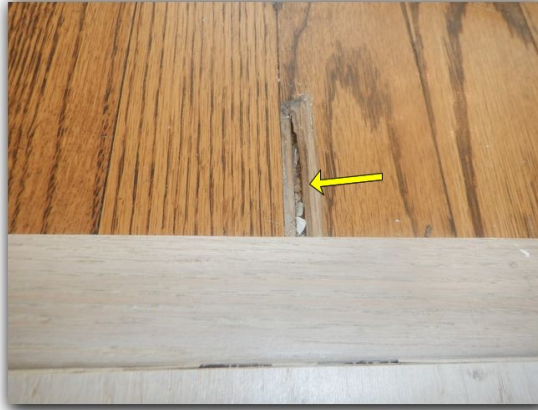
Damaged flooring was present at the entry to the southwest bedroom.

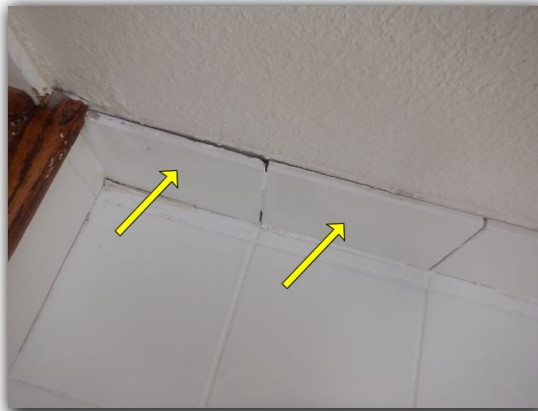
Multiple loose baseboard tiles were present in the 1st floor master bathroom.

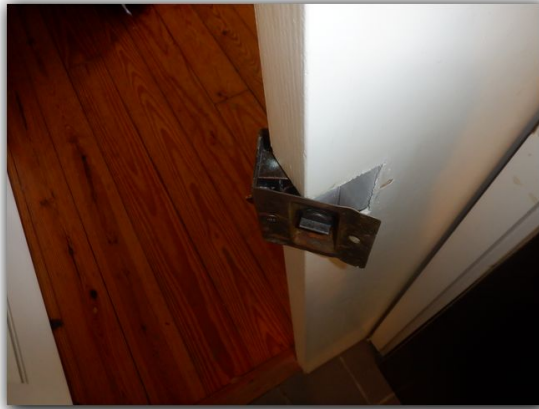
The pocket door pull / latch was loose / damaged on the door to the pool house bathroom.

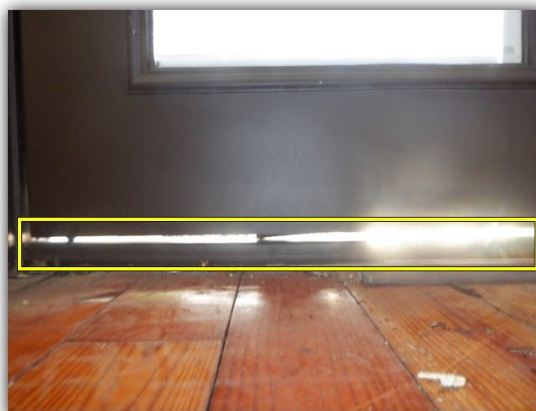
The lower door sweep / weather stripping was loose / damaged on the west door to the pool house.

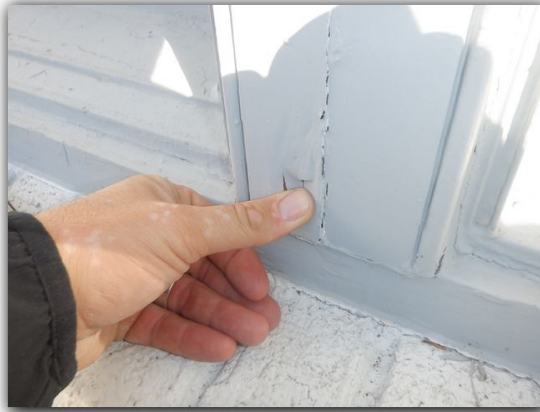
Wood rot of window frame/jambes observed at one or more locations.

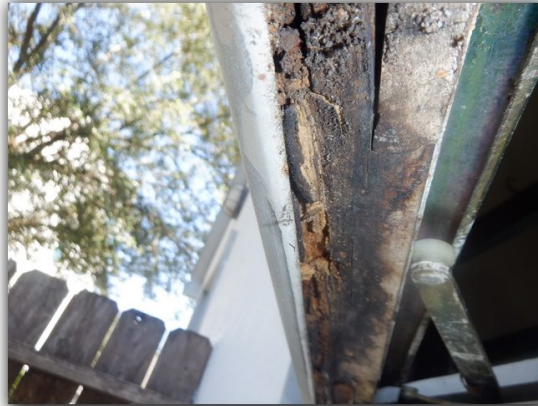
Multiple windows in the pool house are heavily rotted and in need of replacement.

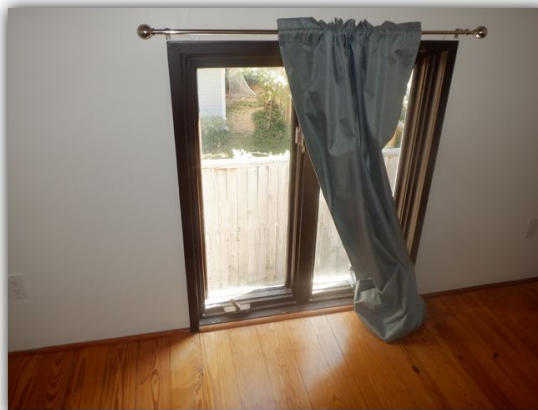
Windows at one or more 2nd floor rooms were a potential fall hazard for small children due to their low height above the floor; did not observe fall protection outside the window. Ref IRC R613.2 Window Sills: In dwelling units, where the opening of an operable window is located more than 72 inches above finished grade or surface below, the lowest part of the clear opening of the window shall be a minimum of 24 inches above the finished floor of the room in which the window is located. Glazing between the floor and 24 inches shall be fixed or have openings through which a 4-inch diameter sphere cannot pass.

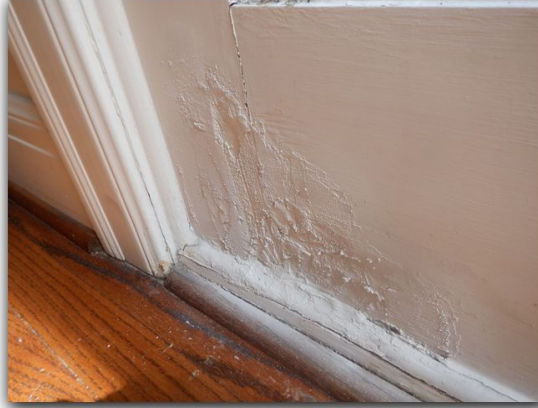
Heavy wood rot was present on the 1st floor master bedroom window.

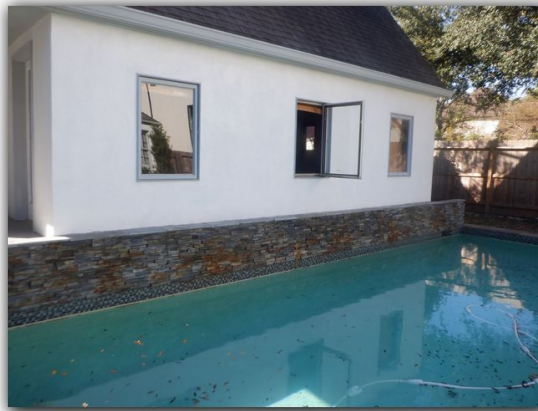
Windows located directly above the pool should be safety glass.

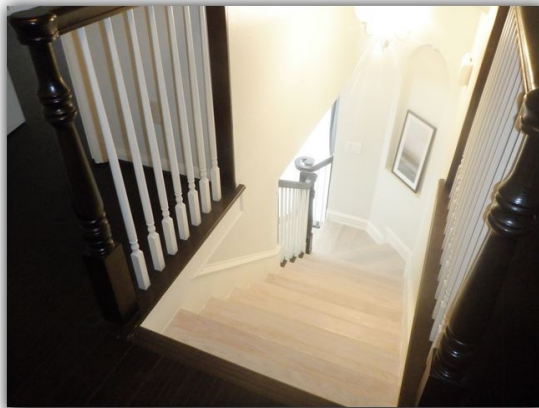
The handrail was not properly present at the top of the stairway.

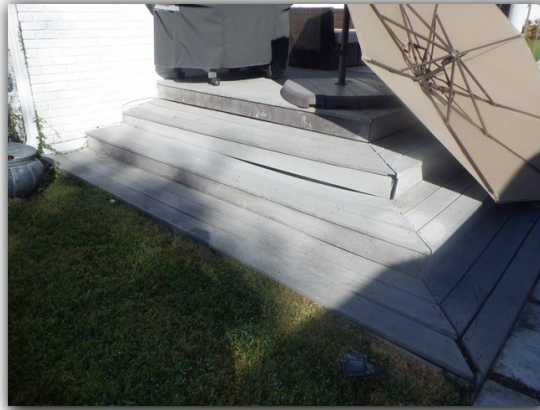
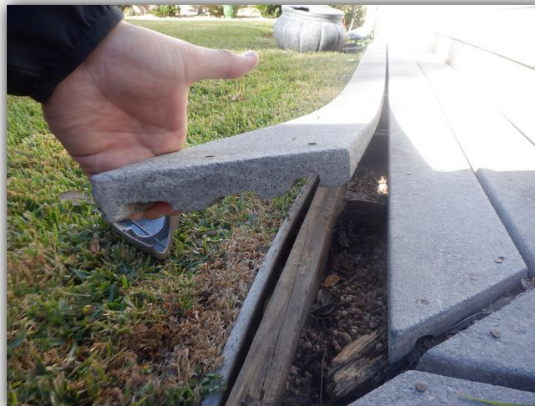
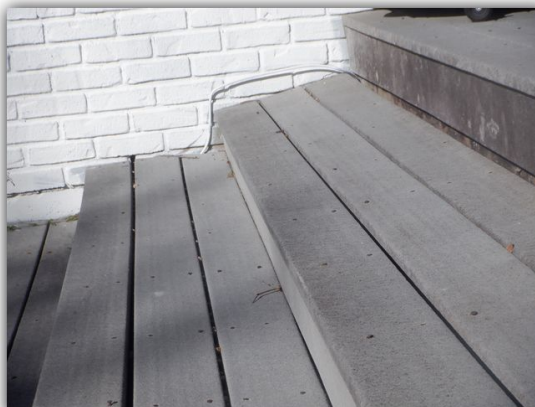
Significant settlement, rotted framing, sloping steps and loose decking was observed at the back patio and at the east entry to the pool house.

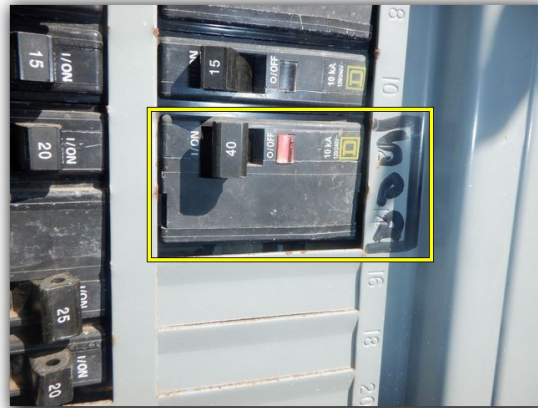
**Breaker(s) tripped during inspection. Indication of serious electrical problem.
Recommend qualified electrician diagnose and correct condition immediately to reduce chances of an electrical fire.**

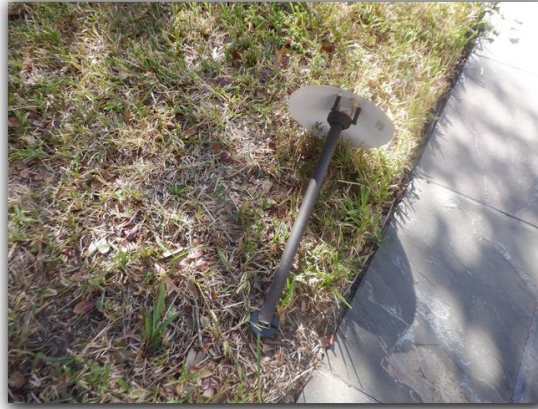
A damaged landscape light was observed along the front walkway.

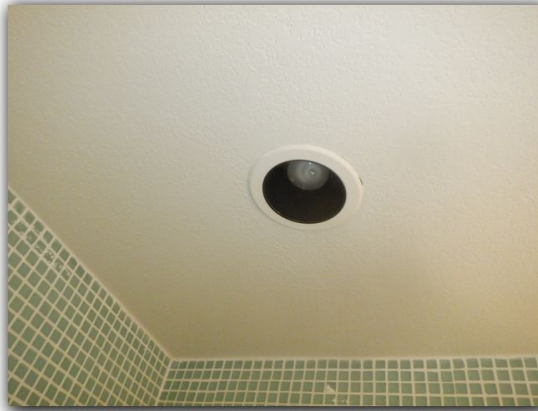
Light fixture over bath not rated for wet/damp locations. Ref. IRC E3908.8: "All fixtures installed in wet/damp shall be marked SUITABLE FOR WET/DAMP LOCATIONS." Bare light bulbs are not to be installed over a bath /shower location.

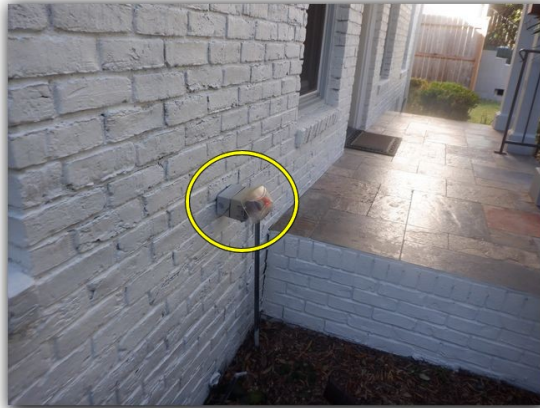
The GFCI at the north exterior indicated an open ground and neutral and only registered approximately 30 volts. Recommend further evaluation and correction by a licensed electrician.

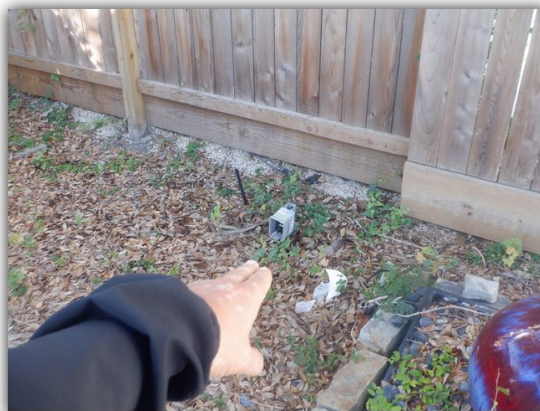
No power to outlet(s); (Southwest corner of the yard)

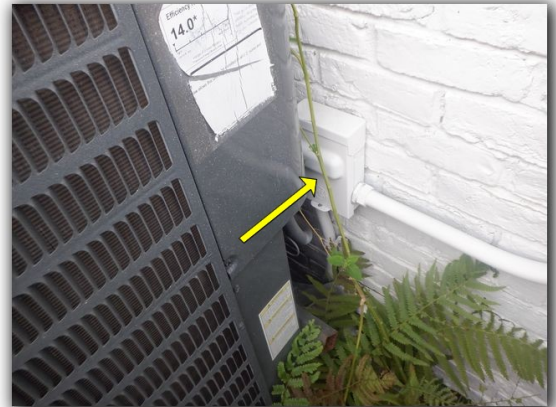
Code requires minimum clearance to electrical service panels to be 36" in front of and 30" from side to side. (House A/C disconnect)

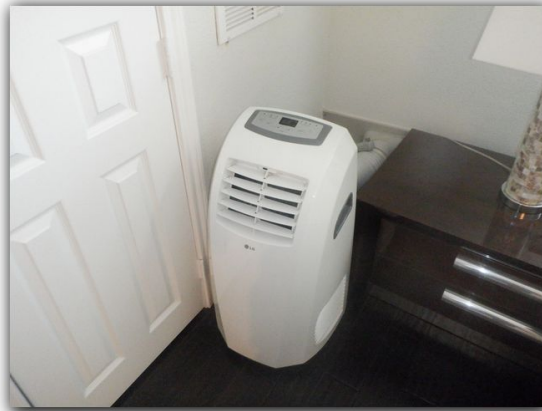
A portable A/C was observed to have been installed in the 2nd floor bedroom, which typically indicates the central air conditioning is not adequately cooling this area. Recommend inquiry of the seller.

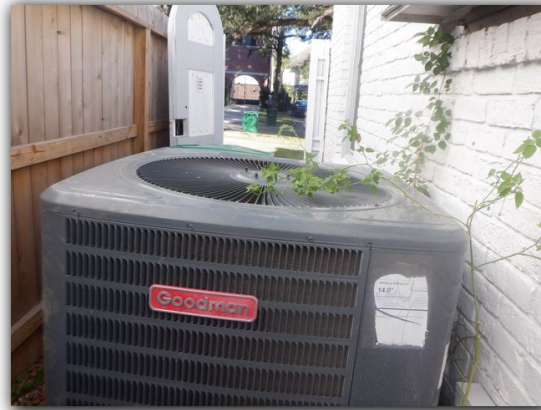
Unit not level, needs to be level for proper operation.

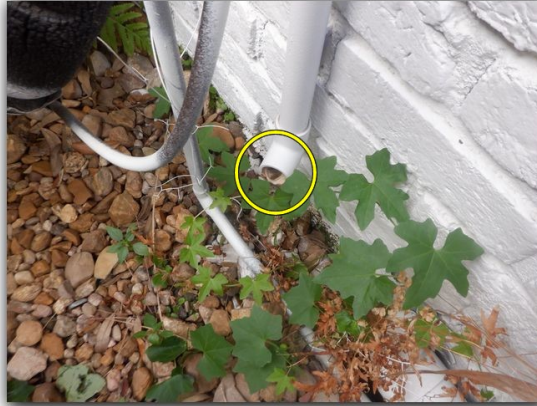
Primary drain line should not be allowed to discharge water right next to foundation.

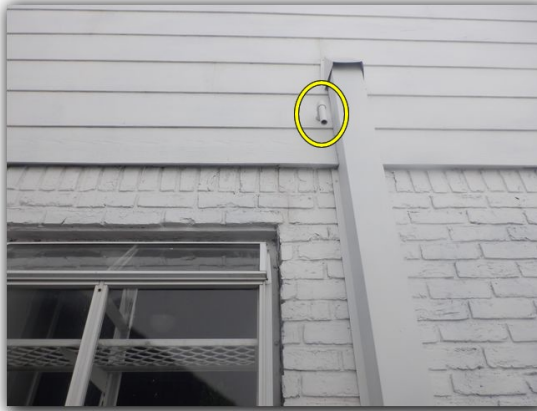
The secondary drain line was not properly terminated over a door or a window as is currently required.

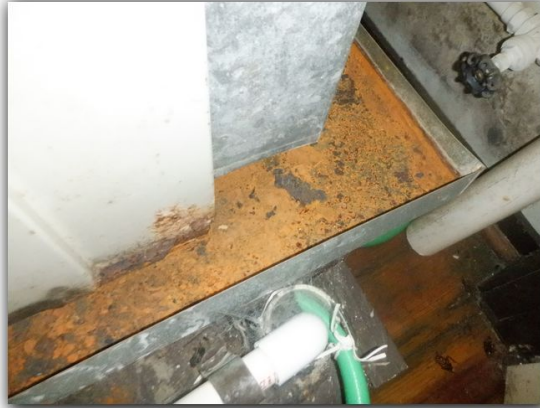
Secondary drain pan is rusted; indication coil (or previous coil) has history of leaking/dripping condensation into pan.

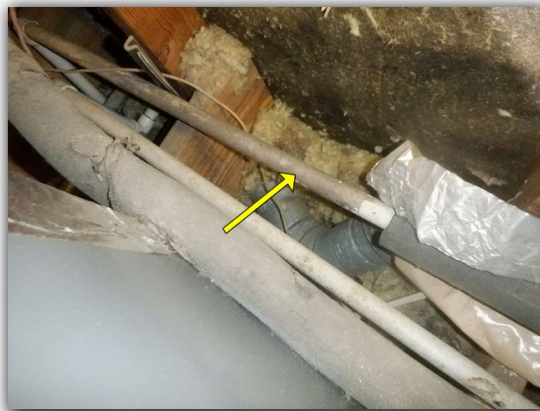
Primary drain line should be insulated along entire length in attic to prevent warm attic air condensing on cool drain line and dripping condensation.

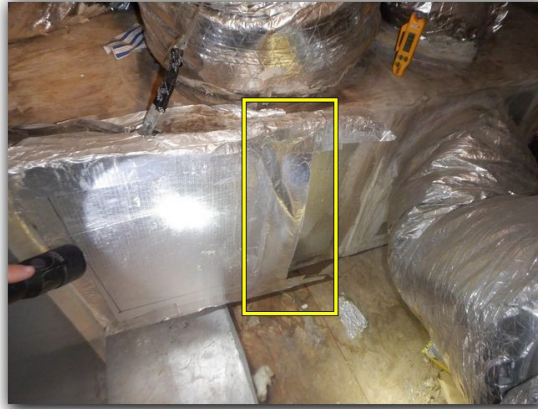
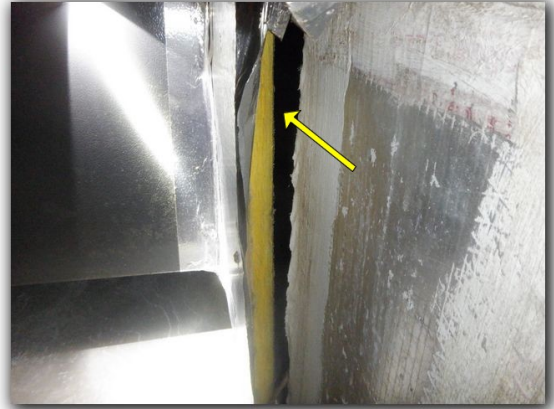
Excessive air loss around transition/coil/heater/plenum.

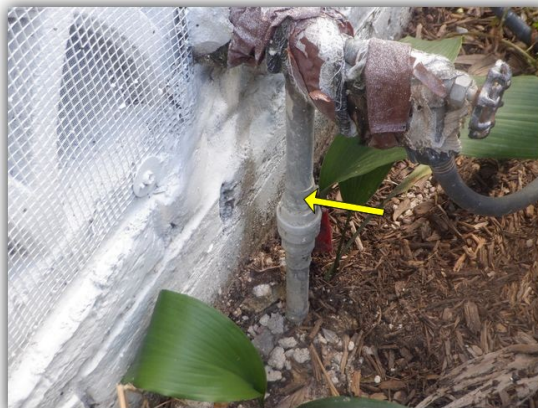
Recommend insulating exterior water line(s) to prevent freeze damage.

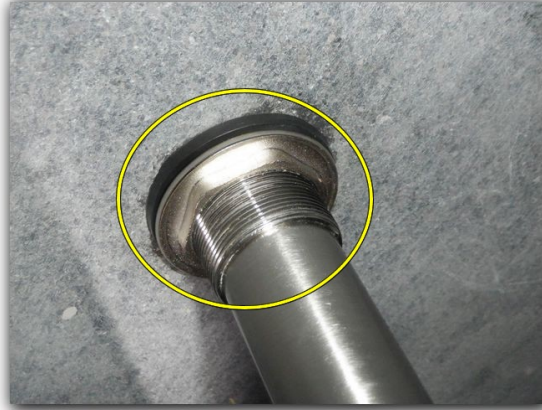
Small leak below sink, (Northern 2nd floor bathroom sink)

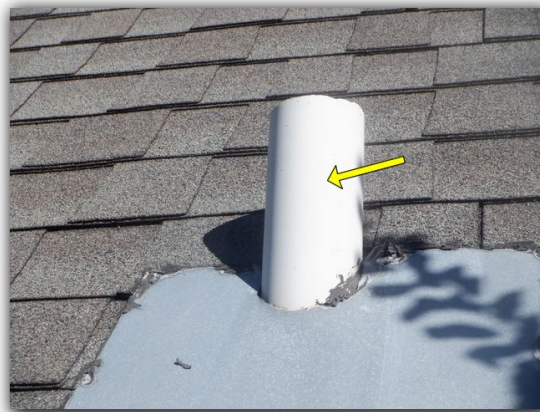
Painting of exterior plastic PVC vents above roof line required to prevent UV damage.

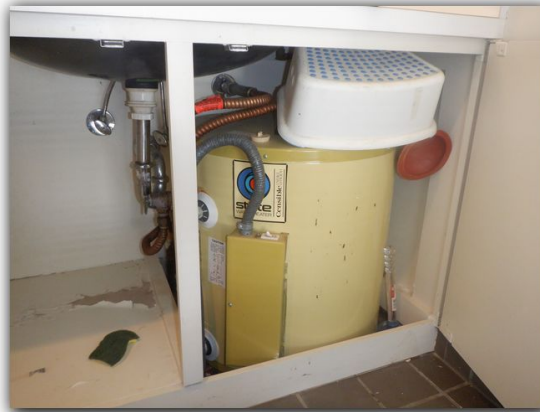
**Unit has exceeded its normal serviceable life; budget for repair or replacement.
(Pool house)**

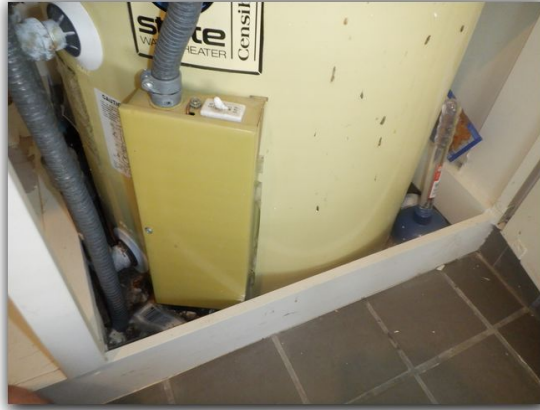
Located in house without benefit of a drain pan. Should water heater leak interior flooring can be damaged REF.: 1991 Standard Plumbing Code 1213.7.1 IRC 2801.5. (Pool house)

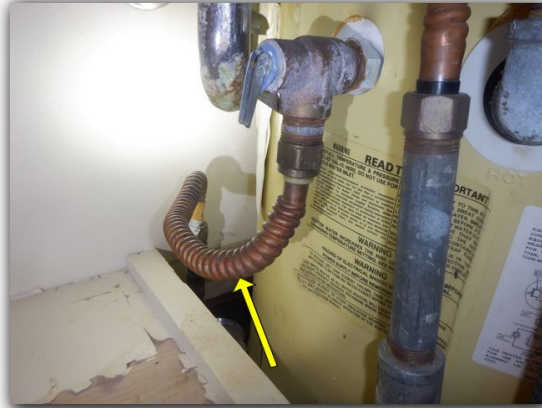
Drain line improperly reduced in size using flexible connector, considered a recognized safety hazard; REF.: 1991 Standard Plumbing Code 1213.7.4 IRC 2803.6.1. (Pool house)

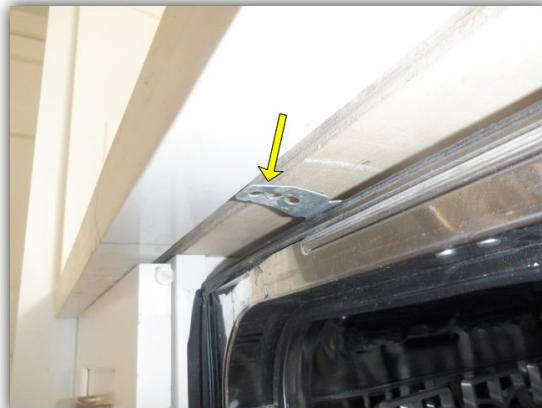
Not secured to underside of kitchen counter top.

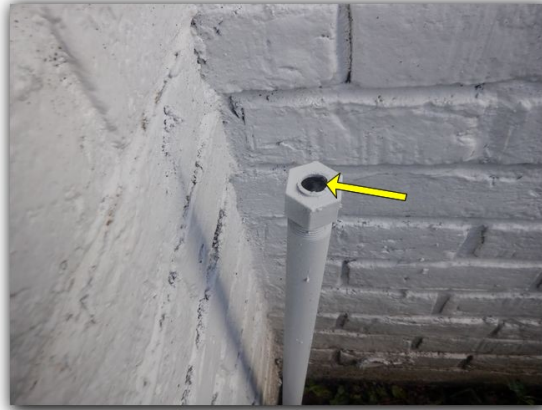
Multiple damaged sprinkler heads were observed around the house.

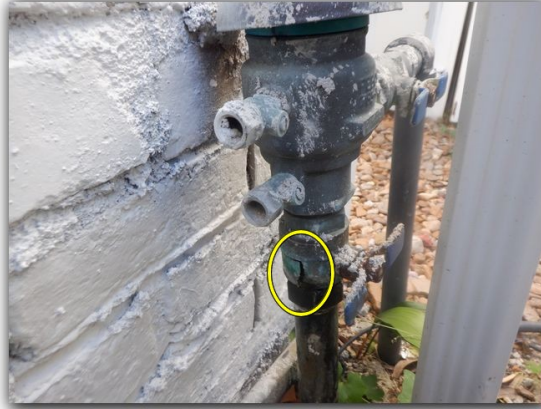
The sprinkler system back flow preventer was cracked / damaged. System could not be operated / checked.

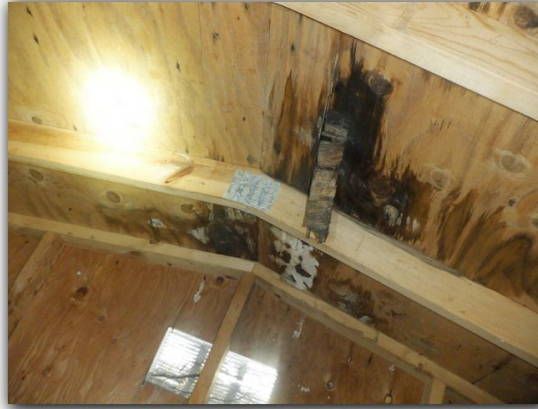
The shed was not fully inspected, but appeared to be in poor condition.
