Inspection report for the property at

Precision Building Inspection LLC

This is a 30 year old park model with deck and screen room added to one side and master suite added to other. For age the subject appears to be in above average condition and very well suited for the area.

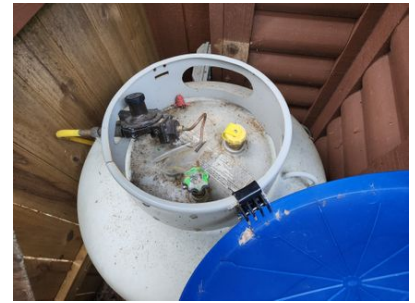
Gas shut off

Description: 📷 This shows the fuel shutoff for the building.

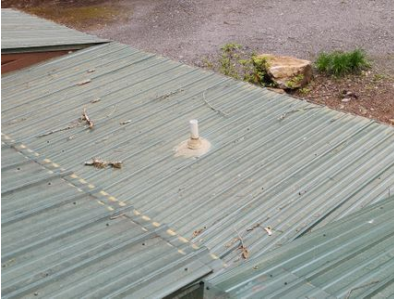
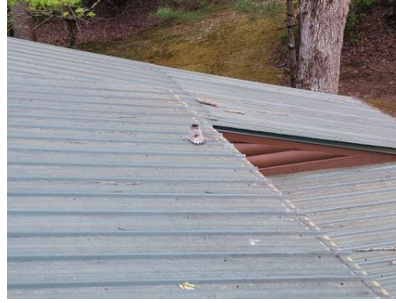
Roof vents

Condition: Marginal 2 vents noted and visibly no defects noted

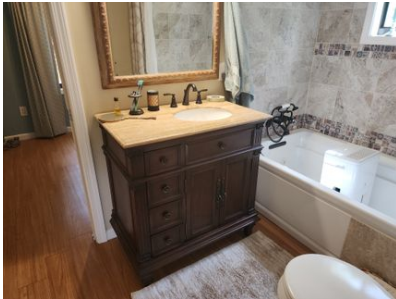
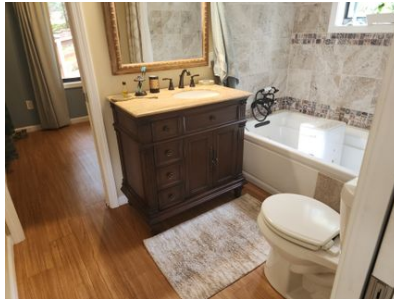
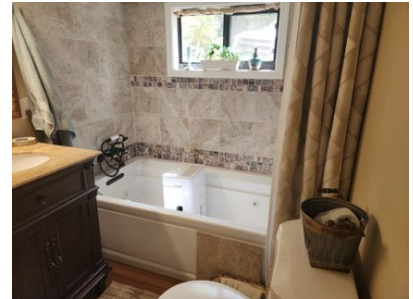
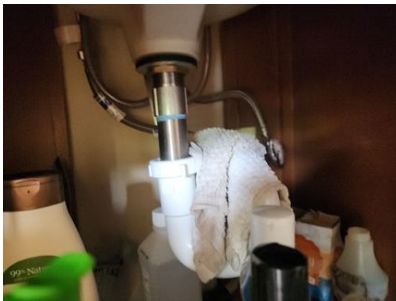
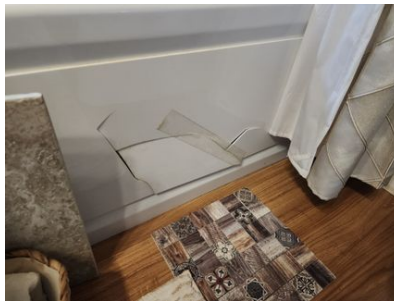
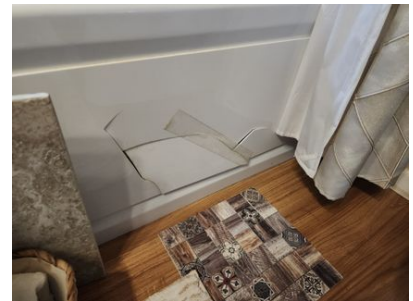
Bathroom Photos

Jetted tub access from sun room. Appears dry no visual signs of damage

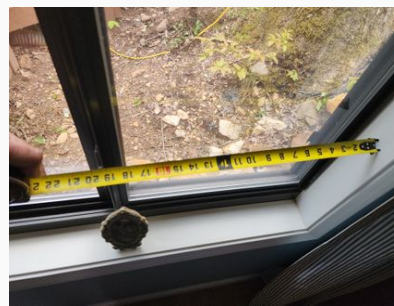
🔧 (I-5) Repair:

Repairs are needed to the window(s).

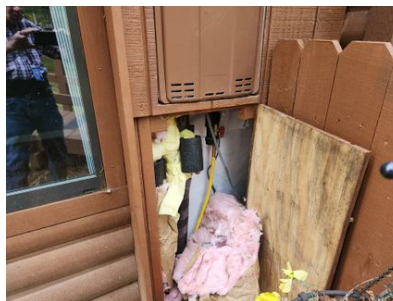
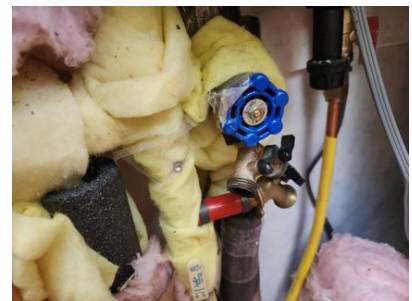
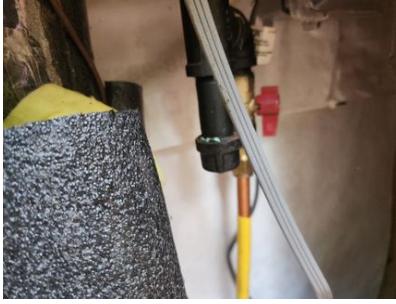
The water temperature tested slightly below the recommended 120 degrees F. Adjust the water temperature as needed.

Exterior tankless water heater

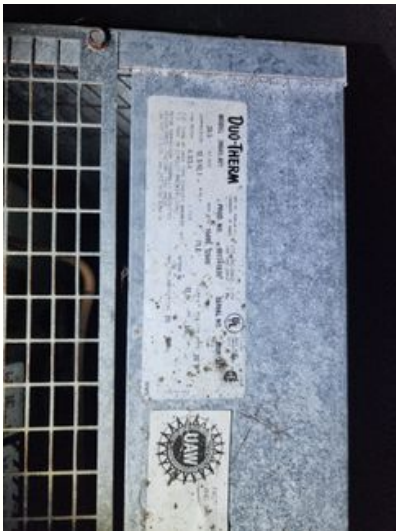
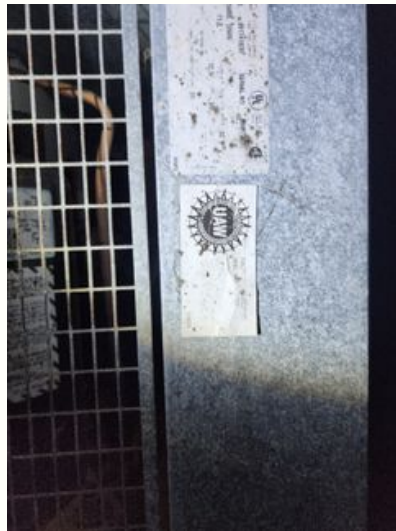
✦ (HCS-1) Note: Domestic Park model heat

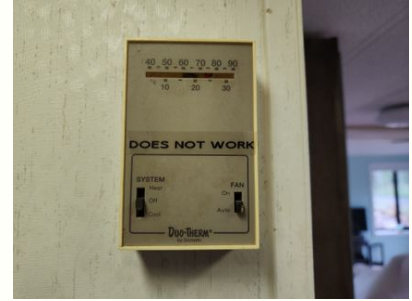
📍 (HCS-6) Note:
No central heat or cool noted

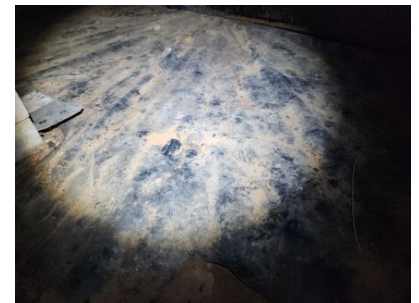
Material: Plastic

Condition: Satisfactory

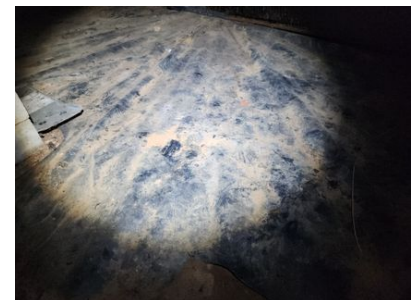
Vapor barrier in crawl spaces
