1428/report 6898

## Electrical

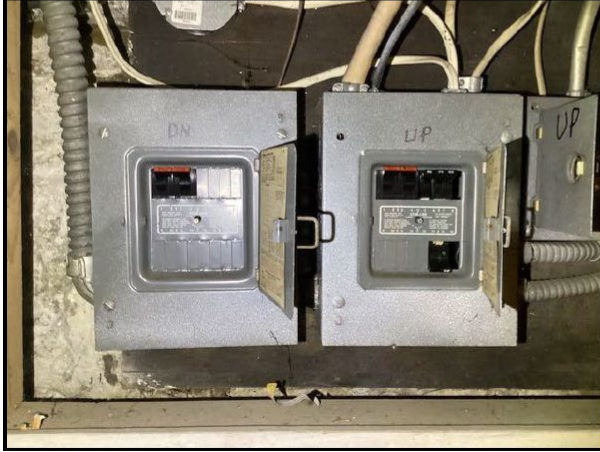
Condition: • [Federal Pacific panel](#)

Federal Pacific panels / breakers have been known to fail creating a fire hazard. Click on the blue link above to learn more. Recommend having a licensed electrician further evaluate / replace panel.

5. Federal Pacific panel

Task: Further evaluation - **update with Eaton Panel \$1,600**

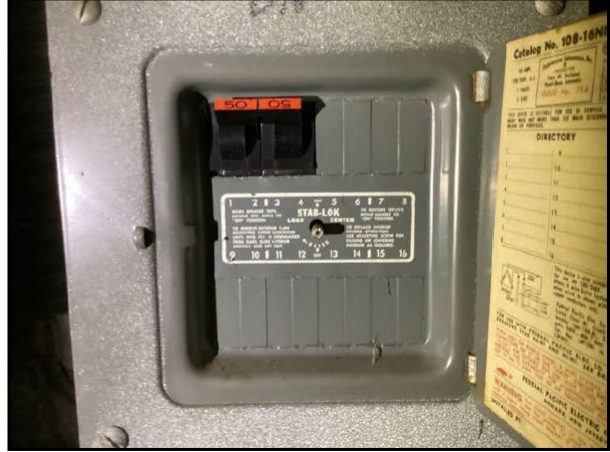
6. Federal Pacific panel

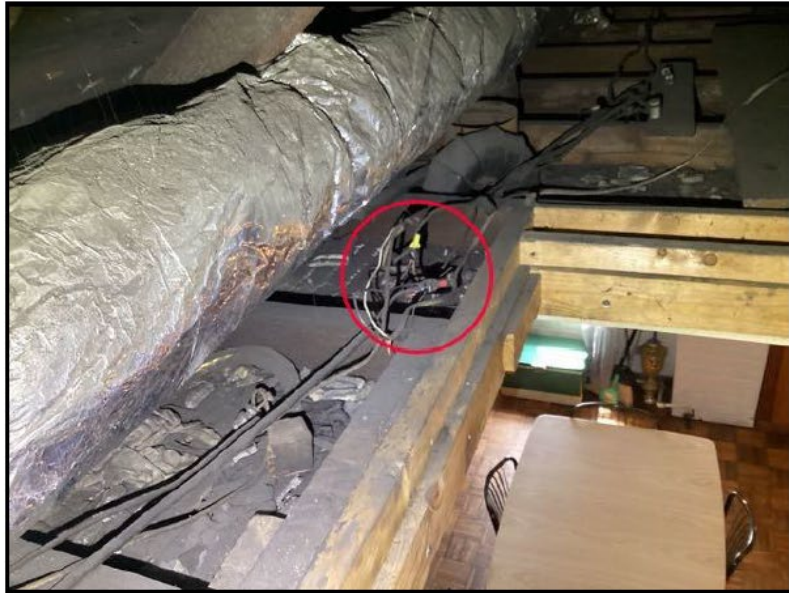
7. Open splices

**Task:** Correct -add junction box \$325

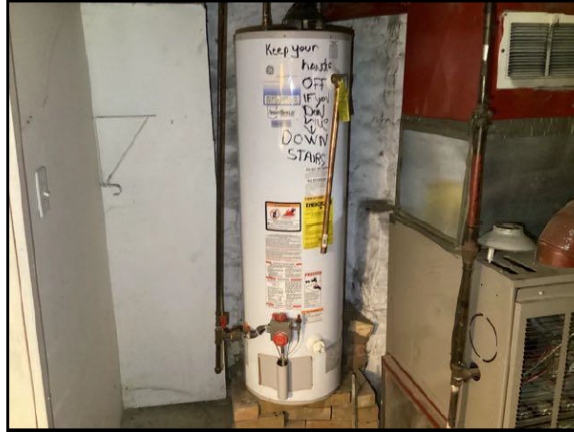
**Condition:** Past life expectancy

17 year old tank is past the typical life expectancy and may need replaced in the near future.

16. Past Life Expectancy

**Task:** Monitor

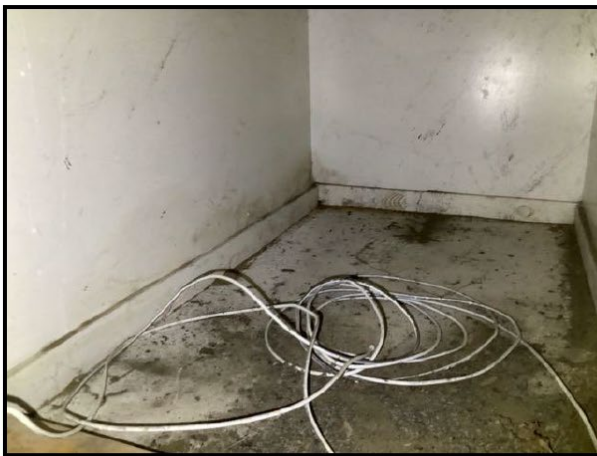
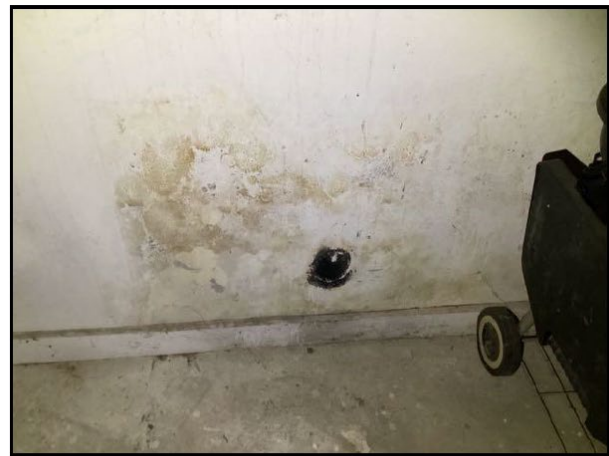
**Condition:** • Stains

Stains and crumbling plaster/ masonry noted to walls in the basement. Areas appeared dry at time of inspection. Recommend ensuring all gutters / downspouts / drain tile are free and clear. Ensure proper grading on exterior. Use of de-humidifier may be needed to control moisture levels. Recommend monitoring area and seeking further evaluation by water proofing contractor if conditions worsen or desired.

**Task:** Further evaluation - **Remove drywall and molding, coat wall where seepage, replace with new drywall & molding \$600.** (once wall is open additional work requirements may become evident. Possible sump pump may be needed.)

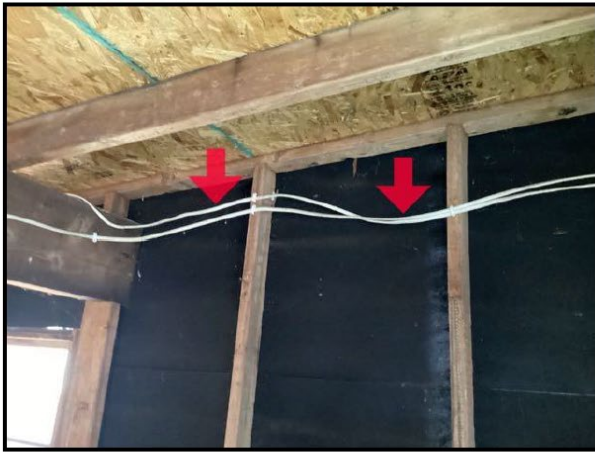
74. Exposed on walls or ceilings

Task: Correct - Install electric conduit and wire \$\$\$\$425

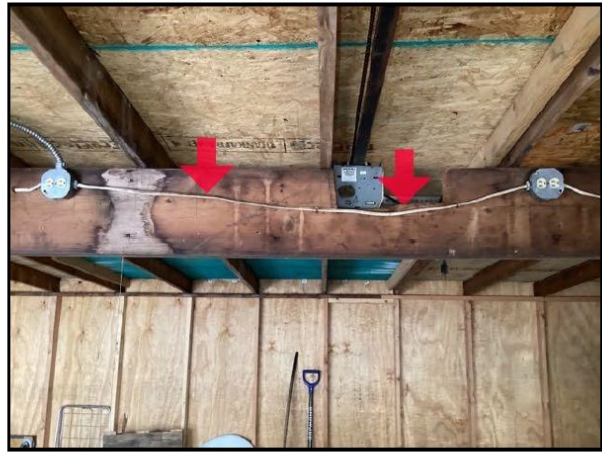
75. Exposed on walls or ceilings

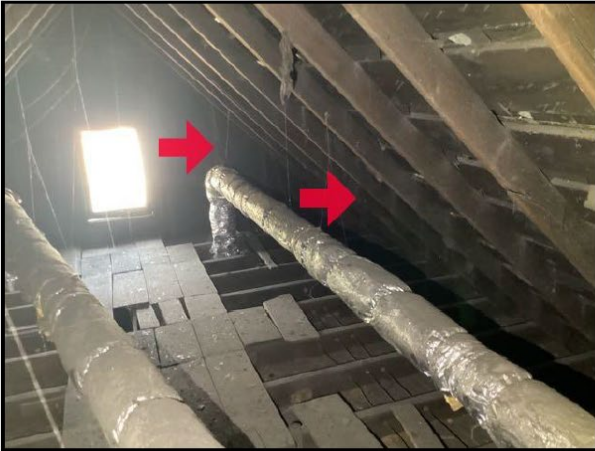
95. Poor support

**Task:** Improve

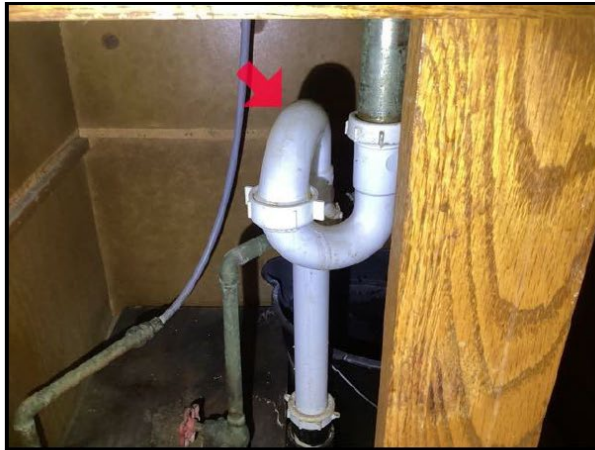
124. Nonstandard shape

**Task:** Correct

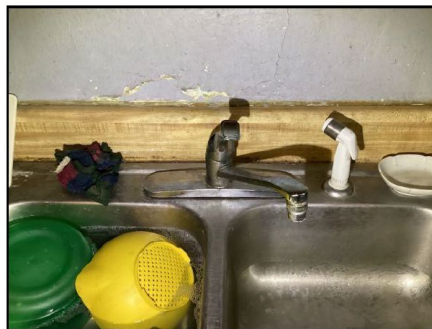
130. Hot and cold reversed

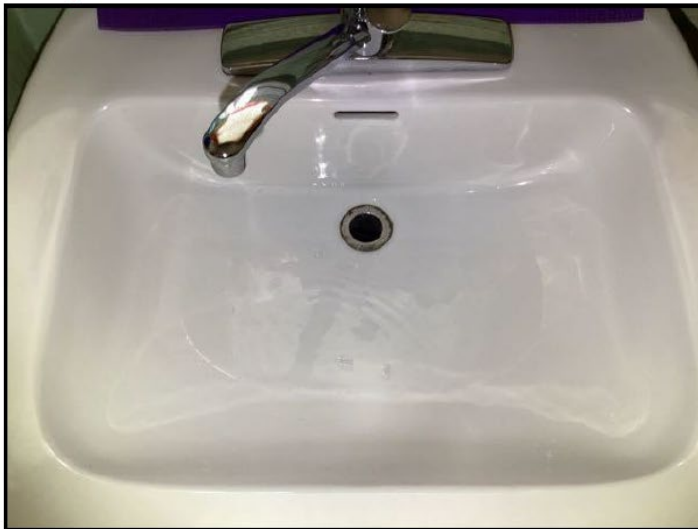
*132. Slow drains*

**Task:** Improve - **snake drain \$45 per man hour.**
