Report Introduction

Report Summary

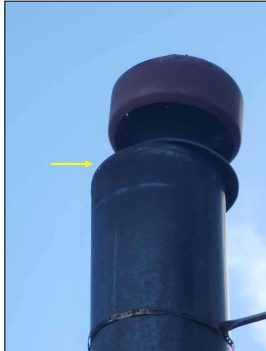
Page 46 Item: 4 Spark Arrestor • Rain Cap with Spark Arrestor are not secured to the pipe, it is just sitting on top of it.

Slightly tilted to the Right

Not Secured to Chimney Pipe as seen in the Picture. This can let out hot embers into the Air and could ignite something. Recommend not using this until it has been gone over by a Fireplace specialist.

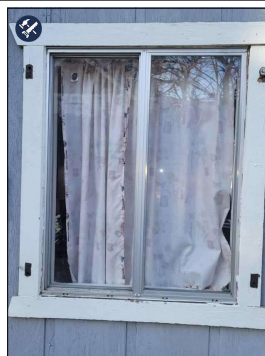
South Side--No Screen

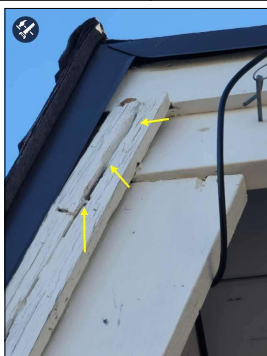
Page 47 Item: 3 Siding Condition • Caulk and seal all gaps, cracks and openings.
 • Some siding nails need to be reset.
 • Trim Cracked in Some Places Coming Loose in others.

North Side Trim Split

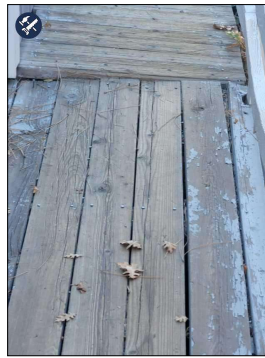
East Side bouncy boards

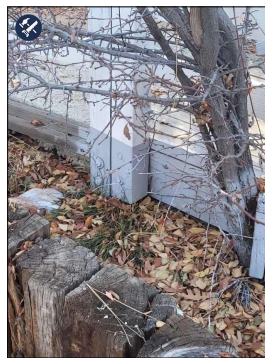
East Side--Material to Soil

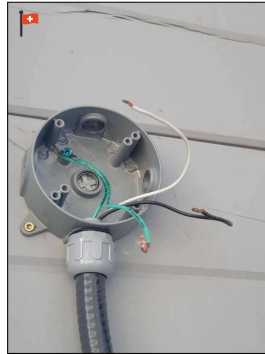
Page 54 Item: 8	Grounds Electrical	<ul style="list-style-type: none"> • Junction Box Covers missing or damaged; install cover for safety.
-----------------	--------------------	---

North Side--Open J-Box

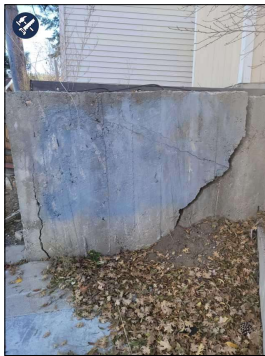
Page 56 Item: 15	Fence Condition	<ul style="list-style-type: none"> • RETAINING/GARDEN WALL • Damaged/Severely Cracked Recommend further Evaluation by a General Contractor for Answers & Options to this issue.
------------------	-----------------	---

Retaining Wall is Cracked clean through and separating with a shift. On the the far west edge of th Property.

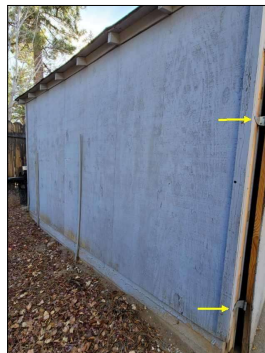
There are the Hinges for the Front Door

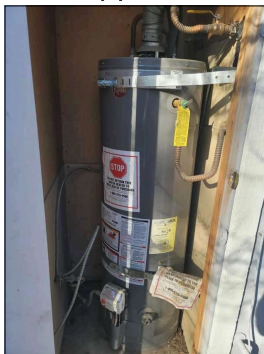
This Rheem 40 Gallon Gas Water Heater was Manufactured October 25th 2018--3 Yrs.old

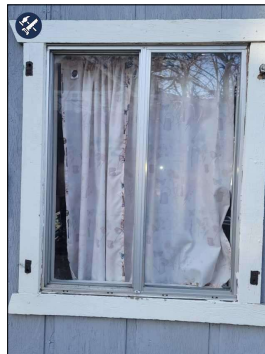
South Side--No Screen

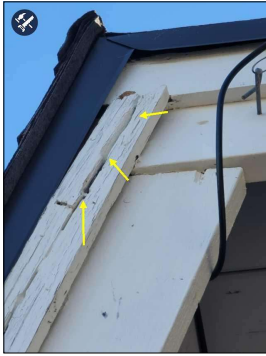
North Side Trim Split

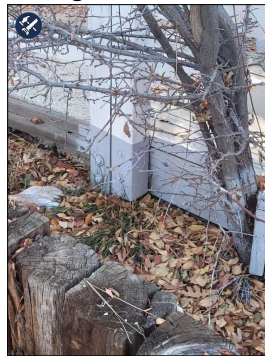
East Side--Material to Soil

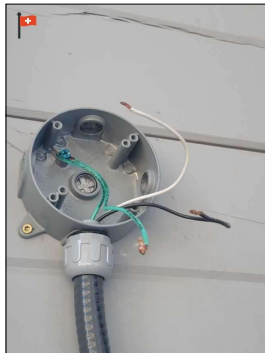
Observations:
• No Apparent Issues with the Electrical
• OUTLETS:
• No Apparent Issues with the Outlets
• Junction Box Covers missing or damaged; install cover for safety.

North Side--Open J-Box

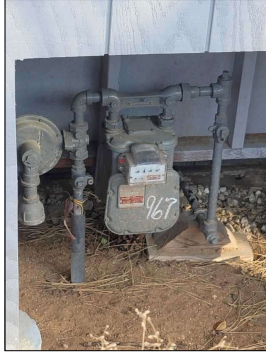
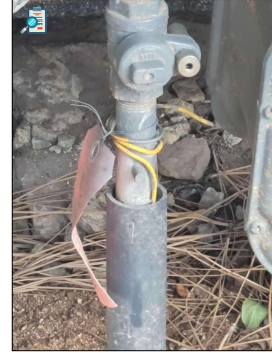
Gas Main Valve has Been By the Utility Company

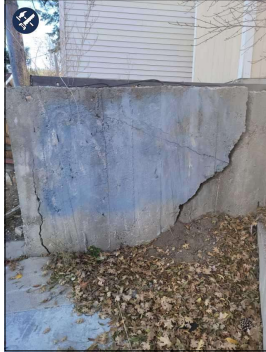
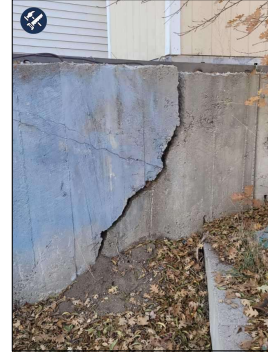
- **RETAINING/GARDEN WALL**
- **Damaged/Severely Cracked Recommend further Evaluation by a General Contractor for Answers & Options to this issue.**

Retaining Wall is Cracked clean through and separating with a shift. On the the far west edge of separating with a shift. On the the far west edge of th Property.

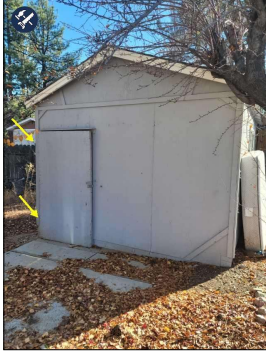
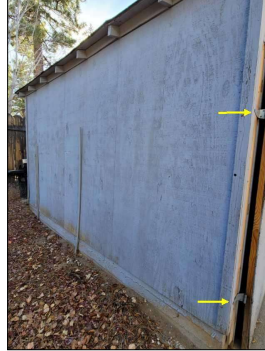
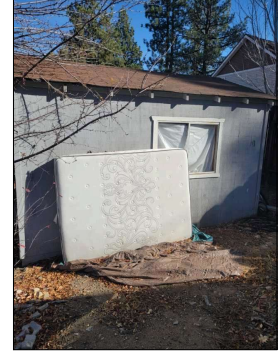
- Front Door is barely holding on with the way the Hinges are
- Some of the Siding is Material to Soil.

Hinges on the Door are placed in a strange place.

There are the Hinges for the Front Door

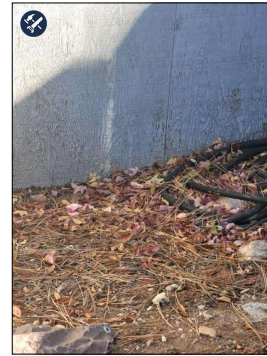
Siding is Material to Soil

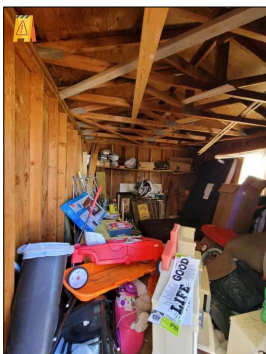
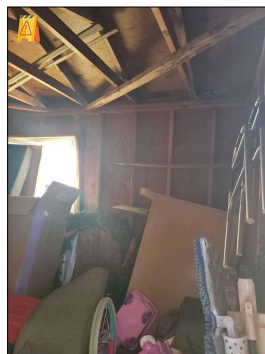
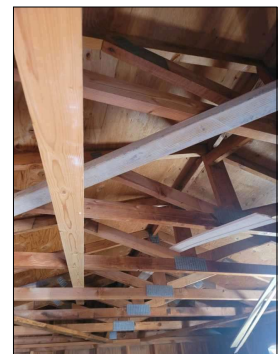
2. Storage Shed Interior Condition

- Full of Personal belongings really could not move around too much.
