# PROPERTY INSPECTION REPORT

**Donald D'Angelo  
Big Bear Home Inspectors**

**828 Angeles Blvd.  
Inspection Prepared For: Jaiden Ng  
Agent: Lila Mova -**

**Date of Inspection: 10/25/2021  
Age of House: Built in 1930--91 Yrs..old Size: 695 SqFt.  
Weather: Raining & Cold**

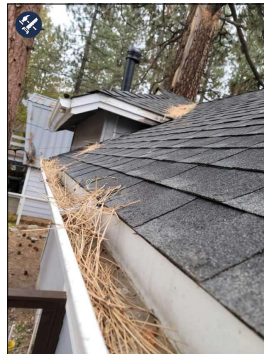
Gutter

- Clean gutters: Significant amounts of debris evident.

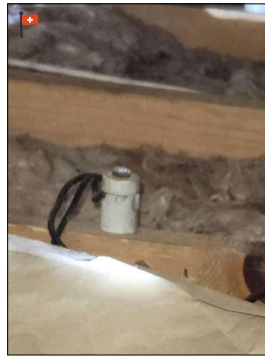
- Knob and tube wiring present, cannot be sure if it has been disconnected.

Old Knob & Tube in the Attic.

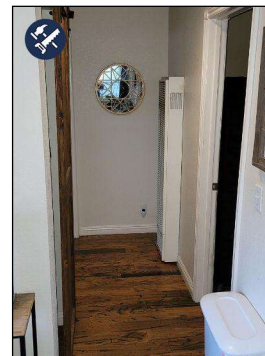
Hallway--In this Area there was a Smell in the hallway that actually smelled like a Dead rodent. Could not find and even when opened closet on the Left and the Crawlspace hatch was opened smell was not under there just in the Hallway.

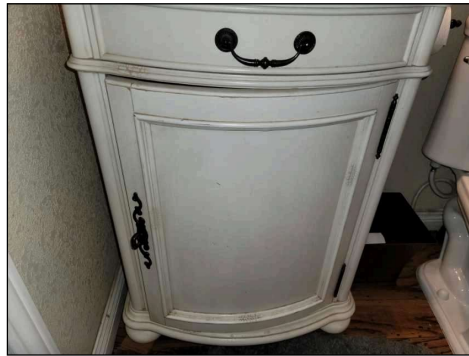
Bathroom

- Appeared functional and in satisfactory condition, at time of inspection.

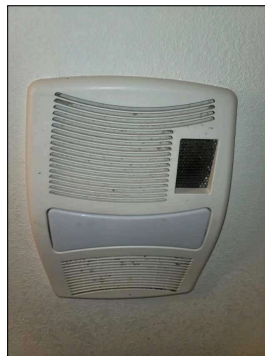
Bathroom

- Observations:
- The bath fan was operated and no issues were found.

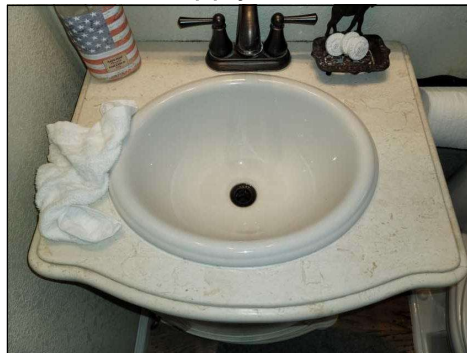
Bathroom

- **\*\*DRAINS\*\***
- No Apparent Issues with the Drains
- **\*\*SUPPLY\*\***
- No Apparent Issues with the Supply

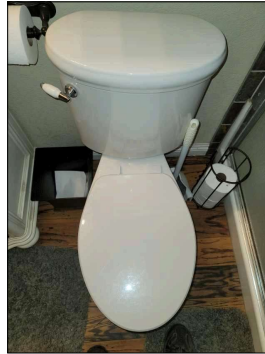
Bathroom

- Observed as functional and in good visual condition.

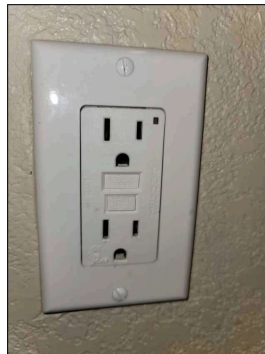
Bathroom

- Observations:
- **GFCI** in place and operational

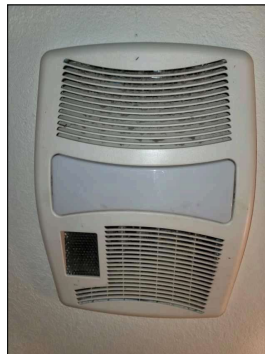
Bathroom

- Observations:
- Electric ceiling mounted heating noted in this room. At the time of the inspection, it appeared to be functioning and in serviceable condition.

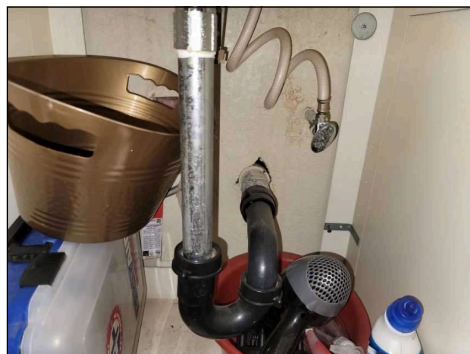
Bathroom

- No Apparent Issues with the Plumbing

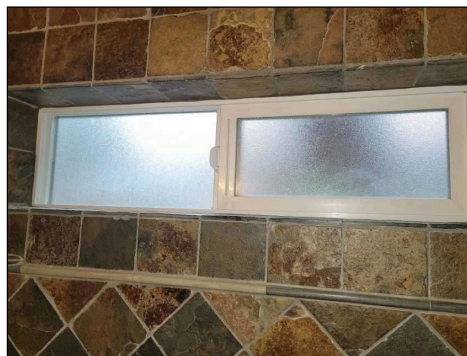
Bathroom

- No Apparent Issues with the Windows

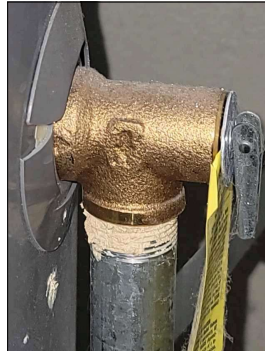
- Appears to be in satisfactory condition -- no concerns.

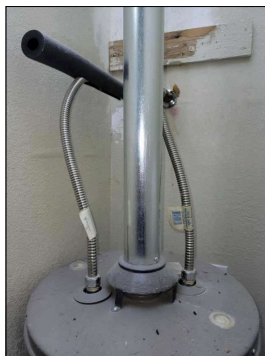
Water Supply Shut Off Valve for the Water Heater

- No Apparent Issues with the Plumbing

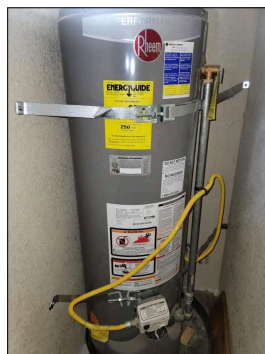
- The Water Heater Is Strapped

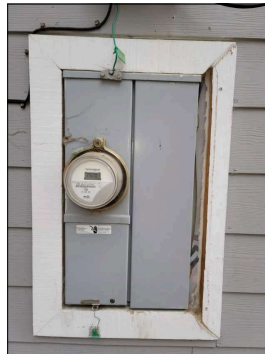
East Side

- No Apparent Issues with the Electrical Panel

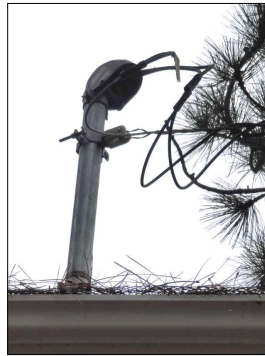
East Side

- There is an overhead service drop noted.

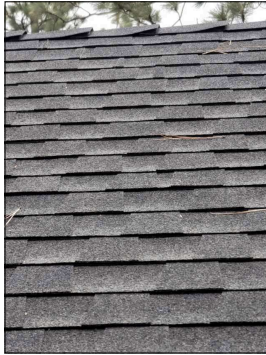
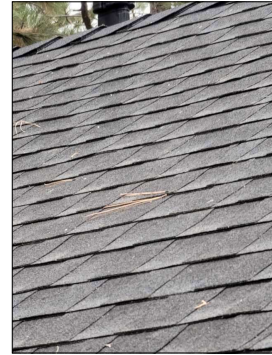
Materials: Inspected from ladder.  
Materials: Asphalt shingles noted.  
Observations:  
• No Apparent Issues with the Roofing

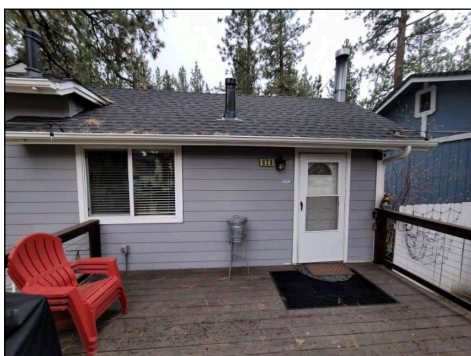
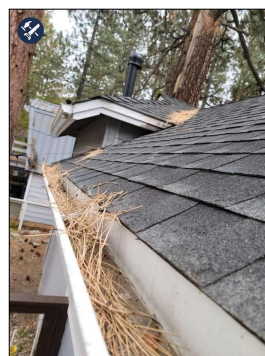
- No Apparent Issues with the Gutters
- Clean gutters: Significant amounts of debris evident.

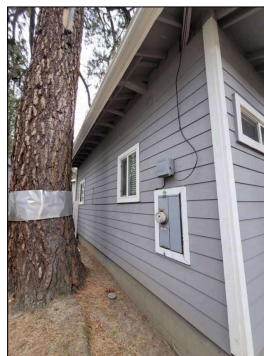
East Side

- No Apparent Issues with the Siding.
- **Caulk and seal all gaps, cracks and openings.**
- **Some siding deterioration noted. Have repaired as necessary.**

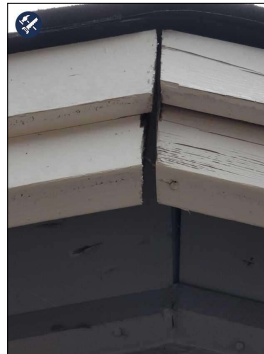
Fill & Seal All Gaps & Crack in the Eaves.

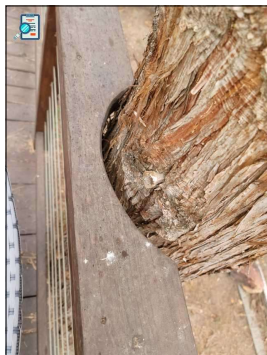
North deck

- Tree limbs within 10 feet of roof should be trimmed away to provide air and sunlight to roof, while minimizing debris & dampness.
- Trim trees that are in contact or proximity to home, as branches can abrade roofing or siding.

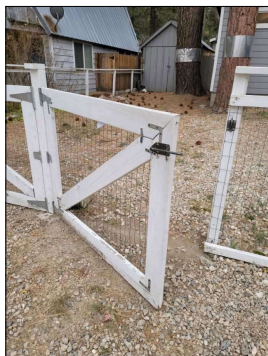
North or Front Side

- No Apparent Issues with the Gates
- Damaged gate observed.

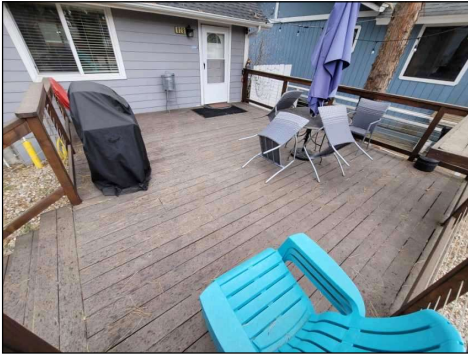
North Deck

- Appeared functional at time of inspection.
- Deck Railing is Loose
- Deck Railing has Peeling Paint & Bare Wood Observed
- Floor Boards are Showing Peeling Finish & Bare Wood

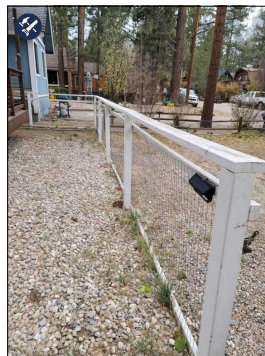
Materials: Wood  
Observations:  
• **\*\*FENCING\*\***  
• No Apparent Issues with the Fencing  
• **\*\*FENCING\*\***  
• Fencing Shakes easily.

North Side is Shakey
