## Wright-Pro Home Inspection, LLC

# Home Inspection Report

Inspection Date: April 18, 2023

**12345 Main St.**  
**Any City, MI 48190**

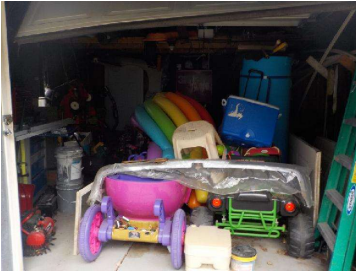
Garage was full of stored items. Limited Inspection - Difficult to see many areas of walls and floor. Ratings below reflect areas which could be seen.

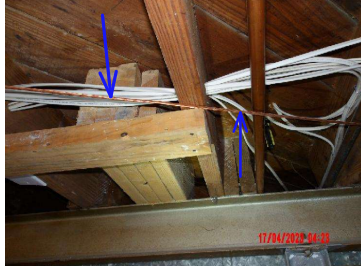
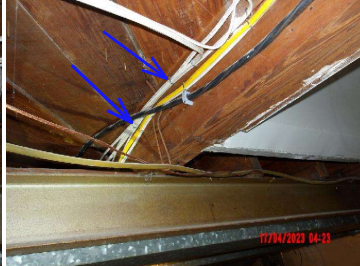
120 VAC Branch Circuits: Too many wires under staple fasteners

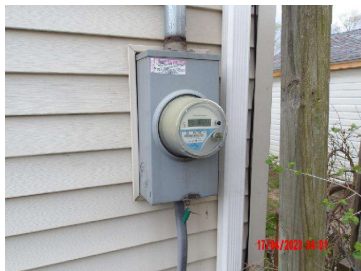
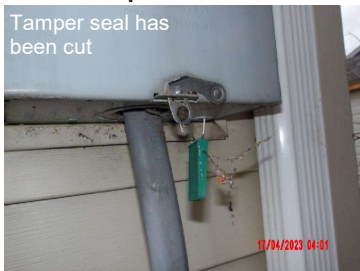
Electrical Meter: Smart Meter - Tamper seal has been cut.

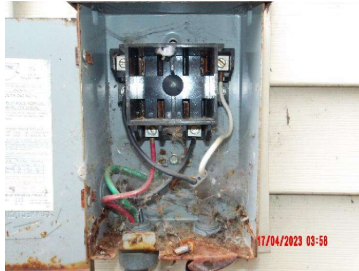
Good Electrical Disconnect: Pull out disconnect on wall next to unit

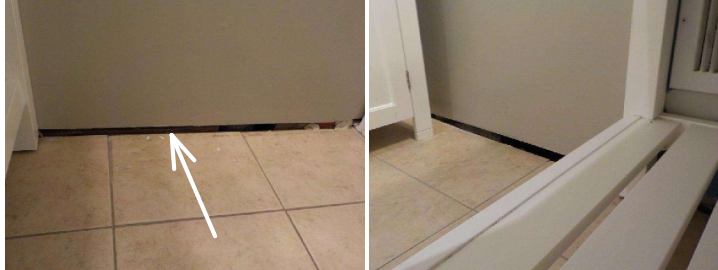
Walls: Drywall - Not finished with baseboard molding along the West wall.
