# Inspection Report

Produced on behalf of – CITY

Site location – Broadway Hill

Adirondack Septic Tank, Inc.

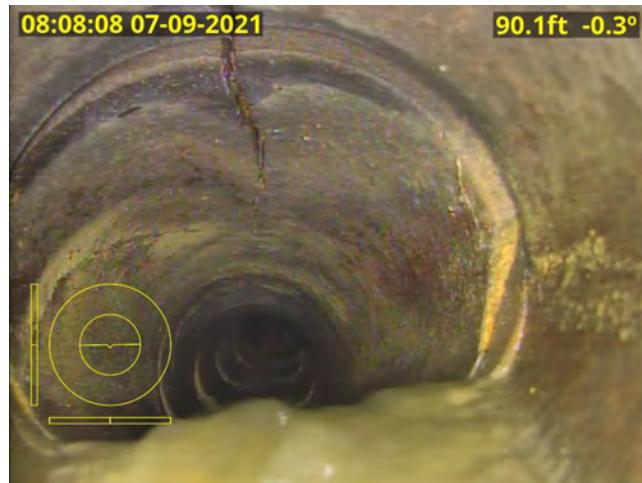
CL survey0000079/2021\_07\_09-08\_08\_824.jpg

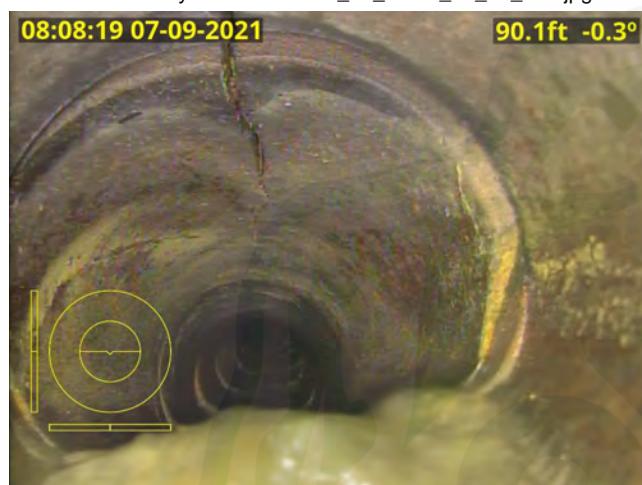
CC survey0000079/2021\_07\_09-08\_20\_079.jpg

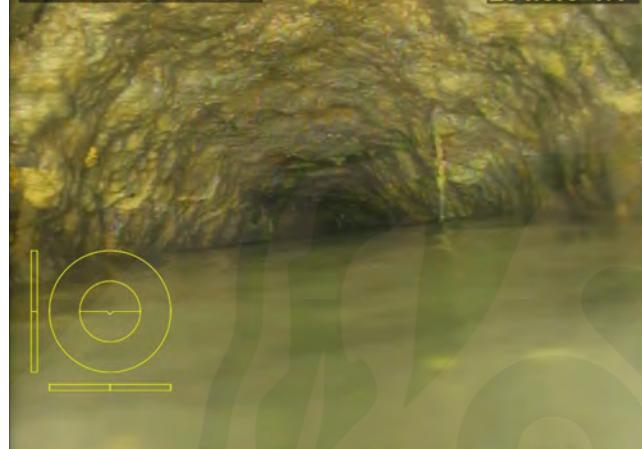
EH survey0000079/2021\_07\_09-08\_27\_20\_199.jpg

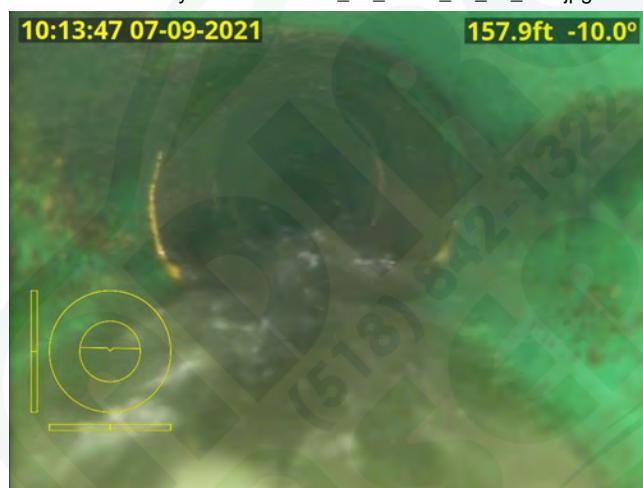
AT MC
0:12:55	157.9		MC	survey00000088/20 21_07_09-					TRANSITION BACK TO VC

MC survey0000088/2021\_07\_09-10\_13\_47\_290.jpg

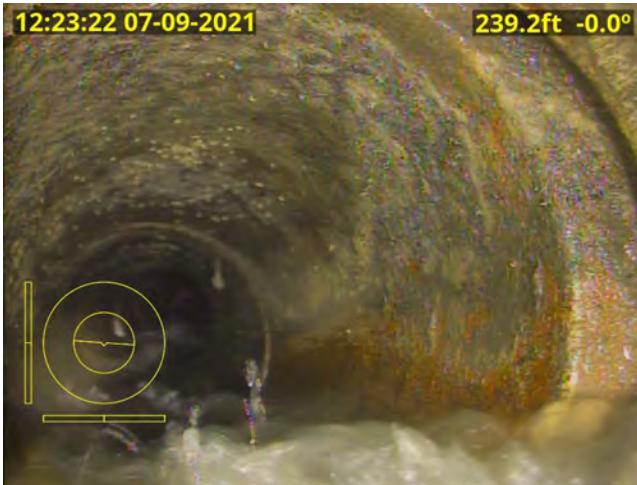
JDM survey0000091/2021\_07\_09-12\_23\_22\_105.jpg
