Manning Home Inspections

Home Inspection Report

Prepared For:

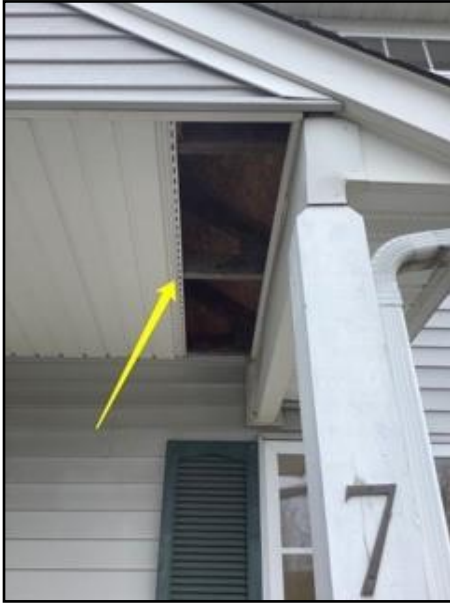
Figure 3-1

Recommend repairing vinyl soffit to prevent pest entry into home.

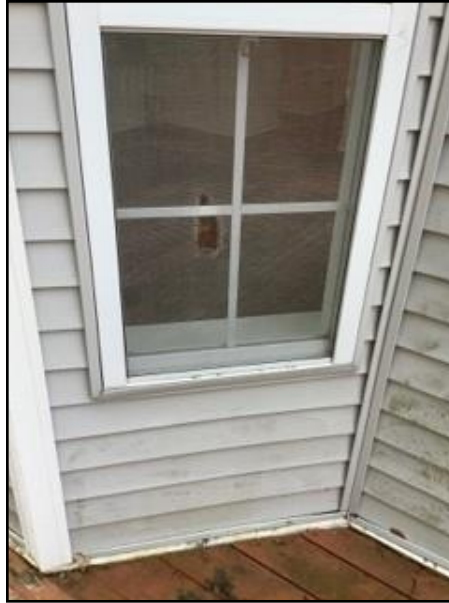
Some screens on the home are damaged. Recommend replacing. Cosmetic

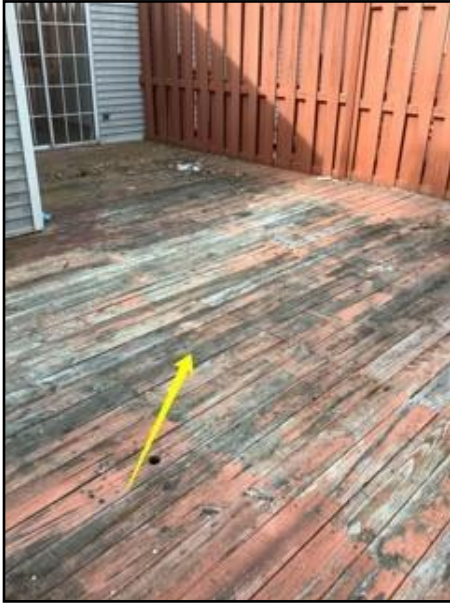
Figure 6-1

Recommend painting deck. Cosmetic

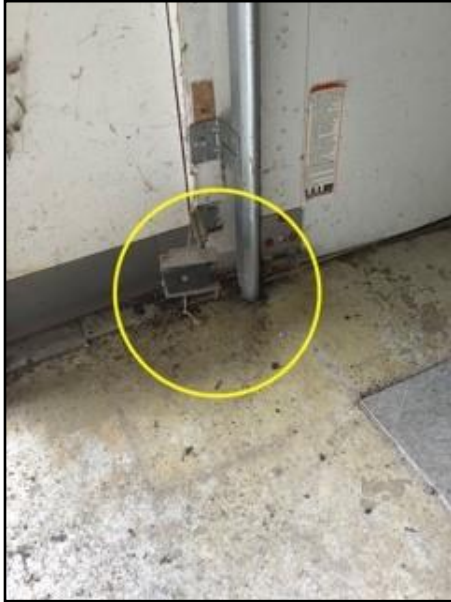
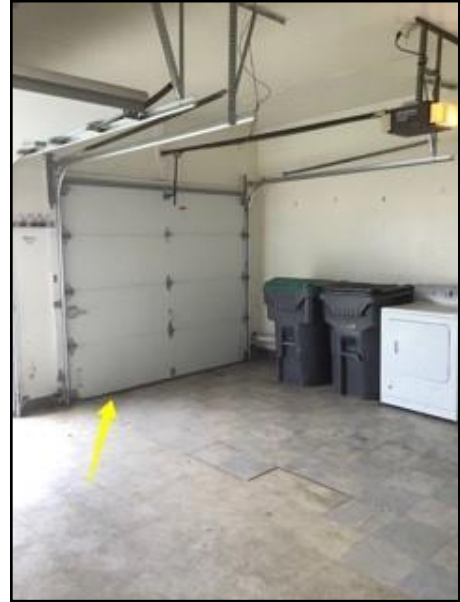
Recommend repair and ensuring that garage door is working properly prior to

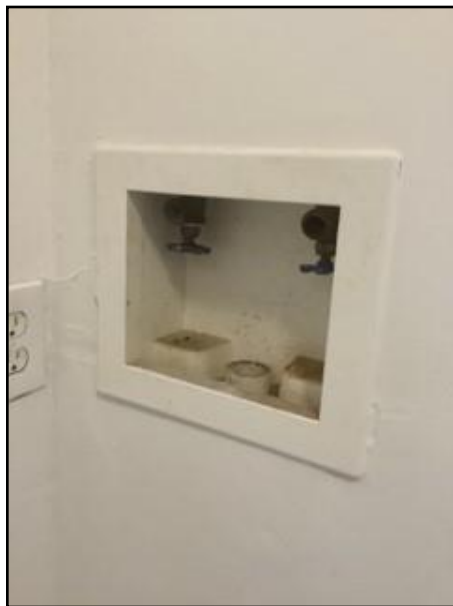
Figure 31-1

Laundry room appeared ready for proper appliance installation .

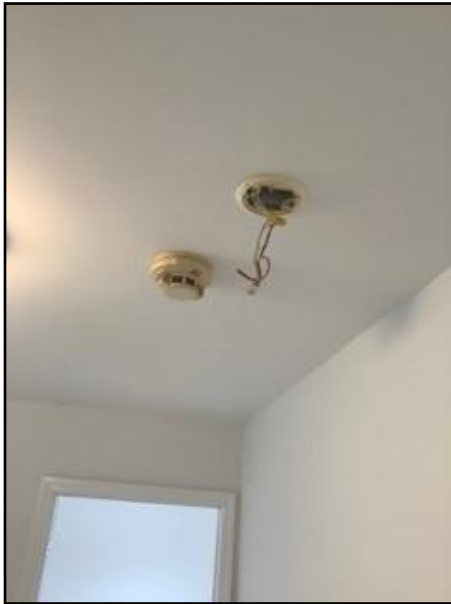
Figure 32-1

We do not inspect Smoke Detectors/Carbon Monoxide detectors. We advise all of our clients to purchase new ones prior to moving in and place them accordingly to manufacturers instructions.

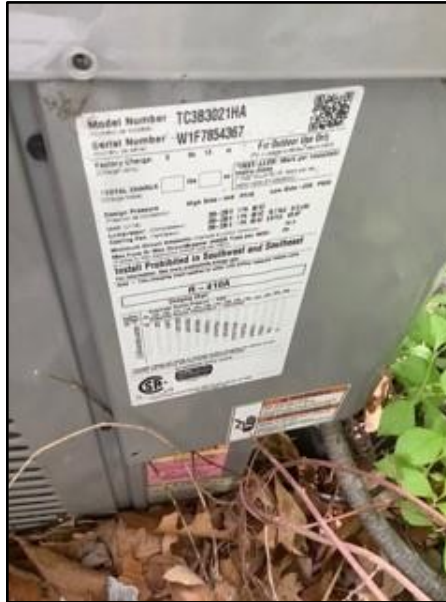
Recommend clearing vegetation away from home to ensure compressor can operate properly. We did not test AC due to outside temperature. Recommend ensuring it is working properly using normal controls (thermostat) prior to close.

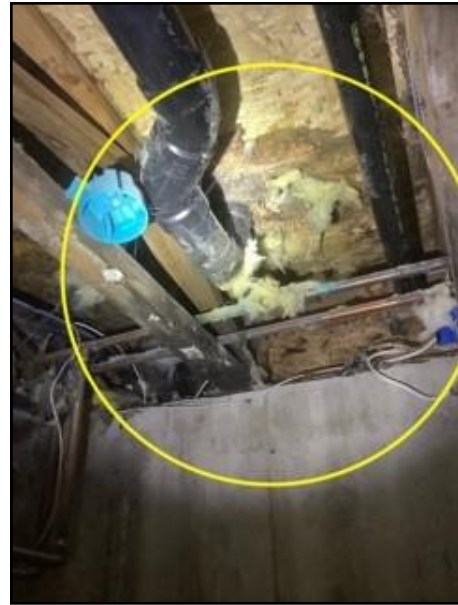
Figure 36-2

There was a leak observed in the utility room. It appears to be coming from the bathroom above. It is also in close proximity to exposed wiring. Recommend having a licensed contractor evaluate and repair

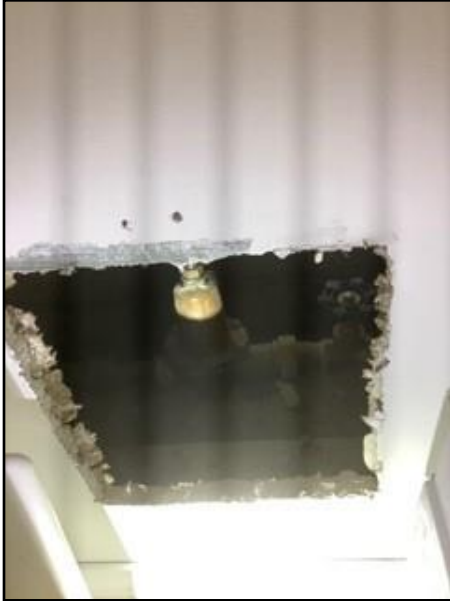
Figure 37-1

Main water shut off located in basement bathroom under sink. In case of plumbing emergency shut the blue turn valve located in wall

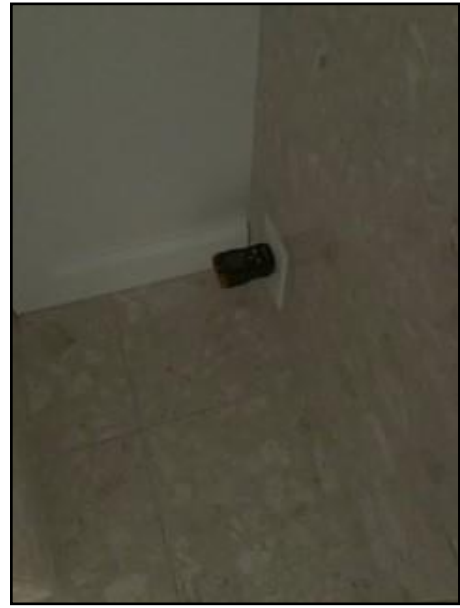
Figure 38-2

Several lights and outlets were not working in the basement. This could be from a thrown breaker. Recommend evaluation and repair.
