Developer, Development, House Type, Plot Number

Saturday, 01 April 2023

102 Identified

Boiler Commissioning

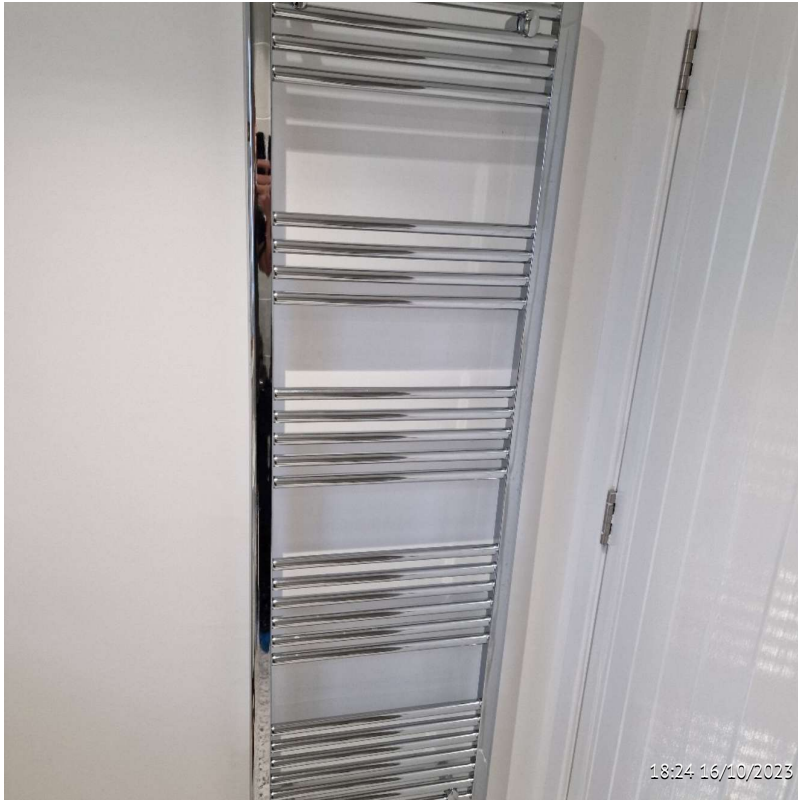
Location: Bed 1

Radiator not heating fully

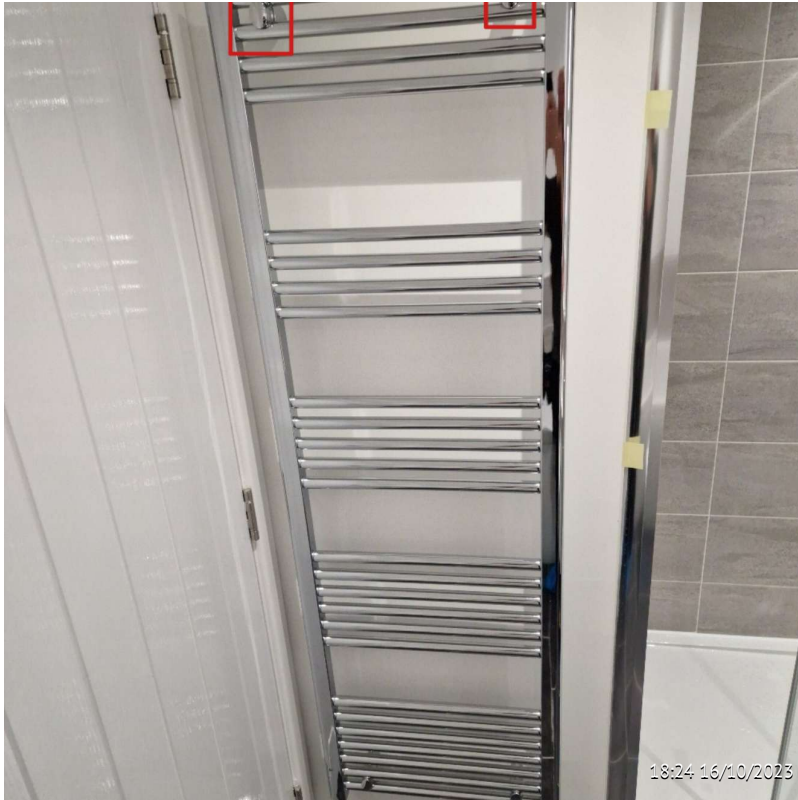
Location: Bed 4

Radiator not heating fully

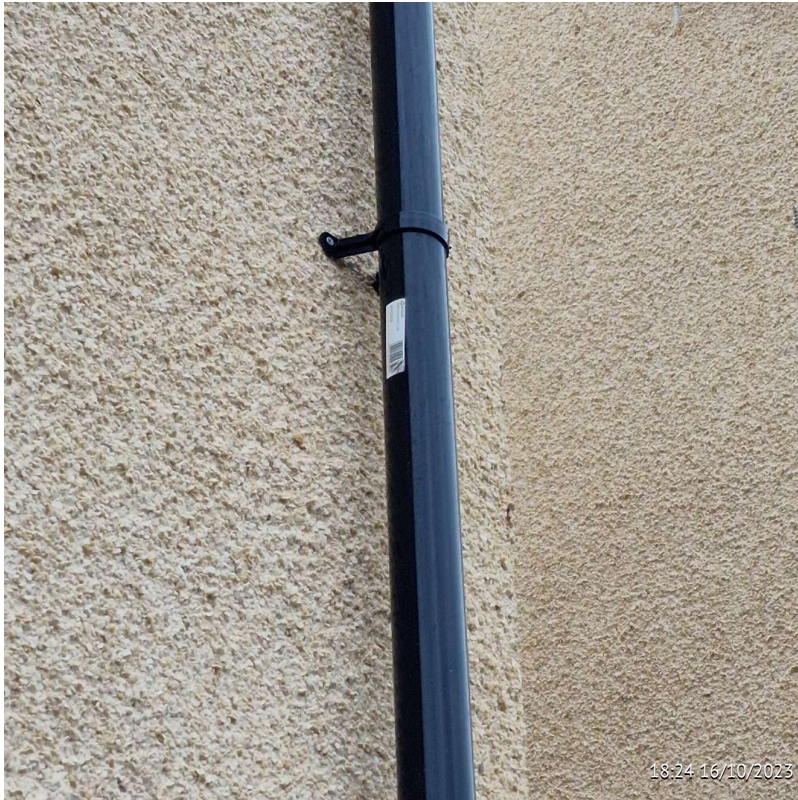
Location: Down Pipes

Incorrect fixings in use at
downpipe brackets.

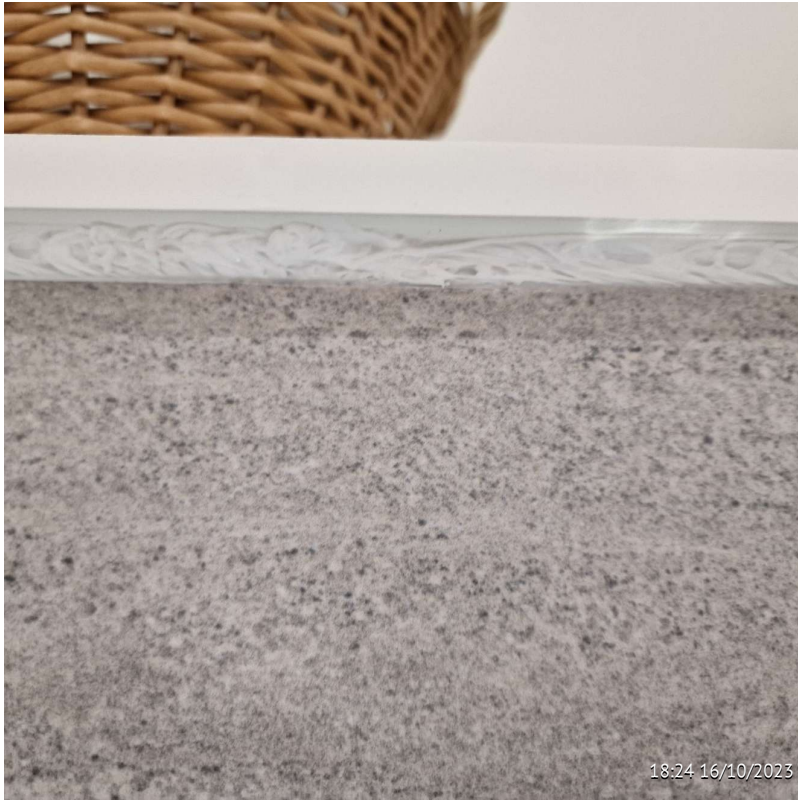
Location: Bed 3

Unsatisfactory finish to window reveals

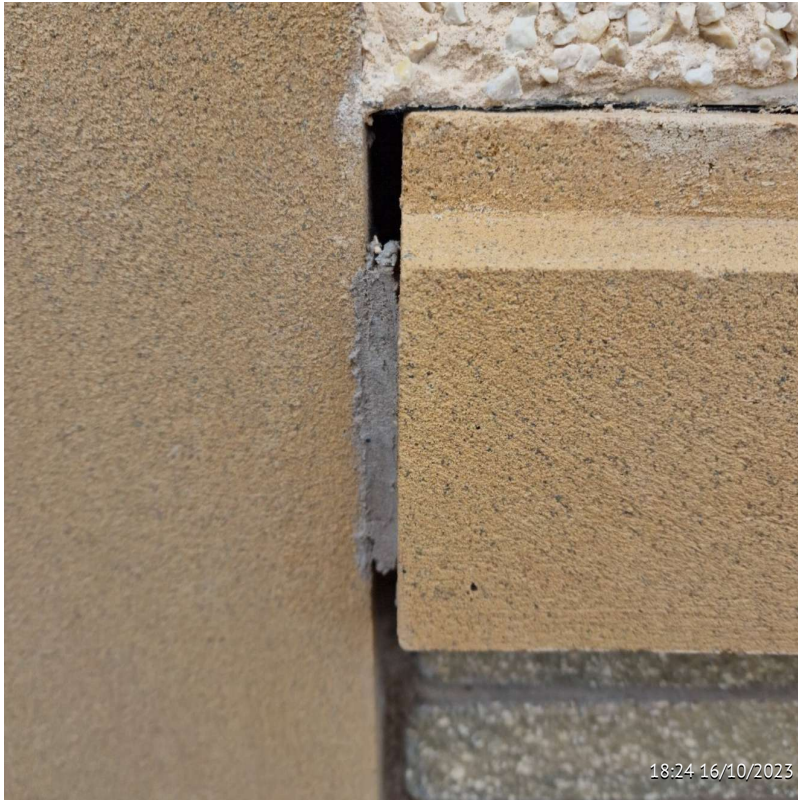
Location: Extent Of Pointing

Insufficient pointing at stoneworks

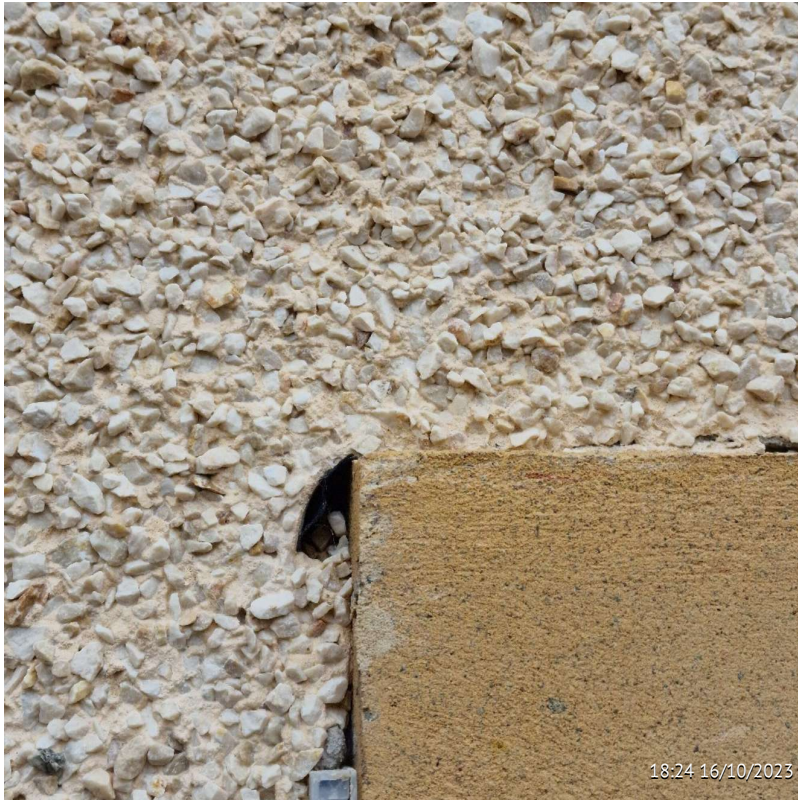
Location: Extent Of Pointing

Insufficient pointing at stoneworks

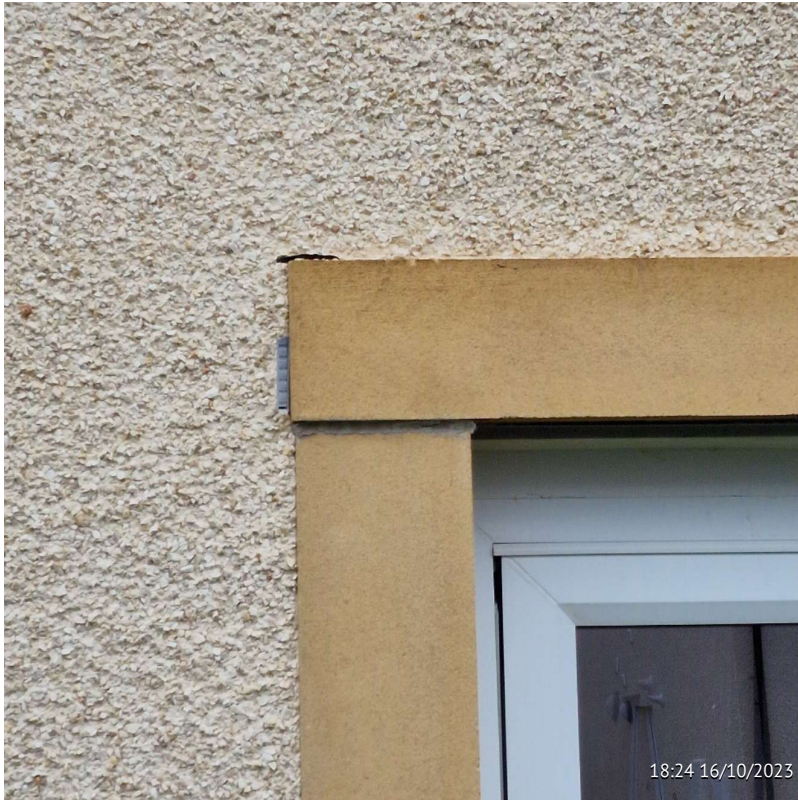
Location: Front Elevation, Front
Door

Horizontal DPC unsatisfactory
finish to extent of superstructure

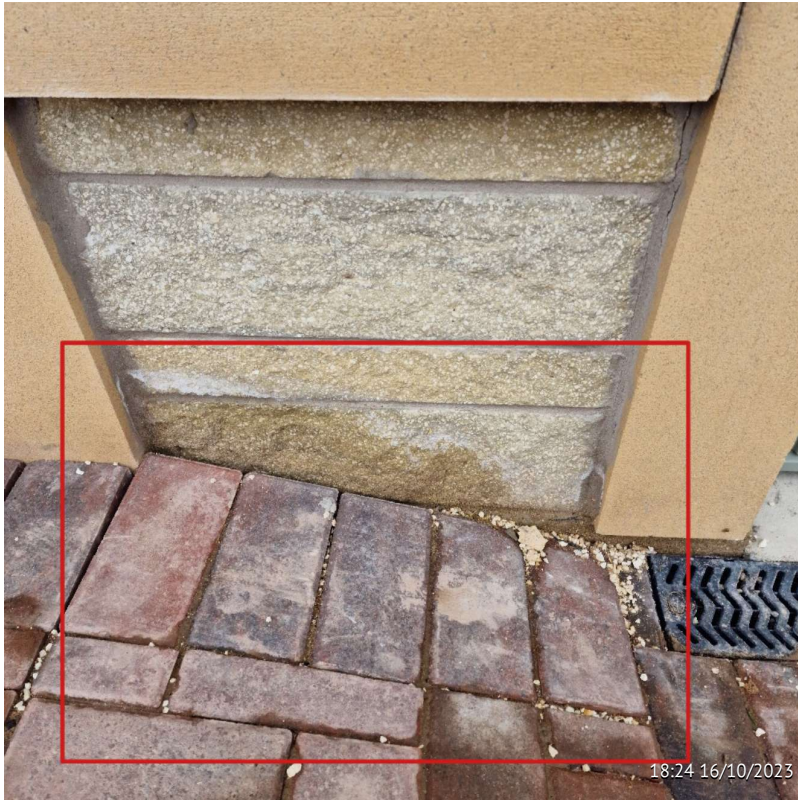
Weep holes should be provided at a maximum of 450mm intervals. Each opening should have at least two weep holes.

Requirement for weep vents at each end of external sill and supporting lintles

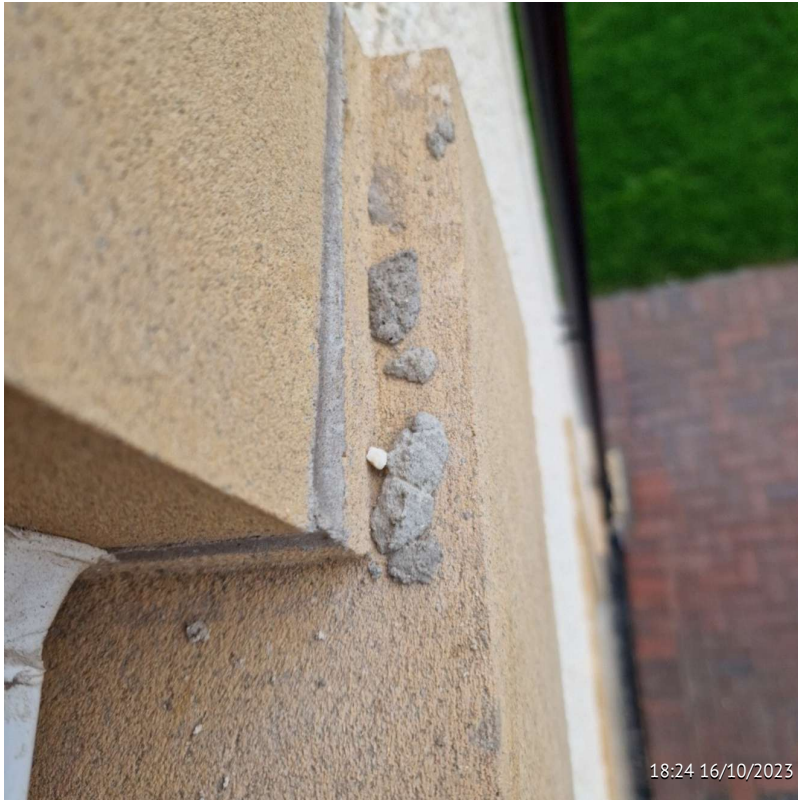
Unpainted lintel inconsistent with
others

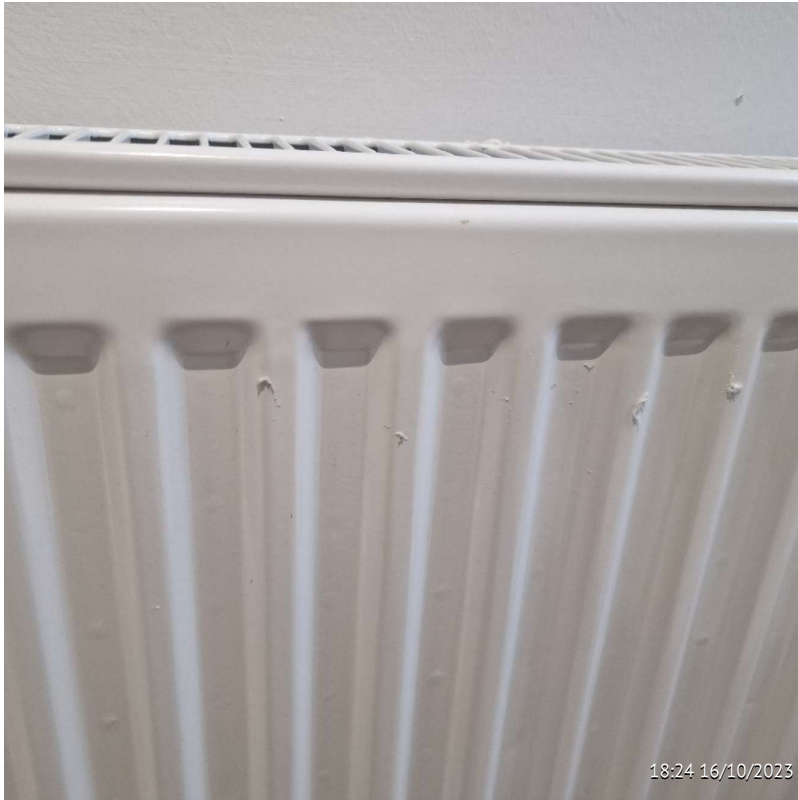
Location: Bed 2

Opening in plasterboard to rear of radiator
