BROOKS-PARK HISTORIC SITE

Adopted Management Plan

SUBJECT: Supplemental Condition Assessment Report
Brooks Park Buildings
128 Neck Path
Springs, NY
SCTM# 300-103-8-6
Purchase Order # 2022-0677

Brooks Park Cottage Condition Photos

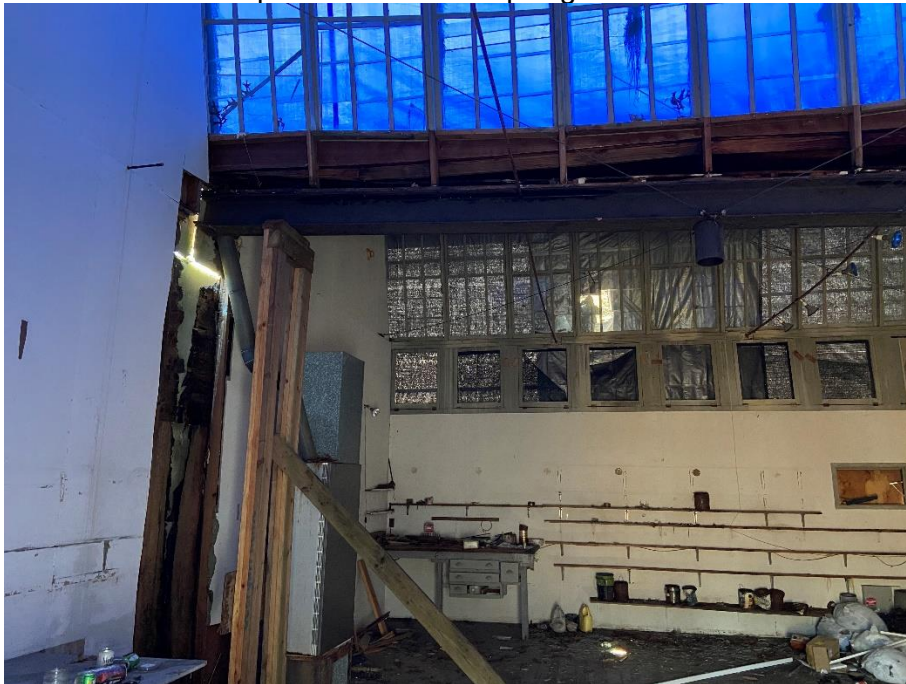
Brooks Studio Parapet roof beam collapsing

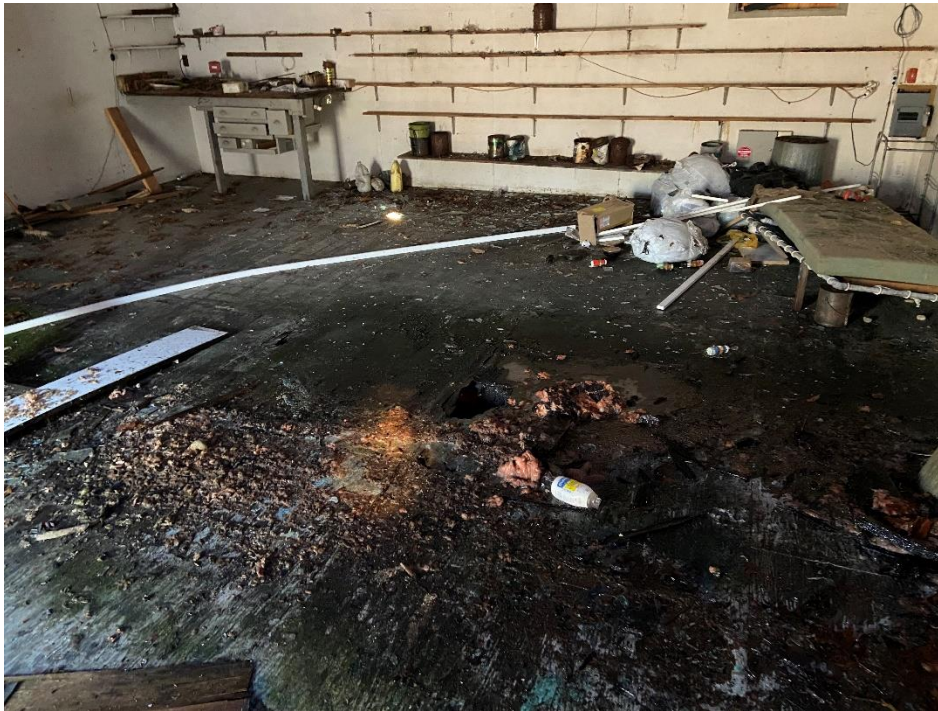
Studio floor

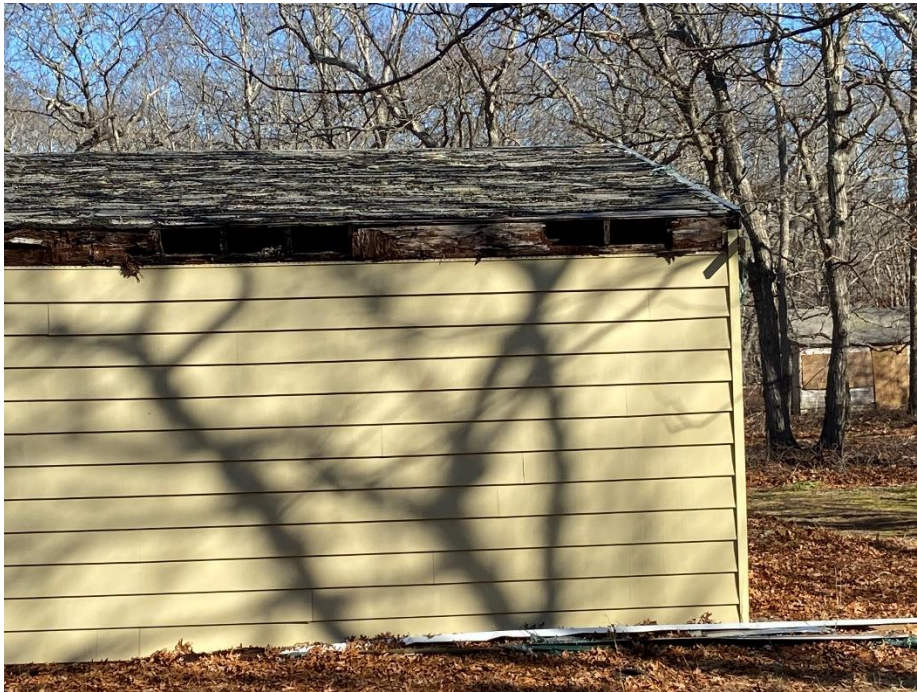
Studio storage roof

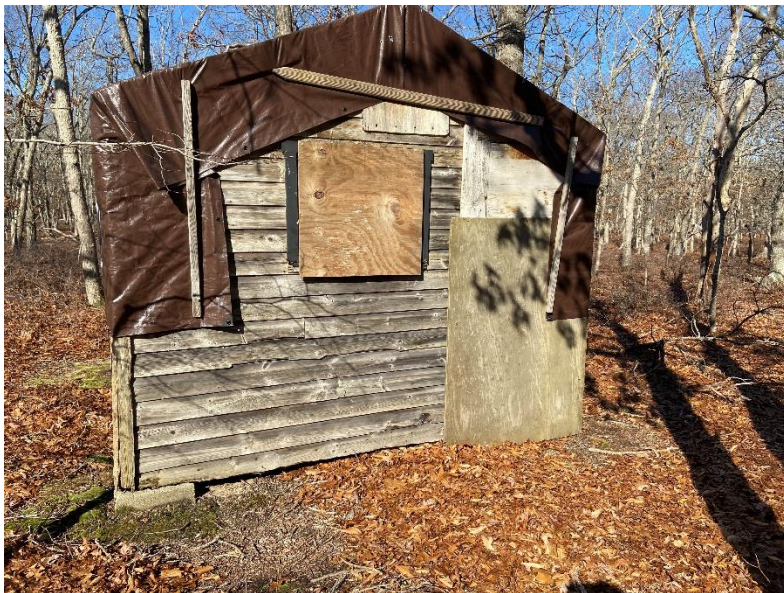
Shed

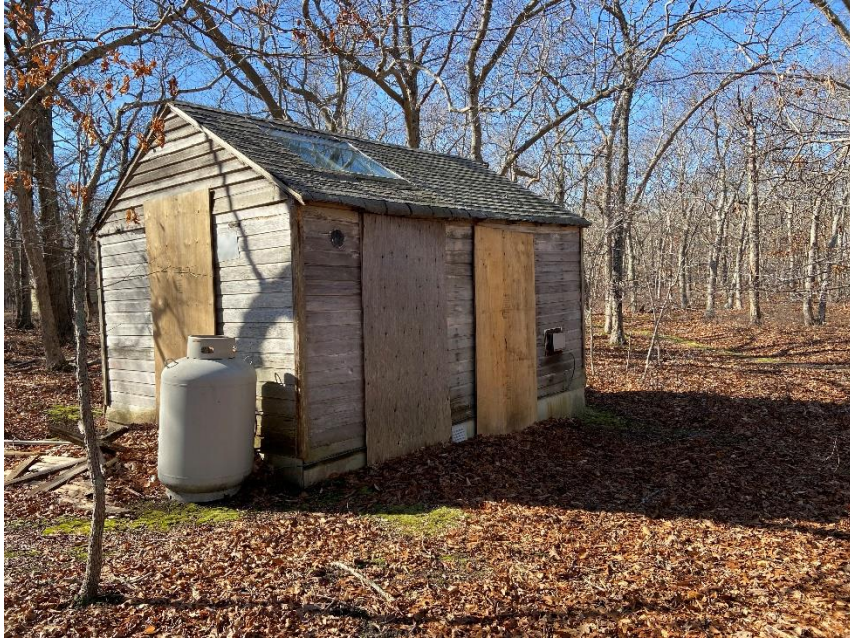
Park studio

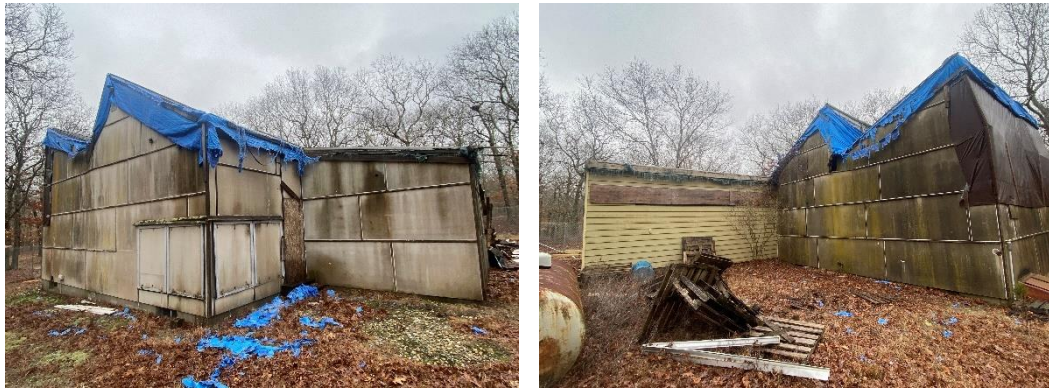
Photo No. 14 and 15: The Brooks Studio was built over two campaigns, the main block clad in Transite panels, and the SE storage wing clad in aluminum siding.

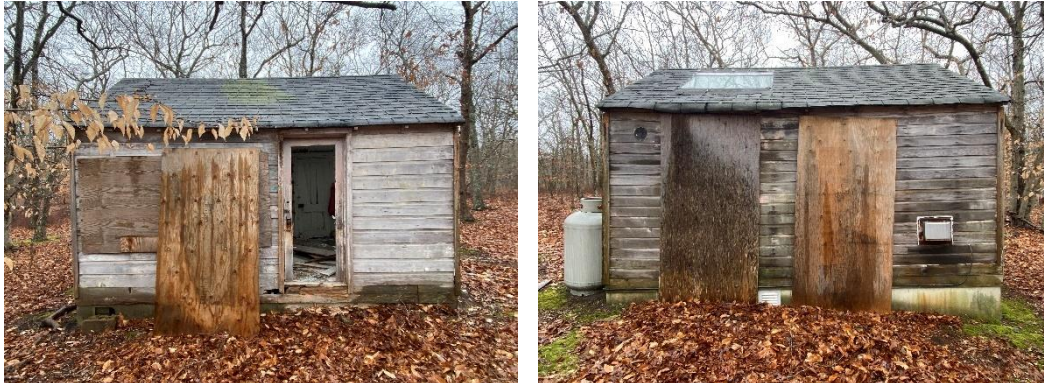
Photo No. 22 and 23: The Charlotte Park Studio is a small one-story cottage structure located northeast of the Brooks Studio.

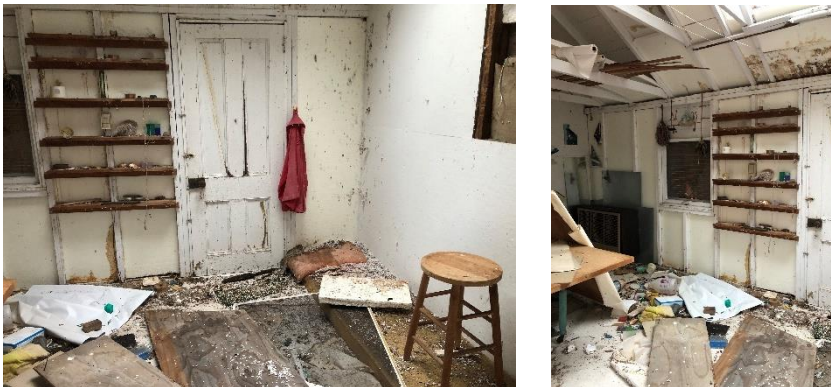
Photo No. 26 and 27: The extant furnishings and artifacts require proper documentation and cataloging.
