PROPERTY INSPECTION REPORT

Dustin Keller
Sky Pines Home Inspections

Your address
Inspection Prepared For:
Agent: Dustin Keller - Test Agent

Date of Inspection: 6/10/2025
Size: 1884

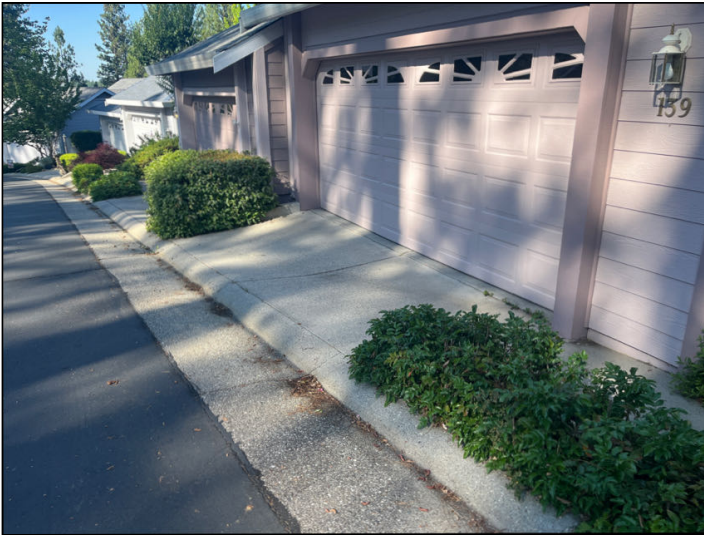
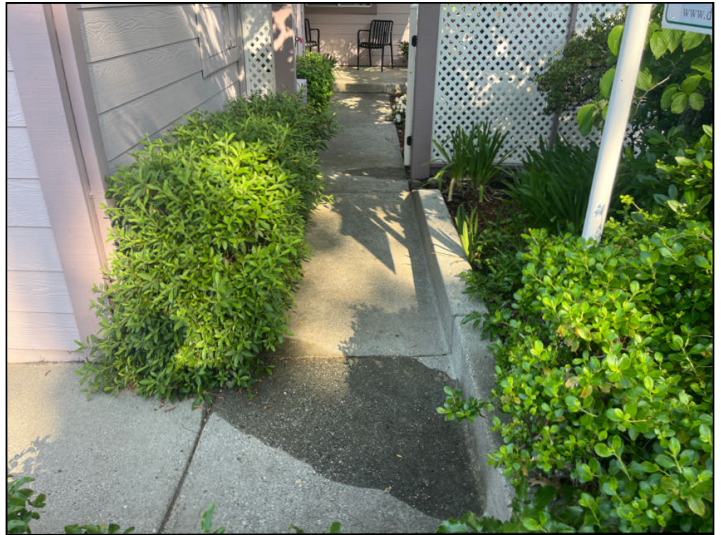
1. Driveway and Walkway Condition

- Driveway and sidewalk are in good shape. No deficiencies noted.

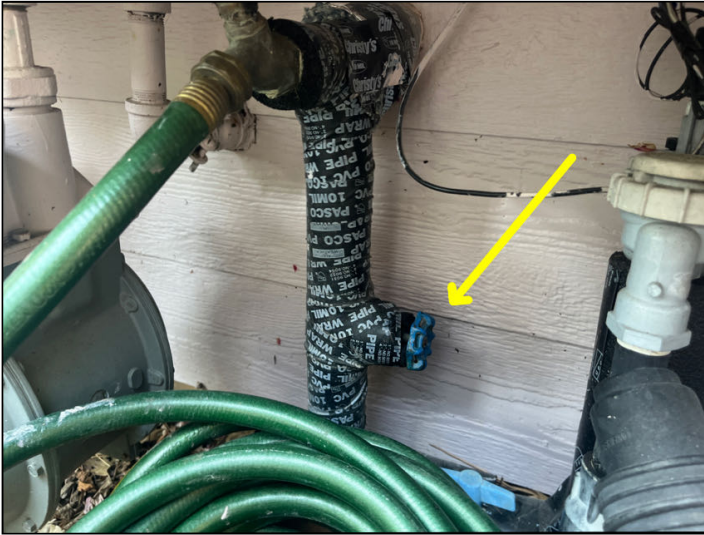
Observations: The water main is located at the exterior faucet near the gas meter and is in a serviceable condition.

There appears to be a secondary shut off at the back of the home along the north wall. Possibly controlling the sprinkler system in the back. Was functional at the time of inspection.

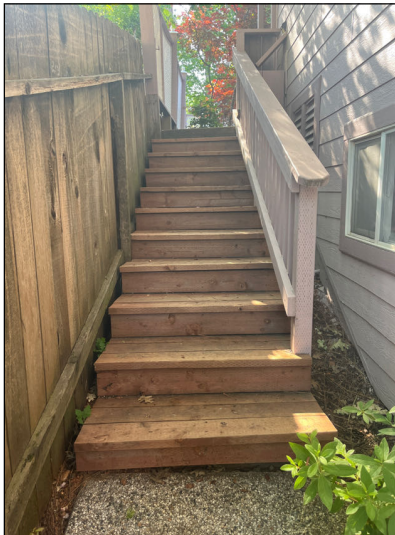
6. Stairs & Handrail

- The stairs and handrail appear to be in a functional condition at the time of inspection.

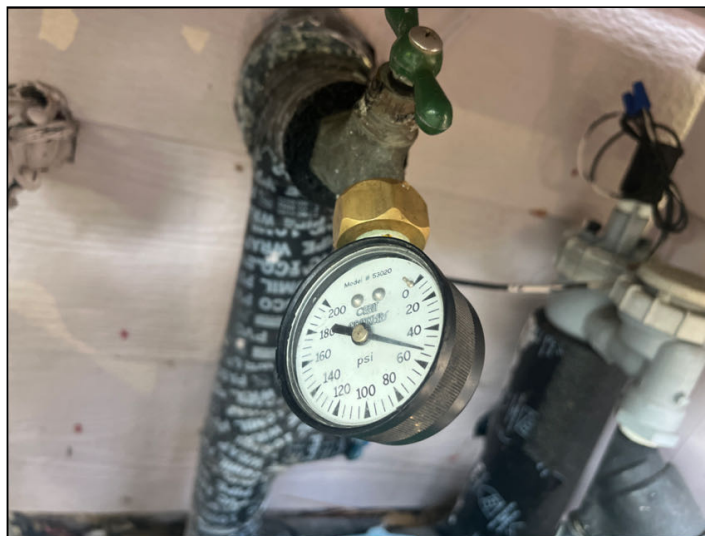
- Pressure is sufficient at the outside spicket.
- 50

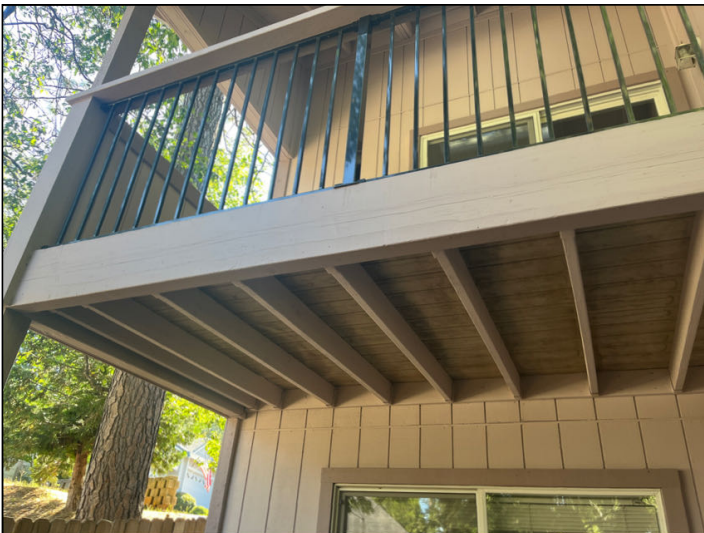
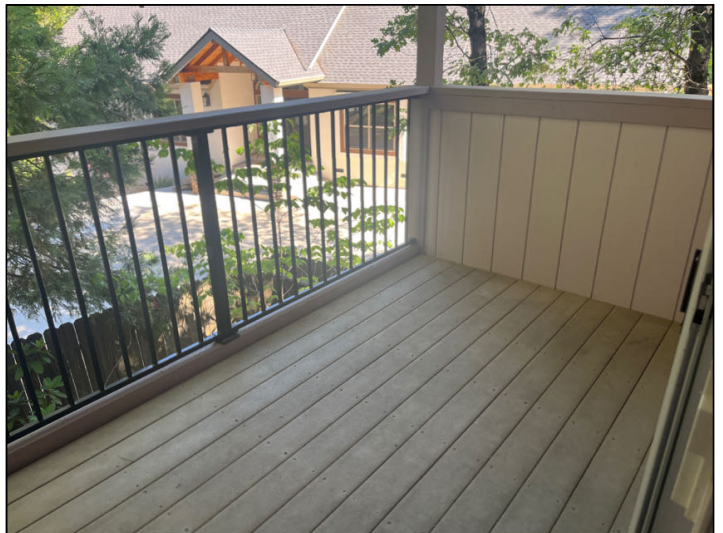
13. Balcony

- Patio/ balcony is in a satisfactory and functional condition with normal wear for its age. Appears to be a sound structure at the time of inspection.

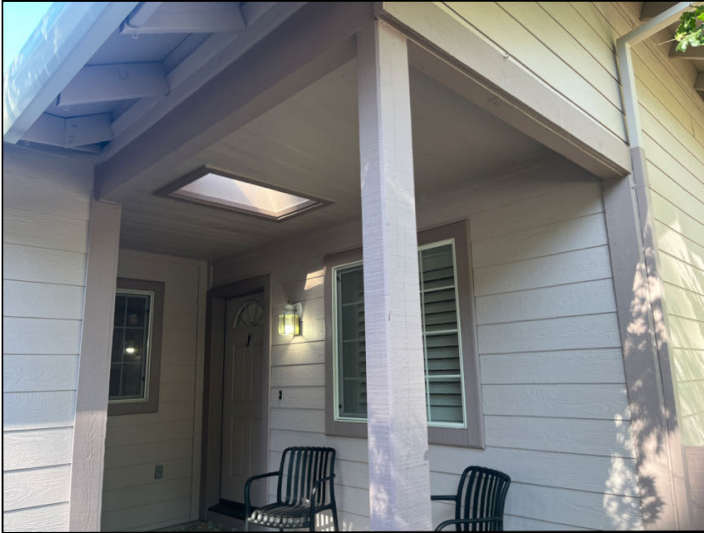
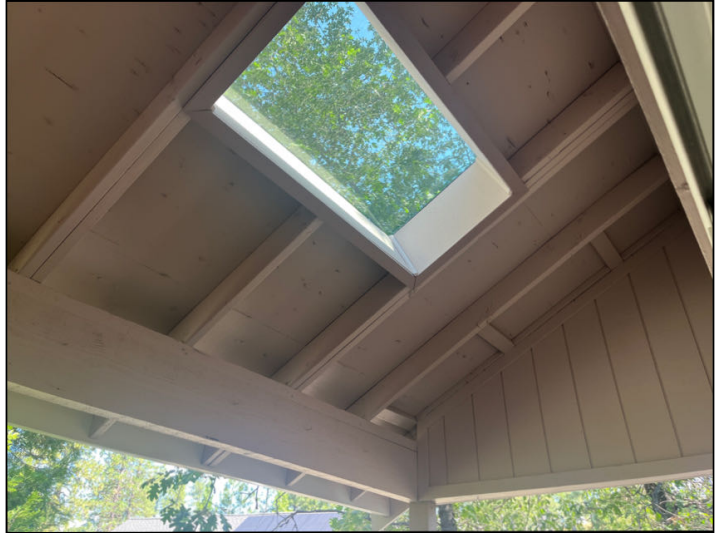
14. Patio Enclosure

- General overall condition appears satisfactory with painted surfaces in good condition, at the time of inspection.

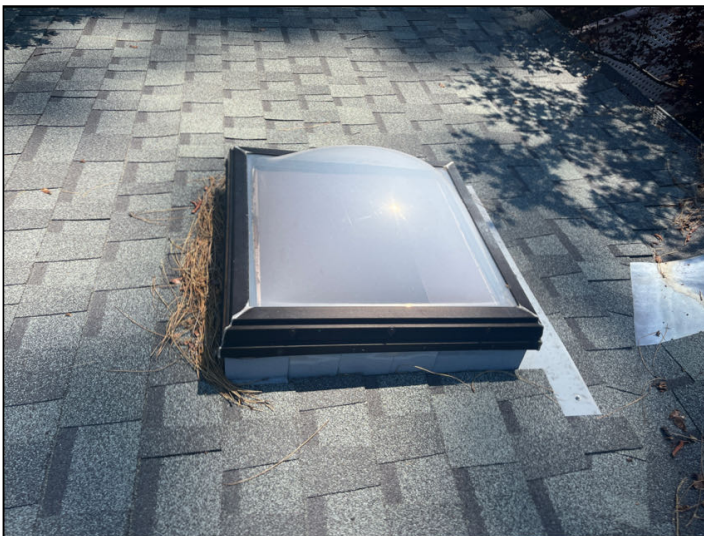
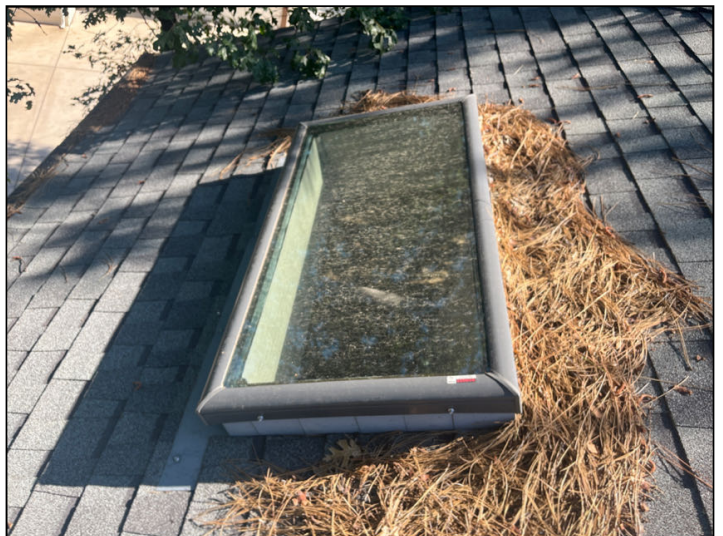
- Skylight(s) appear to be in a satisfactory condition during the inspection.

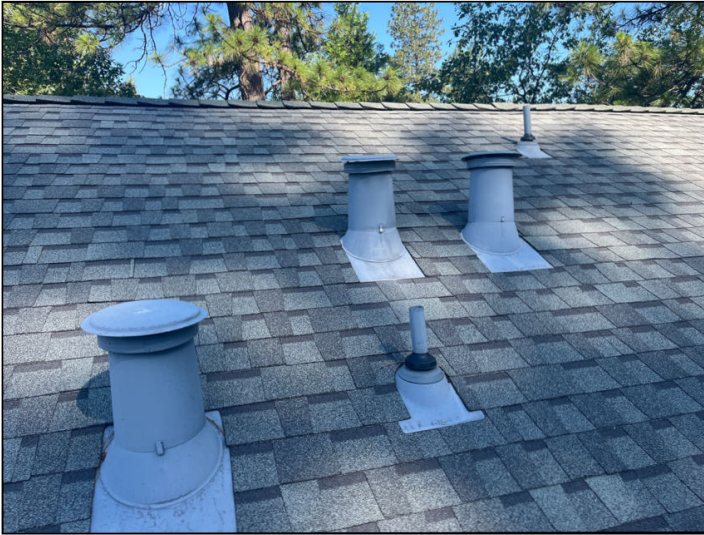
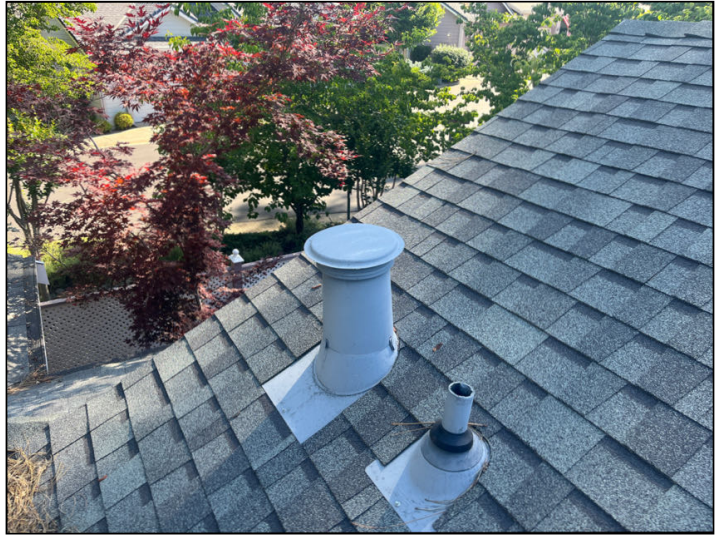
4. Vent Caps

- The vent caps appear to be functional and in a satisfactory condition during the inspection.

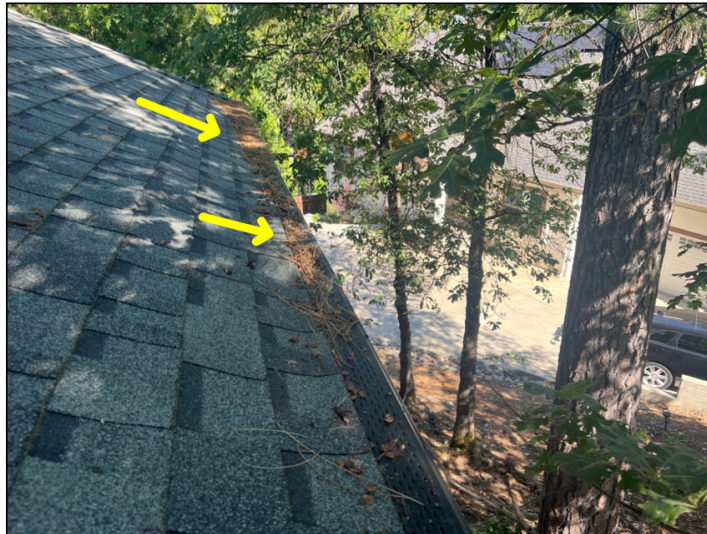
5. Gutter

- No functional concerns around the gutters or downspouts were noted at the time of inspection.
- Gutters should be kept clear of pine needles and other debris to prevent water from flowing over the gutter instead of into the gutter. All gutters are equipped with debris screens, so it would be as simple as sweeping the Pine needles off the top.

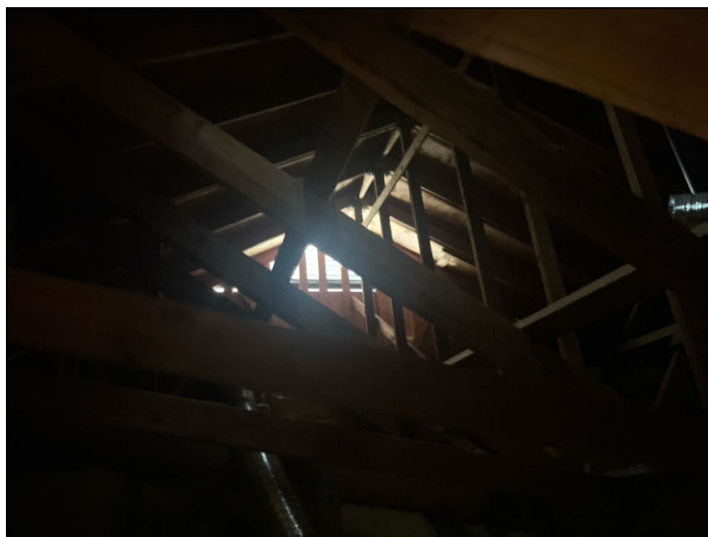
3. Ventilation

- Ridge exhaust venting noted.
- Gable louver vents noted.

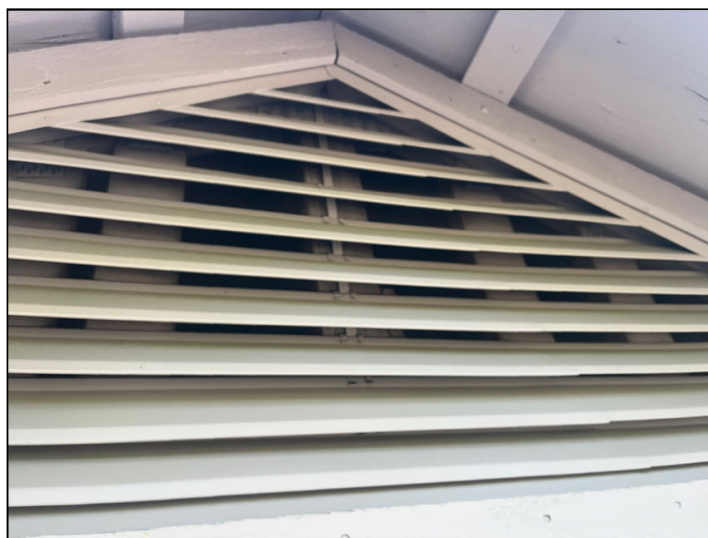
4. Vent Screens

- Vent screens noted as functional.

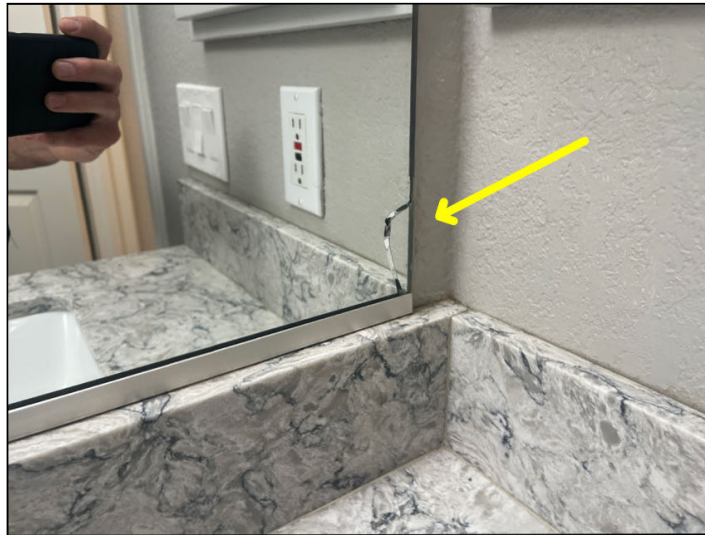
- The mirror is chipped.

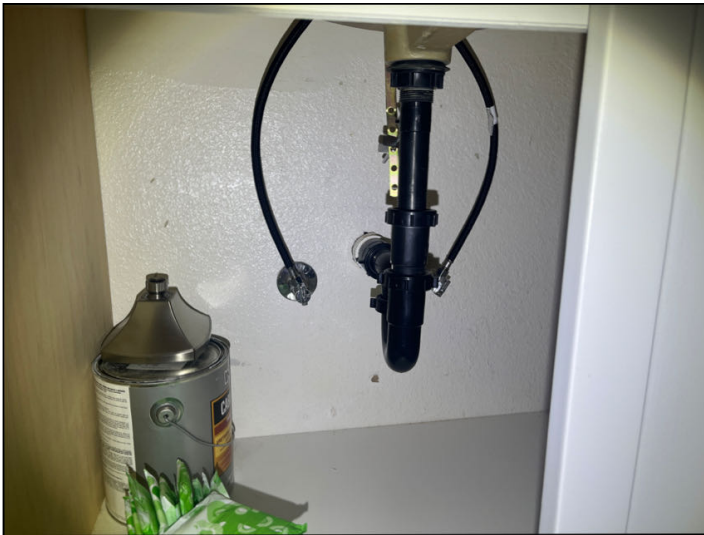
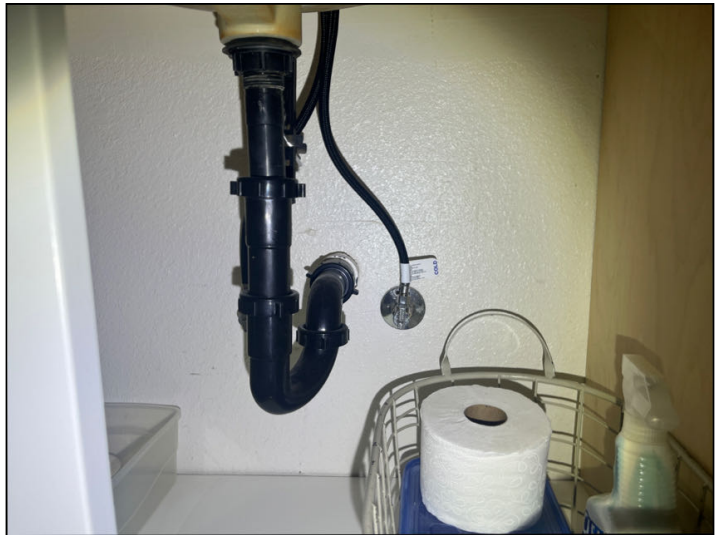
11. Plumbing

- The under sink plumbing is good condition with no defects noted during the inspection.

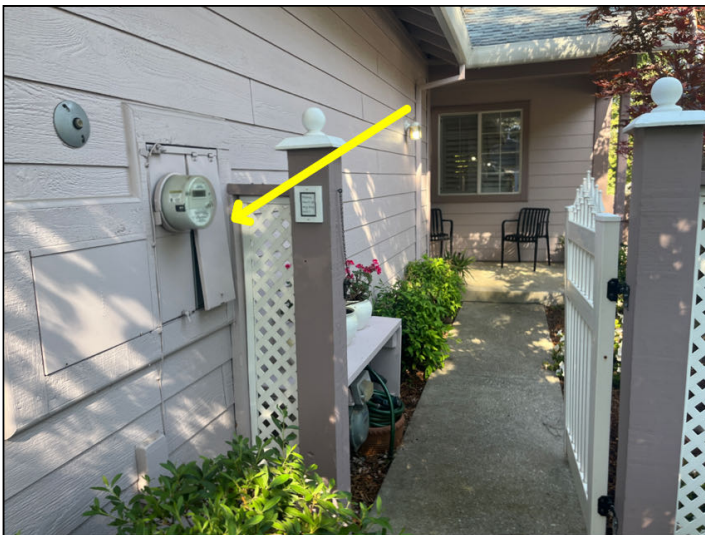
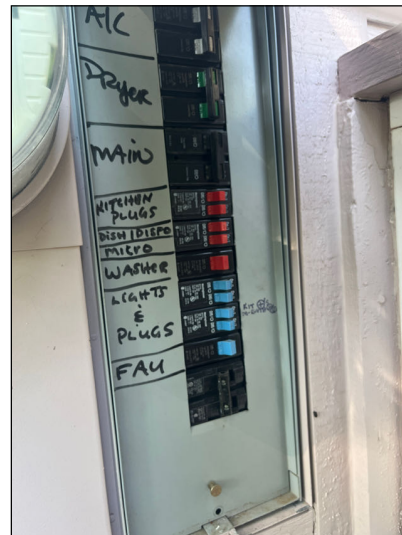
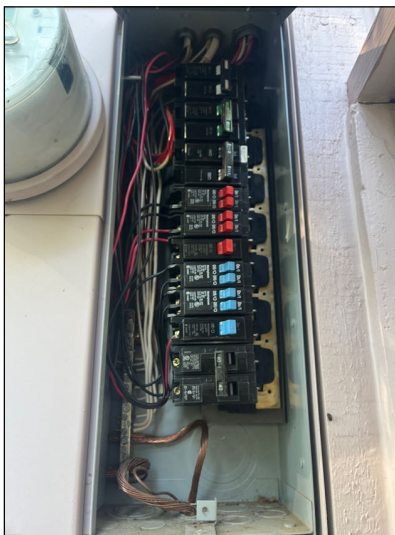
- No system safety or functional concerns noted at time of inspection at main panel box.

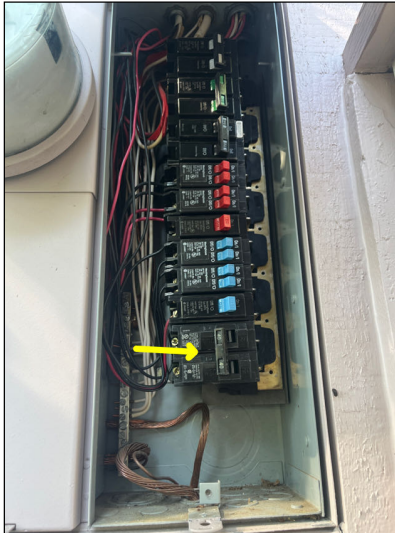
- 1 spare 40 amp 240 volt breaker is present. Currently nothing worked to it. No notable defects.
