# Home Inspection Report

1112 5th St, Lakeport , CA 95453

Tuesday May 3, 2022

Dustin Wallace General Contractor Home Inspections  
16496 Main St.  
Lower Lake, CA 95457  
(707) 293-6307  
dustinjameswallace1985@gmail.com

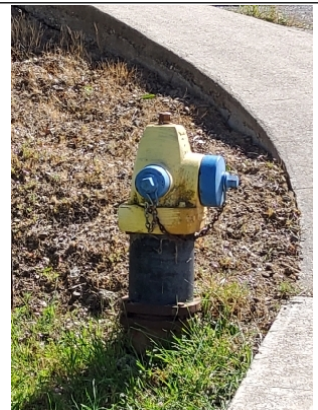
Fire hydrant is located on property. This is good information that should be provided to your insurance company for better rates.

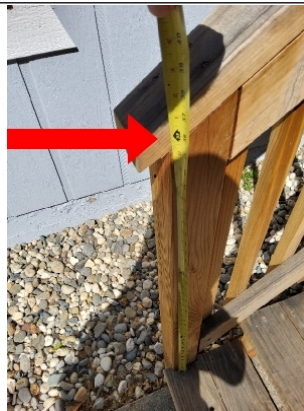
Handrail is not required as the top plate member is 36" and is between 34"-38" which meets the handrail height requirements.

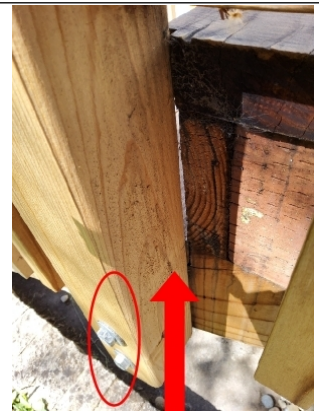
All thread needs to be tightened, additional exterior deck (square or star) bit 3-1/2" size screws should be applied at an angle from post to tread member. Make sure to predrill prior with 1/8" drill bit.

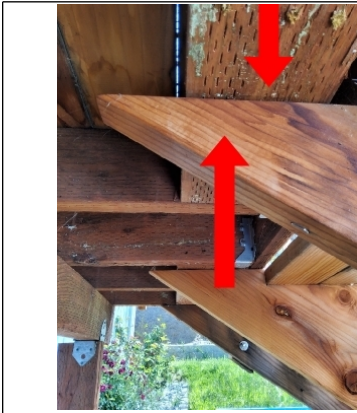
Technically stair stringers are not installed correctly as they should be installed to the rim member of the deck. Solution: Simpson Strong-Tie 3.3 inch W x 4.9 L Galvanized Steel L-Angle

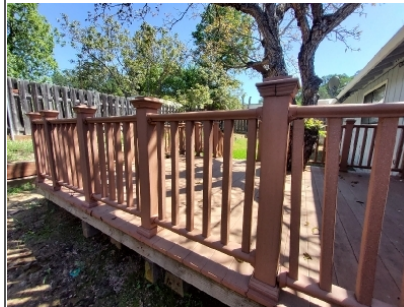
Composite railing is loose and should be properly fastened to the post.

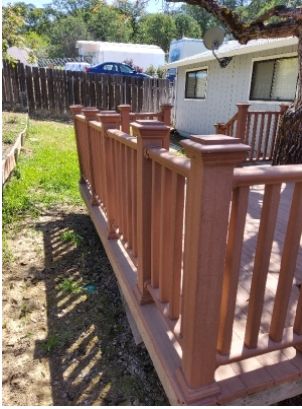
Composite railings from Trex have always had issues especially during this time. This is one of the first generations of composite and have since improved significantly. The problem with composite is its easy for screws to strip and split the composite without an ease of repair.

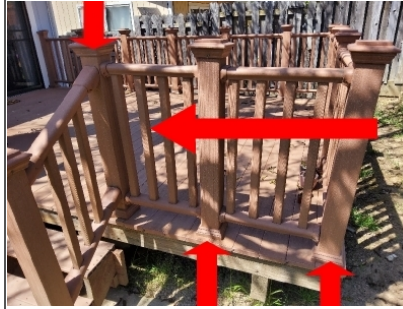
(Down) This is the center post to based adjustments off of. (up) both other posts need to proper tie with the railing to the initial solid post. Tighen railing working from the down arrow to the right.

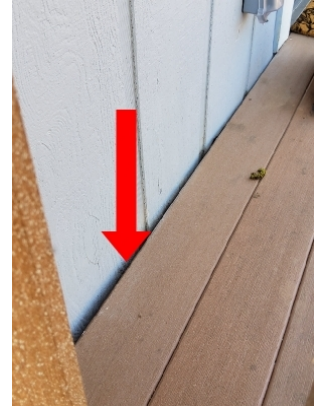
Because of upheaving from the tree root system the deck ledger joist members are pulling away from the ledger member. Galvanized flashing above the ledger members were not required when this deck was built. Deck is not original.

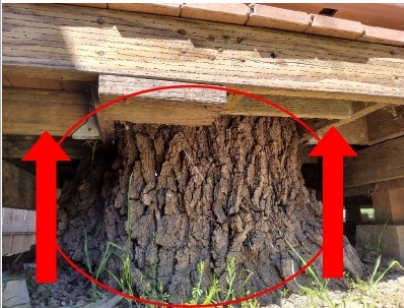
Tree trunk is upheaving the deck joist members. Recommend having tree removed.

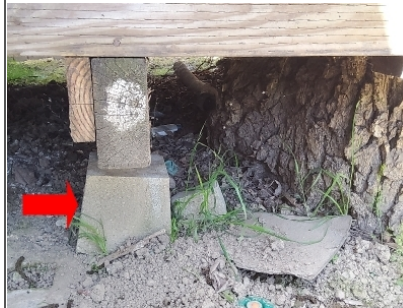
No footing is below pier block. The tree root system has caused the pier block to dip.

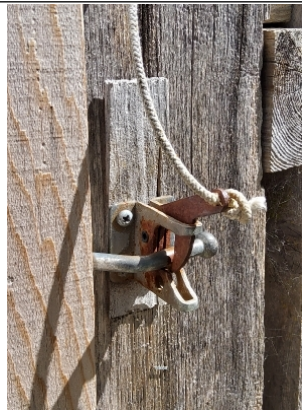
Recommend replacing rusted gate latch

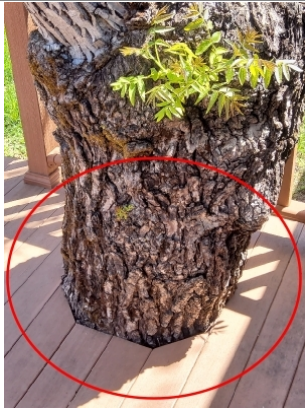
Tree does need to be removed as mentioned prior.

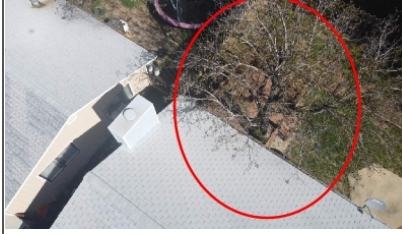
Tree should be removed as tree growth will cause branches to fall on 3-Tab Shingle roof and clog gutters.

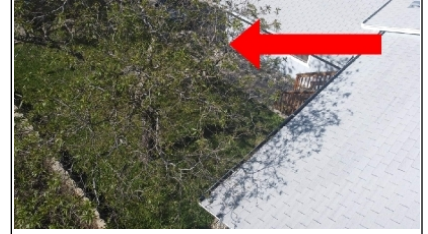
Tree should be trimmed back and gutter covers should be installed on next set of gutters at this location.

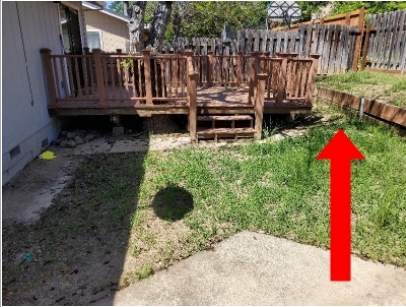
A french drain would help with water intrusion in the crawl space.

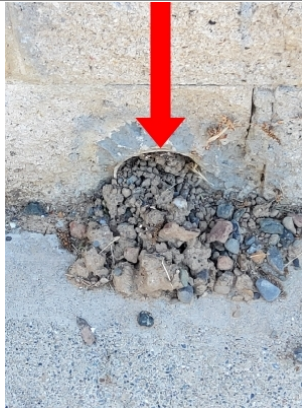
Clear out clogged drain lines of retaining wall.

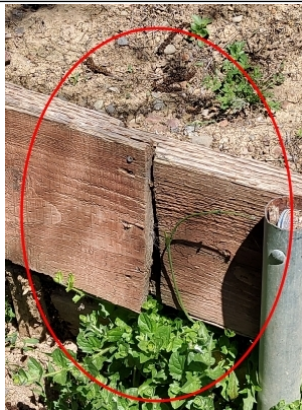
Disconnected pressure treated plank members recommend fastening addition 2x8 treated in front of it.

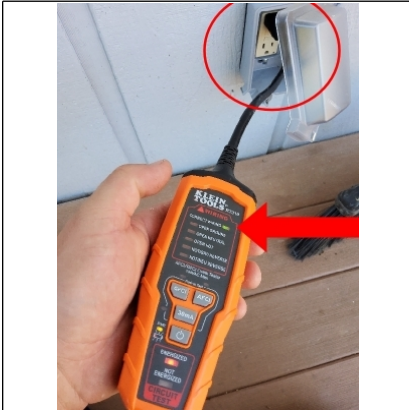
Exterior Electrical outlet shows proper grounding and polarity.

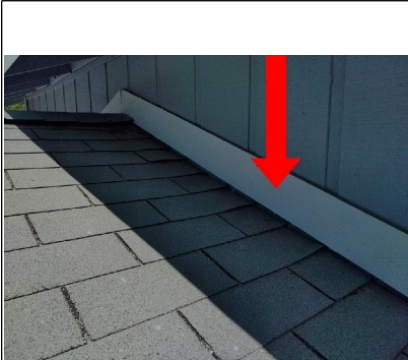
This is the most common way to reflash down the rake on a gable end. Traditional way is that the flashing most often step flashing is tucked underneath the siding then nailed off with the siding being 1" up off the flashing. However, when a reroof is done that can't be done instead roofers install a 1x4 primed trim member across the newly installed flashing and chalk about the 1x4. There is overhang over the 1x4 as there is little to no chance of water protrusion entering the home. However, it is always safe to make sure you chalk above the 1x4.

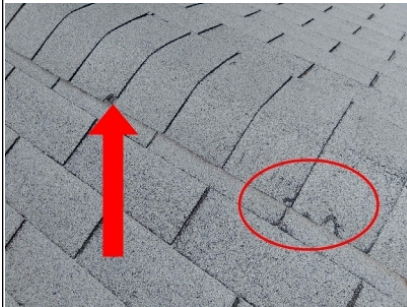
Slightly damaged ridge cap. (Based on conditions presented does not provide a concern with a leak) location: garage

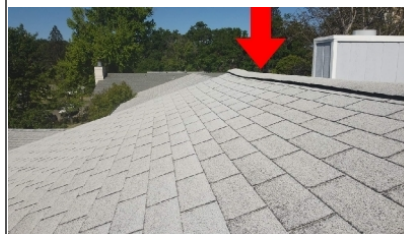
This dip shows not structural concerns when walking the roof line. However, there is no clear view of this location in the attic location

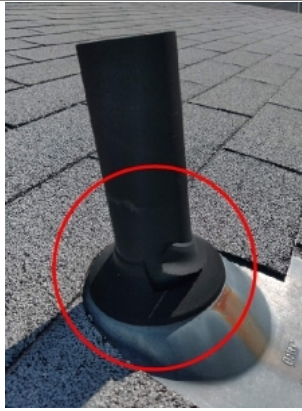
Storm collar needs to be replaced

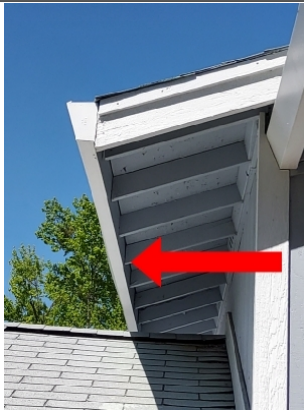
Loose gutter. Gutter needs to be properly refastened to eaves.

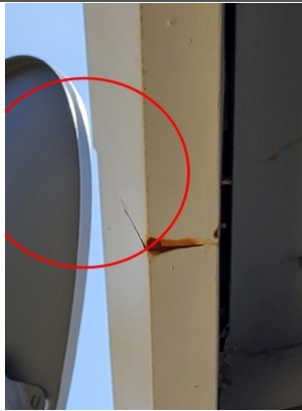
Leak: recommend using Vulcem spray on all elbow connections.

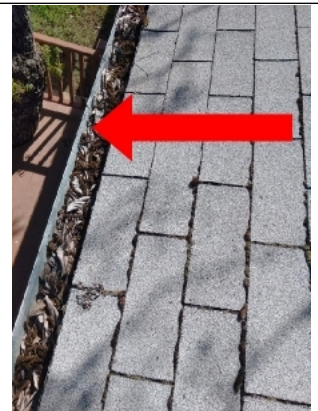
Gutters need to be cleaned

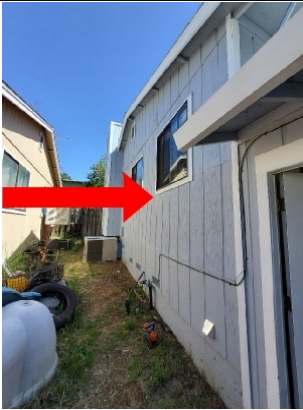
Left side of house is reference location for 4' level plumb check.

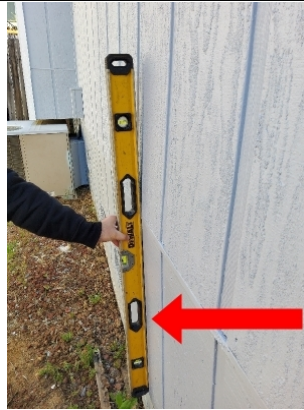
Level is used as a straight edge and shows difference between cripple members and kitchen frame members. This applies the cripple members as the straight edge.

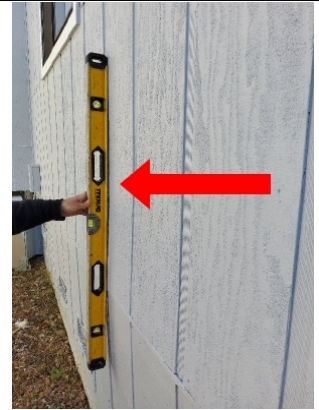
Level is used as a straight edge and shows difference between cripple members and kitchen frame members. This applies the kitchen frame member as the straight edge.

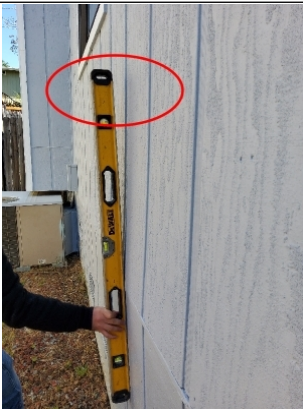
Level is used as a straight edge and shows difference between cripple members and kitchen frame members. This shows the difference between both frame members being out of plumb.

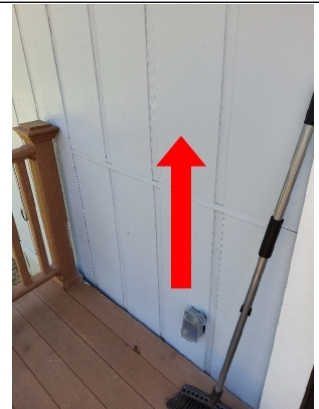
Siding was replaced

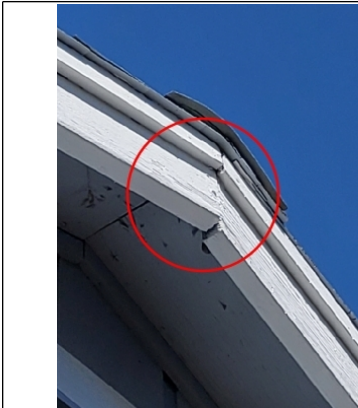
Fascia is twisted from excessive sun exposure and lack of angled screw or nail at the bottom of the fascia member.

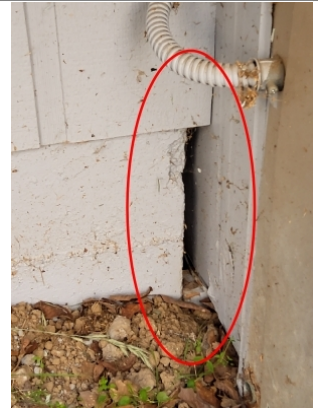
This open area needs to be sealed off between the package unit and foundation. Recommend installing galvanized L flashing.

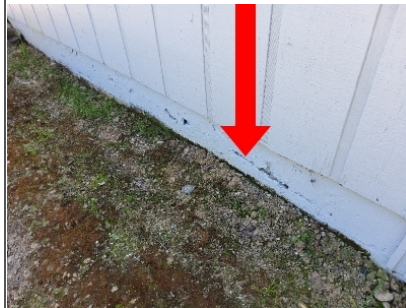
This is a cold joint crack not of structural concern. Recommend using Concrete Epoxy Crack Injection.

Product to use is Simpson Strong-Tie ETIPAC10KT CRACK-PAC Injection

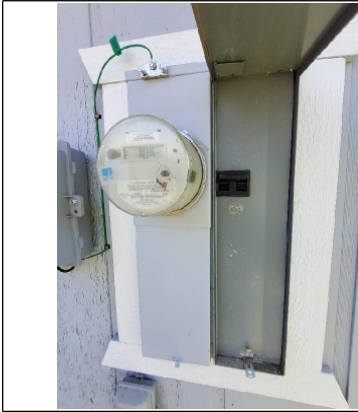
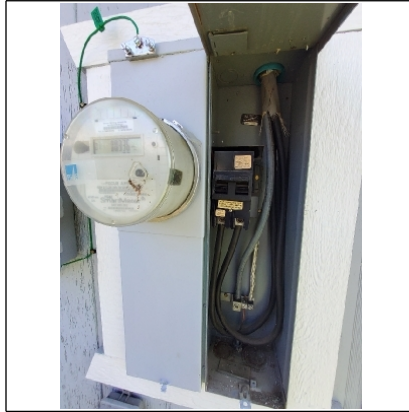
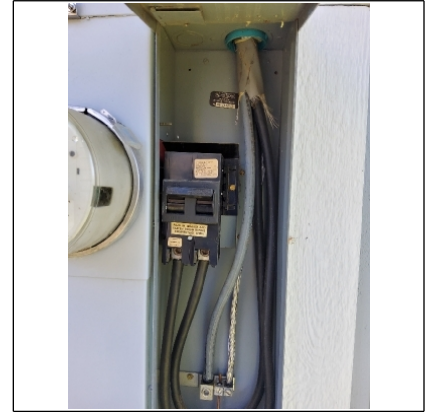
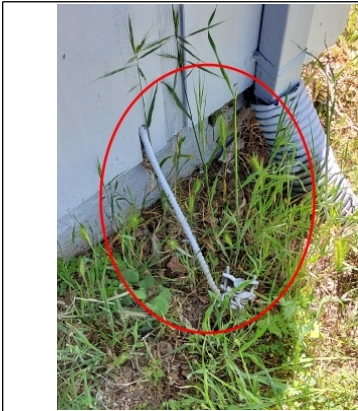
Grounding rod location

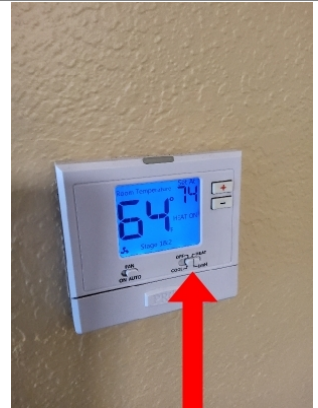
Thermostat shows proper operation on HEAT setting.

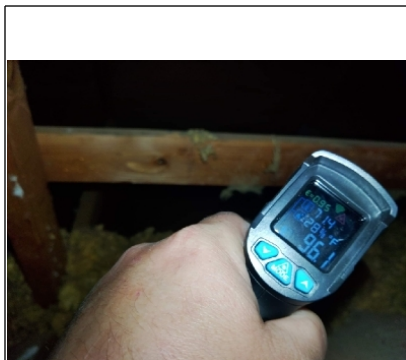
Thermal gun shows 96.1 Degrees on ceiling insulation.

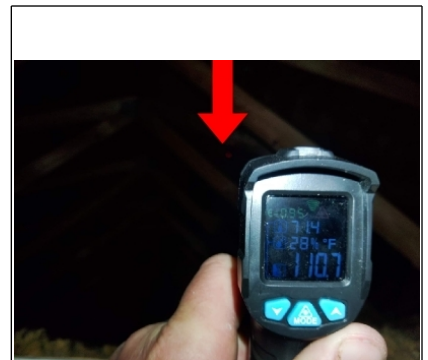
Thermal gun shows 110.7 Degrees on roof sheathing. Which is significantly hot but not much can be done. I can assure that it was much hotter before the ridge vent was installed.

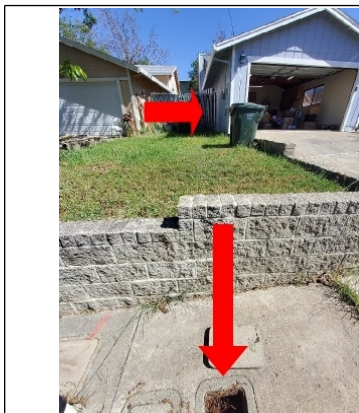
Water shut-off locations.

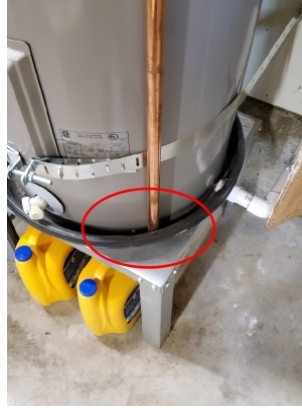
Relief valve extension is supposed to be within 6 inches of floor slab not in the drain pan.  
 (Don't worry about it)

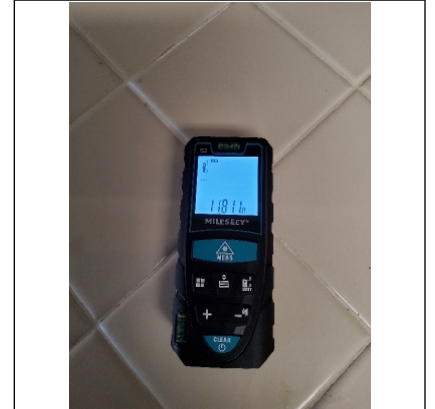
Kitchen measures 11.81' Wide

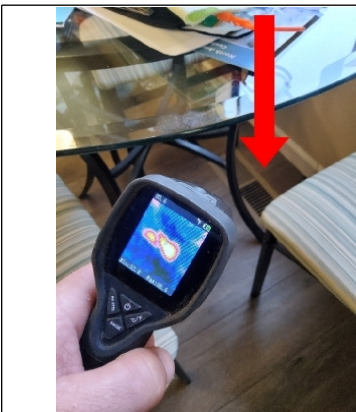
Thermal Imager shows proper HEAT distribution through floor vent.

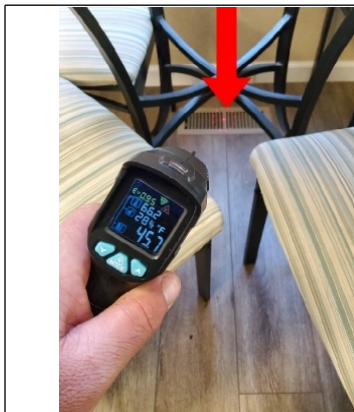
Thermal Gun shows proper AC distribution through floor vent.

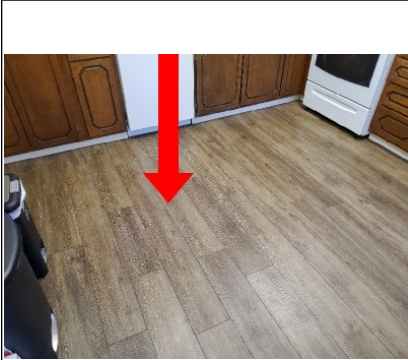
**Condition** ☐ Satisfactory ☐ Marginal ☐ Poor ☒ Sloping ☐ Squeaks

Dip is in relation to crowned girder that joist members sit on.

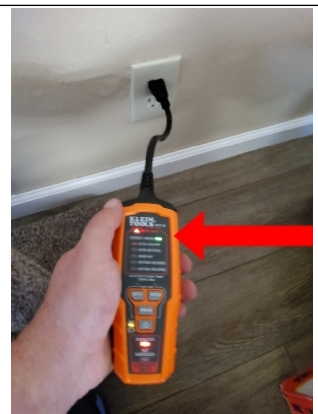
Electrical outlet shows proper grounding and polarity.

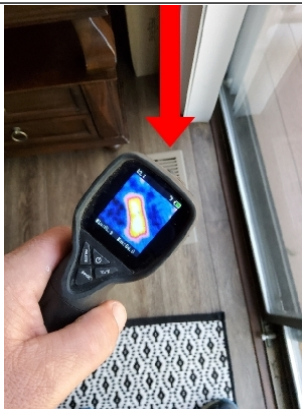
Thermal Imager shows proper HEAT distribution through floor vent.

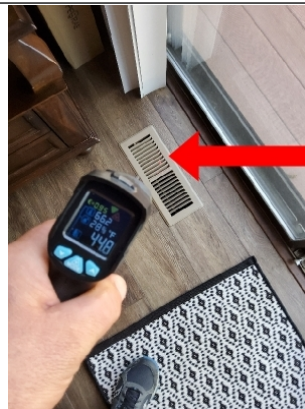
Thermal Gun shows proper AC distribution through floor vent.

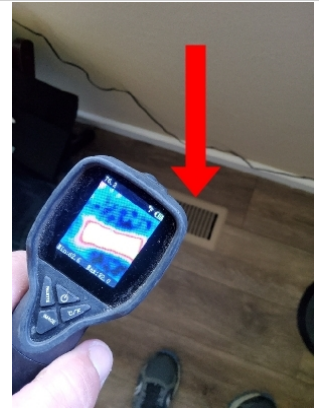
Thermal Imager shows proper HEAT distribution through floor vent.

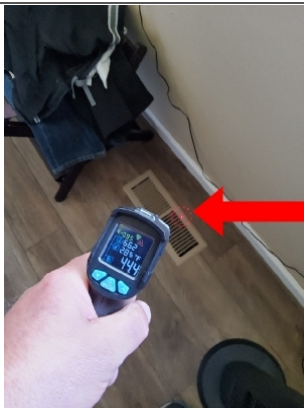
Thermal Gun shows proper AC distribution through floor vent.

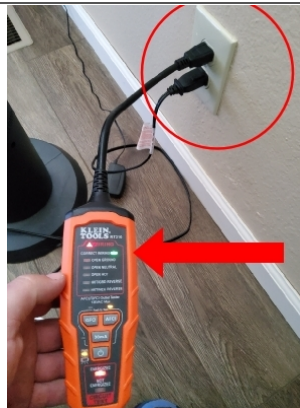
Electrical outlet shows proper grounding and polarity.

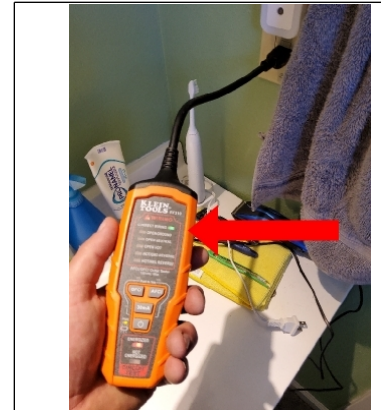
Electrical outlet shows proper grounding and polarity

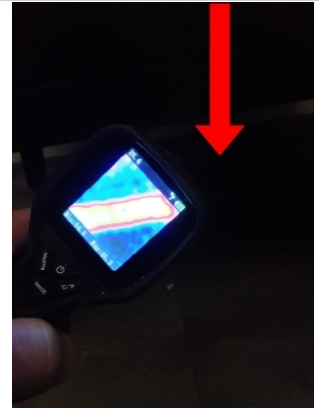
Thermal Imager shows proper HEAT distribution through floor vent.

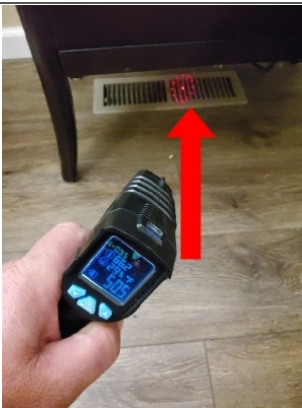
Thermal Gun shows proper AC distribution through floor vent.

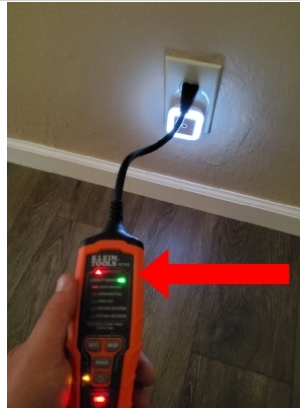
Electrical outlet shows proper grounding and polarity.

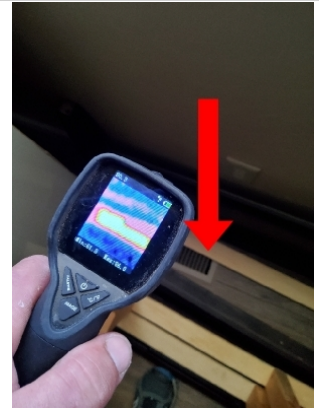
Thermal Imager shows proper HEAT distribution through floor vent.

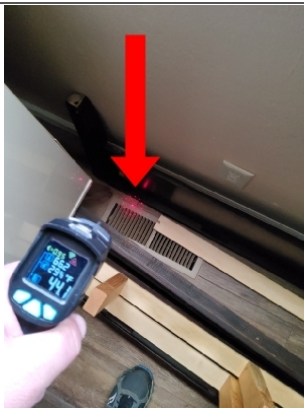
Thermal Gun shows proper AC distribution through floor vent.

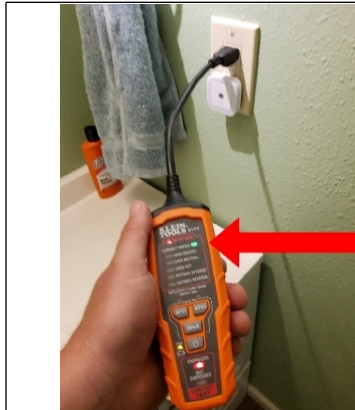
Electrical outlet shows proper grounding and polarity.

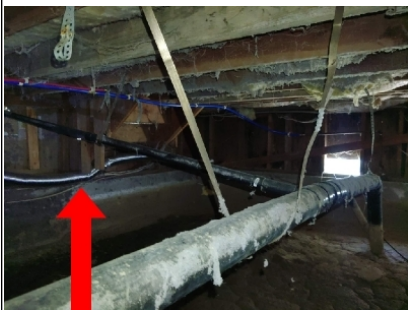
Dryer vent location to exterior wall

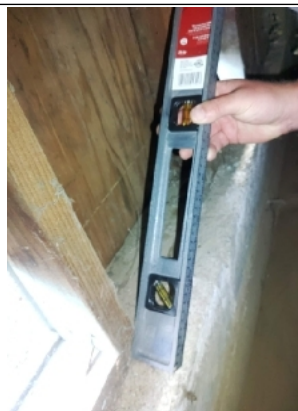
Level is placed on the left side of the home with regards to the cripple wall to confirm it is out of level.

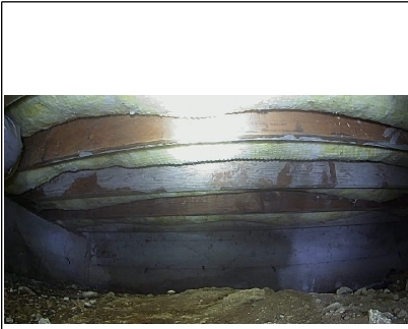
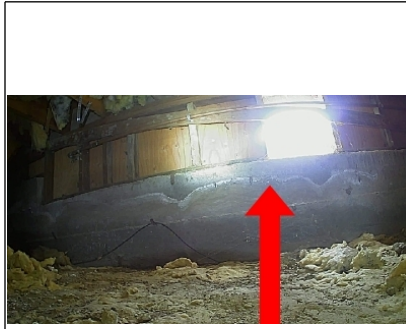
**Comments** In almost all situations these are cosmetic. I have found no vertical cracks on the foundation that would be considered to be a structural concern. The efflorescence is the chalky white salt residue that is noted in the photos by arrows. It carries along with it calcium salts. This is evidence of moisture intrusion but not enough to be considered a concern. Hillsides always have some form of moisture intrusion.

Efflorescence

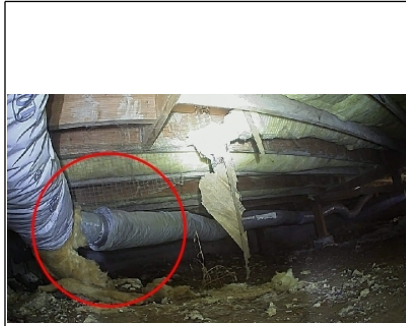
Insulation is evident along with dirt from the ducting in the crawl space.

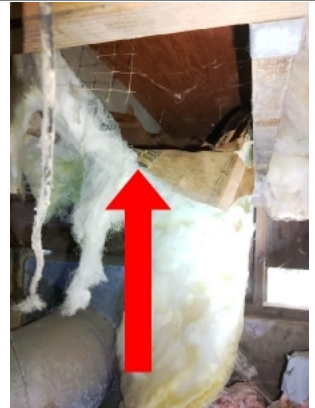
Insulation has pulled away could be in relation of loose duct work that needs to be further inspected.

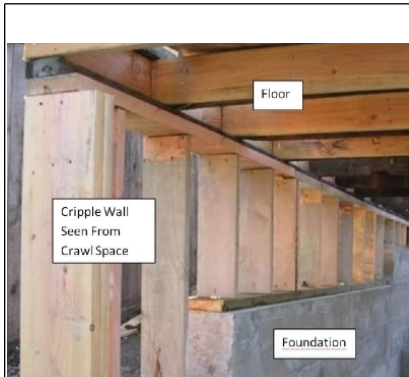
This is the better way to do an interior structural support span from perimeter to perimeter instead of a post and girder design.

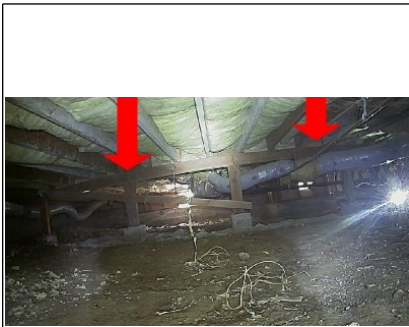
Both girder members are crowned up (correctly) this explains the humps and dips in the floor.

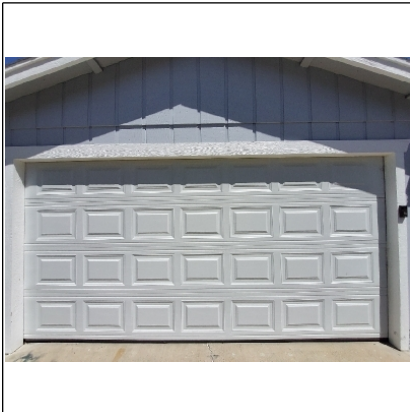
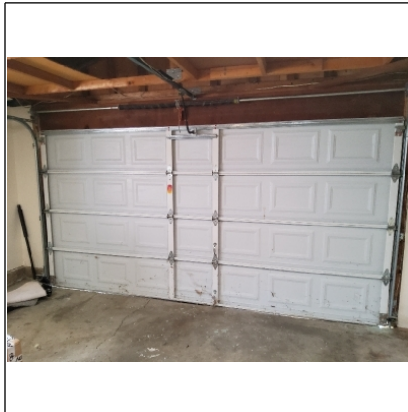
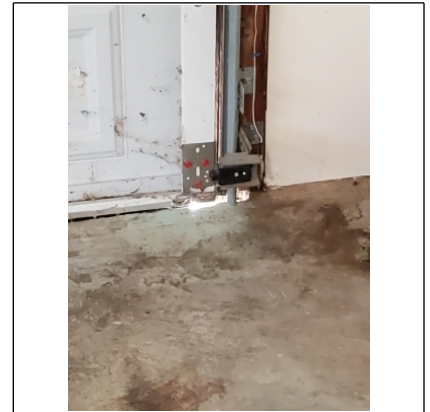
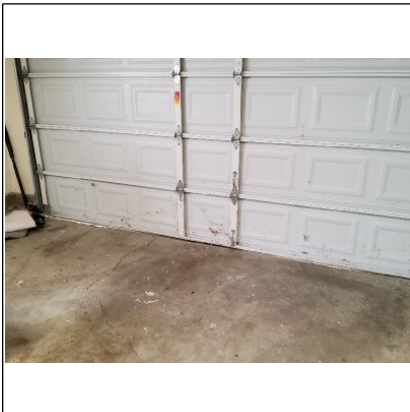
**Condition** ☐ Satisfactory ☐ Marginal ☐ Poor ☐ Hardware loose ☐ Safety Cable Recommended  
☒ Weatherstripping missing/damaged ☐ Loose/missing

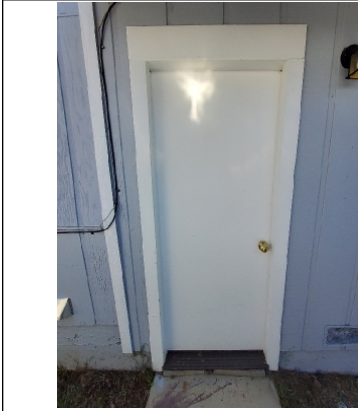
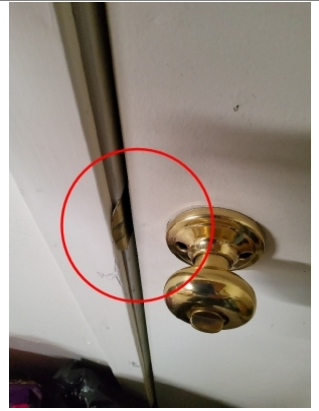
Adjust strike plate

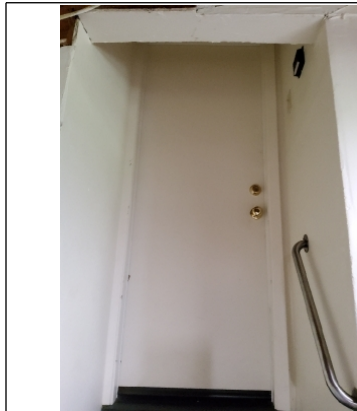
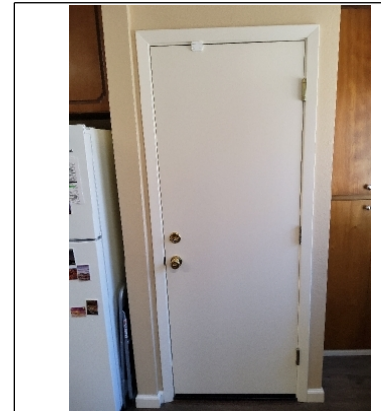
Missing 36" landing at door level. This was not required in 1980 and just cannot be fixed. Installing a landing will take room away from car to park in the garage and your head would hit the wall. The roof line also cannot be changed. Leave as is nothing can be done.
