# Home Inspection Report

5330 Lakeshore Blvd #16, Lakeport, CA 95453

Tuesday August 15, 2023

3233

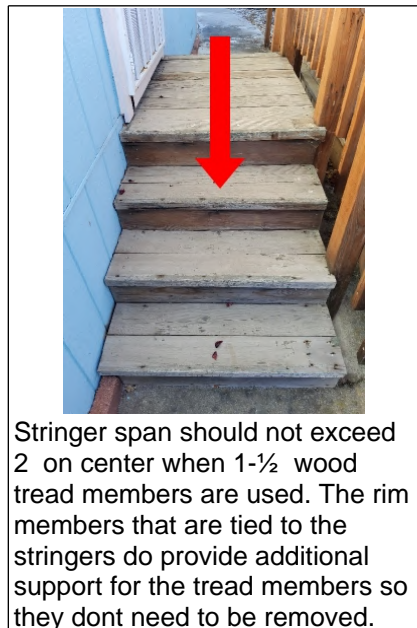
Stringer span should not exceed 2' on center when 1-1/2" wood tread members are used. The rim members that are tied to the stringers do provide additional support for the tread members so they dont need to be removed.

**2. Recommend removing loose nails and installing a new joist member with 2x6 Simpson Strong-Tie hangers and replace nails with 4" exterior screws.**

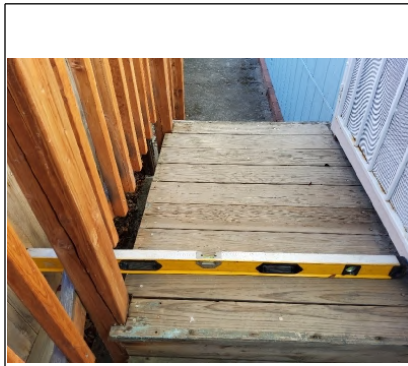
4' level was placed on landing to show it is leaning towards the home.

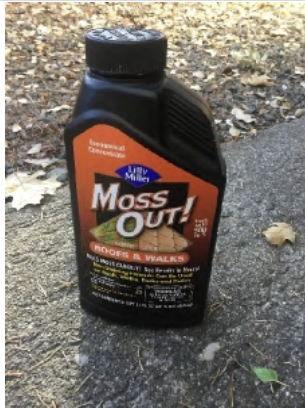
Recommend removing excessive moss growth on sheathing.

With the moss build up I always recommend applying Moss Out! this can be purchased at Home Depot, look at the forecast for about a week to make sure no rain is in site and then spray the chemical on the roof and do not use a pressure washer sprayer ever on asphalt shingles. This will kill the moss in about a month. Option 2 is on a damp morning get a dull chisel and pick the moss off then apply the Moss Out! after.

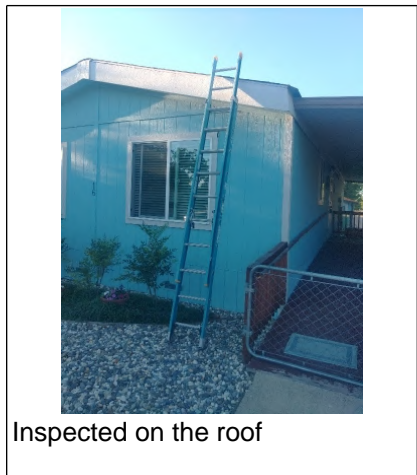
Exterior Temperatures when walking on the roof.

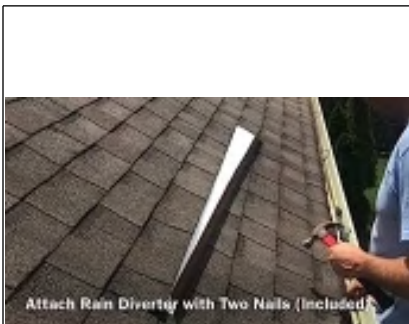
Example of a rain diverter

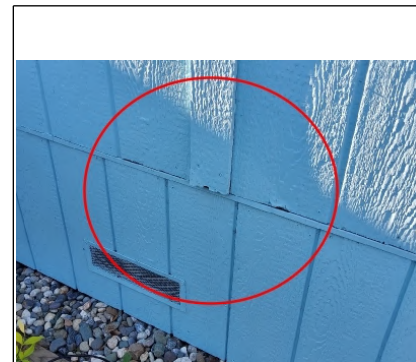
Slight warping and moisture damage is evident on siding.

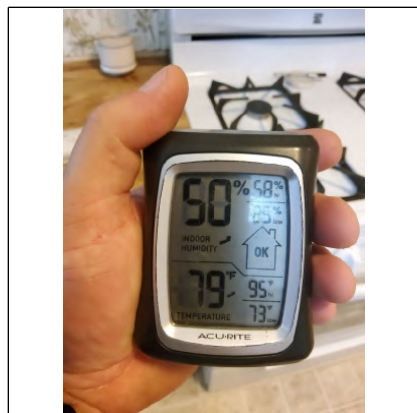
Indoor humidity and temperature levels during time of inspection.

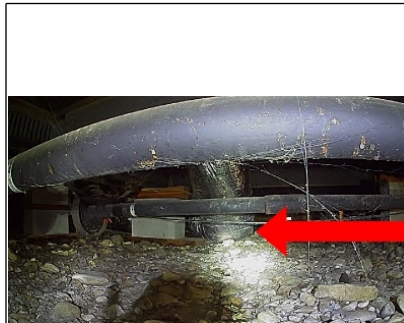
**Comments** **1. Cold air return ducting is on the floor. Recommend having properly fastened to underfloor frame by a Licensed HVAC Contractor.**

Cold air return ducting is on the floor. Recommend having properly fastened to underfloor frame by a Licensed HVAC Contractor.

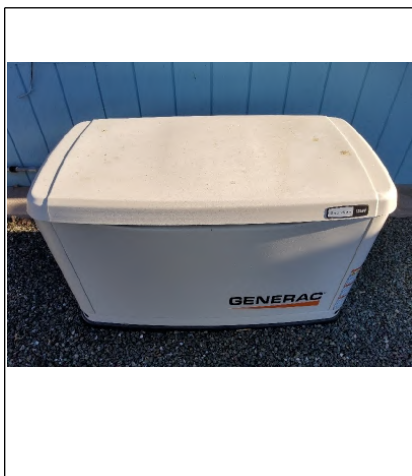
**Main fuel shut-off location 2**

No leaks were detected at shut off valve.

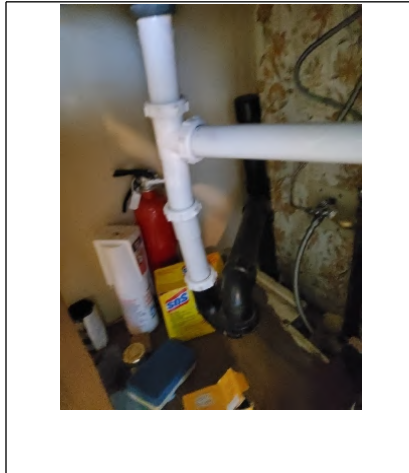
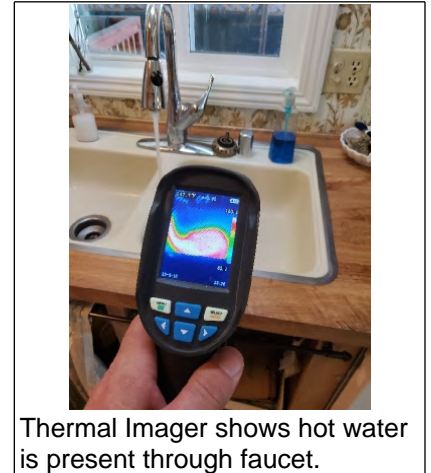
Thermal Imager shows hot water is present through faucet.

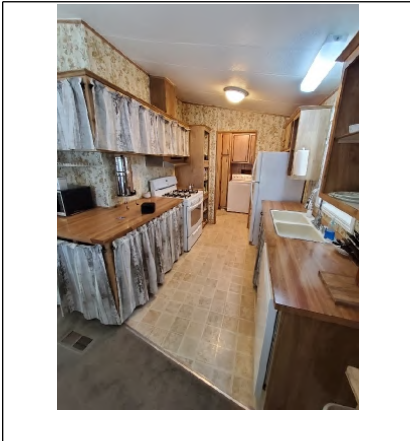
Old water leak from prior roof.

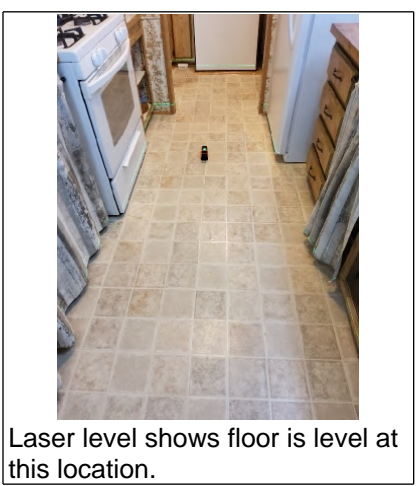
Laser level shows floor is level at this location.

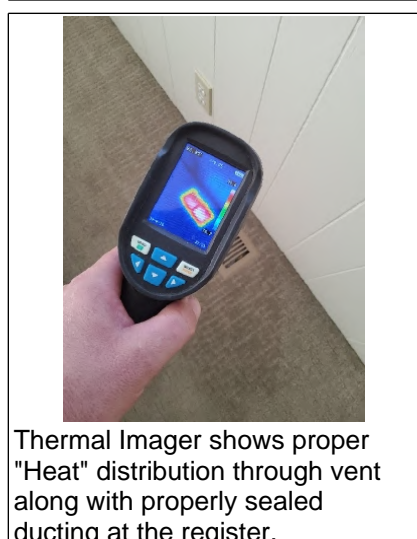
Thermal Imager shows proper "Heat" distribution through vent along with properly sealed ducting at the register.

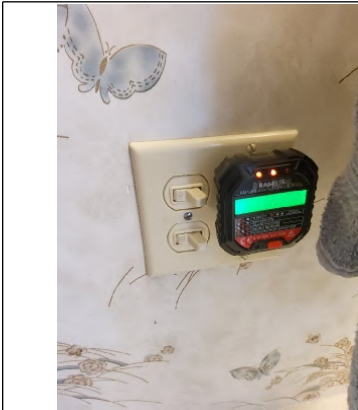
Electrical outlet shows proper operation, grounding and polarity.

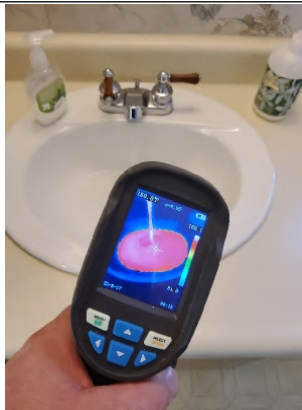
Thermal Imager shows hot water is present through faucet.

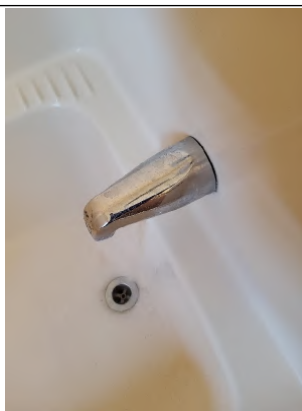
Loose spout

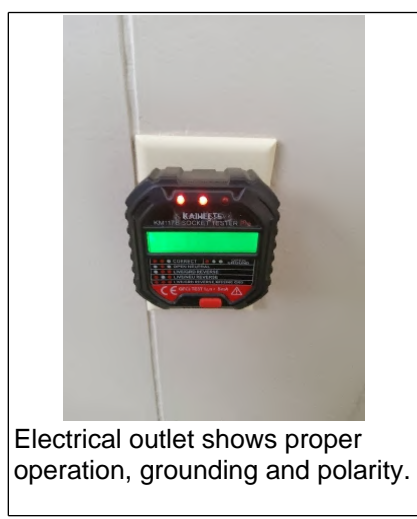
Electrical outlet shows proper operation, grounding and polarity.

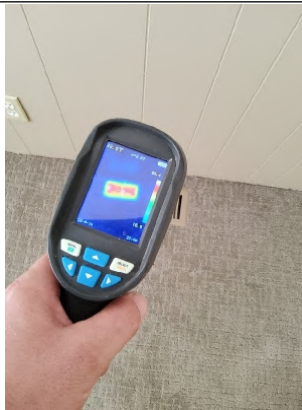
Thermal Imager shows proper "Heat" distribution through vent along with properly sealed ducting at the register.

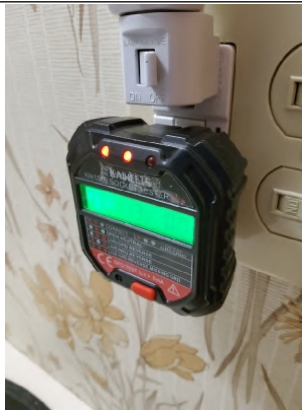
Electrical outlet shows proper operation, grounding and polarity.

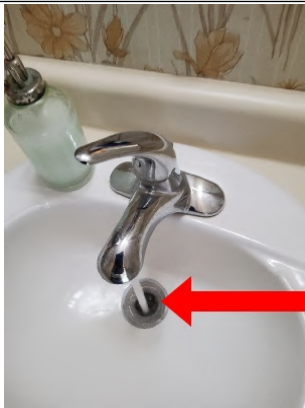
Disconnected drain stop

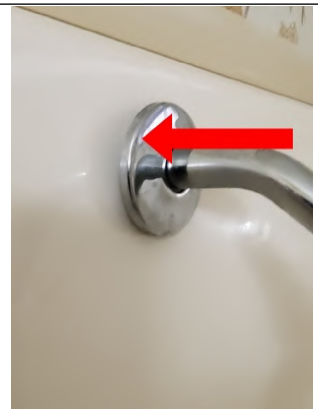
Loose flange

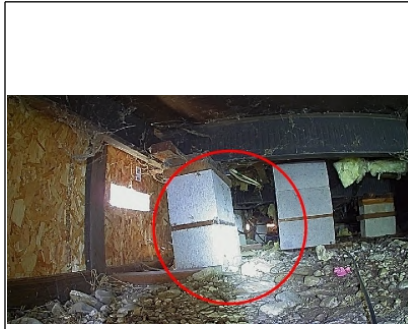
These three pier blocks are leaning significantly.

**Comments** **1. Recommend having leaning pier blocks releveled by a Licensed Contractor.**

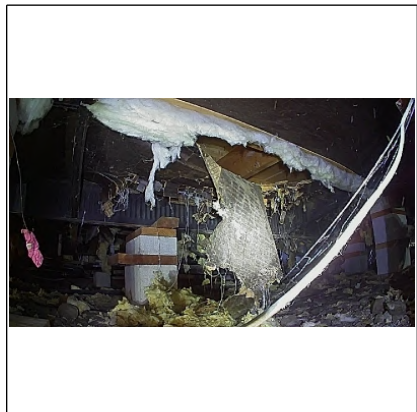
**Comments** **1. Rodent intrusion is evident and should be further evaluated by a Licensed Pest Control Company.**

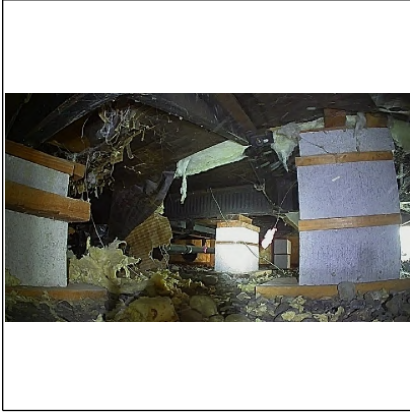
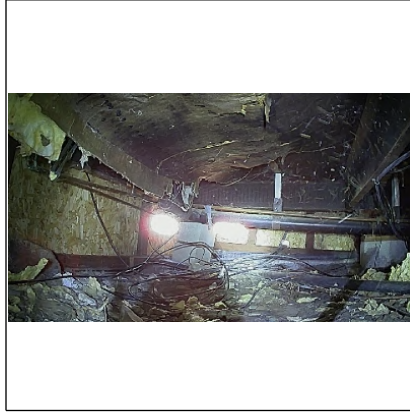
**Comments** **1. Vapor barrier is damaged at various locations and should be repaired.**
