Home Inspection Report

4280 Lakeshore Blvd, Lakeport, CA 95453

Saturday September 9, 2023

Manufactured Home Roof

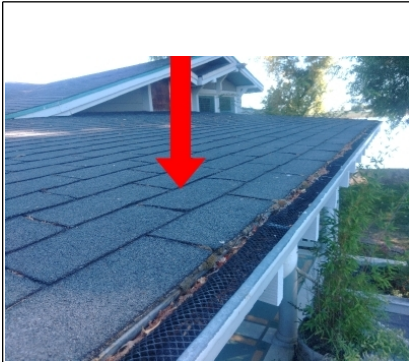
Three-tab asphalt shingles should not be installed on any roof pitch less than a 3/12 unless using roll asphalt as the underlayment prior.

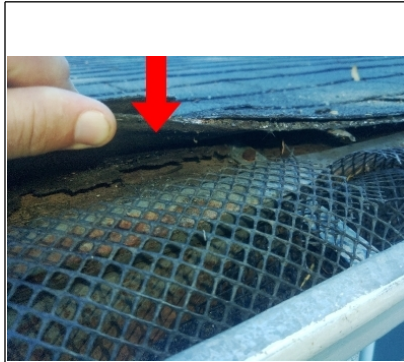
Roll asphalt was not installed below three-tab roofing shingles on 2/12 pitch location.

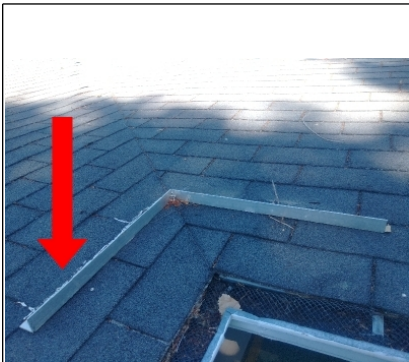
Rain diverter should have proper pitch to gutter run.

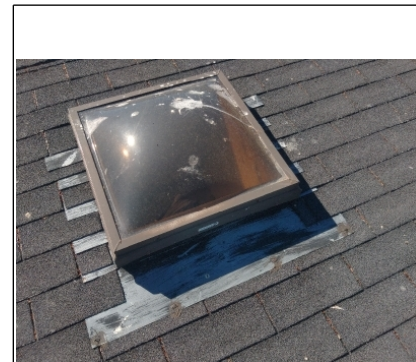
This area can be a concern with water intrusion underneath the flashing at the valley location.
