# Home Inspection Report

2865 Nectorine Way, Clearlake Oaks, CA 95423

Monday August 10, 2020

143

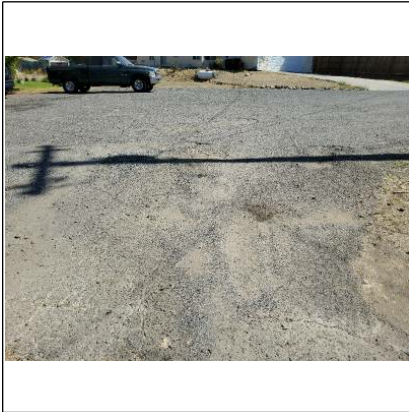
Walkway had some cracking, but is usable.

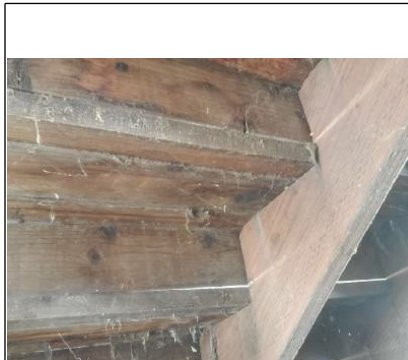
Missing riser for stairs needed for support of treads.

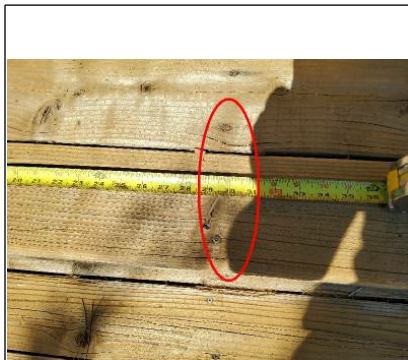
Span is 30 inches minimum requirement 24 inches for wood.

Refer to picture before for description

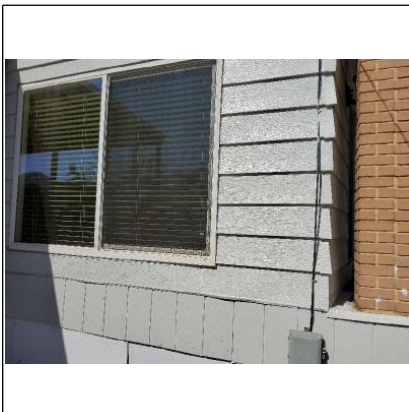
**Comments** Siding appeared to be all intact and in overall satisfactory condition.

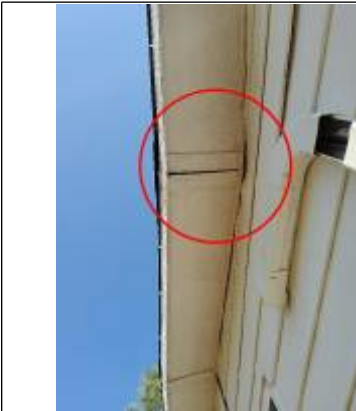
Possible settlement

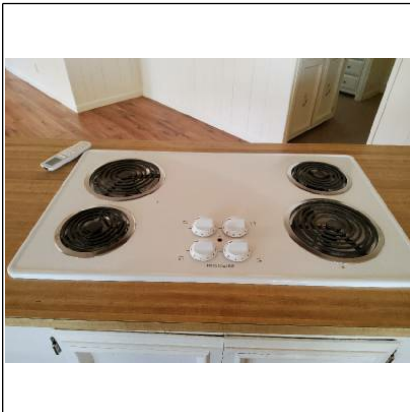
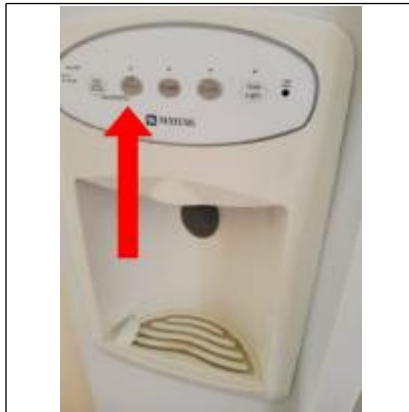
- Disposal** ☐ N/A ☐ Not tested Operable: ☒ Yes ☐ No  
**Oven** ☐ N/A ☒ Not tested Operable: ☐ Yes ☐ No  
**Range** ☐ N/A ☐ Not tested Operable: ☒ Yes ☐ No  
**Dishwasher** ☐ N/A ☐ Not tested Operable: ☒ Yes ☐ No  
**Trash Compactor** ☒ N/A ☐ Not tested Operable: ☐ Yes ☐ No  
**Exhaust fan** ☒ N/A ☐ Not tested Operable: ☐ Yes ☐ No  
**Refrigerator** ☐ N/A ☐ Not tested Operable: ☒ Yes ☐ No  
**Microwave** ☐ N/A ☒ Not tested Operable: ☐ Yes ☐ No  
**Other** Operable: ☒ Yes ☐ No  
**Dishwasher airgap** ☐ Yes ☒ No  
**Dishwasher drain line looped** ☒ Yes ☐ No  
**Receptacles present** ☒ Yes ☐ No Operable: ☐ Yes ☐ No  
**GFCI** ☐ Yes ☒ No Operable: ☐ Yes ☐ No Recommend GFCI Receptacles: ☒ Yes ☐ No  
☐ Potential Safety Hazard(s)  
**Open ground/Reverse polarity:** ☐ Yes ☒ No ☐ Potential Safety Hazard  
**Comments** Water on ice machine on fridge is not working

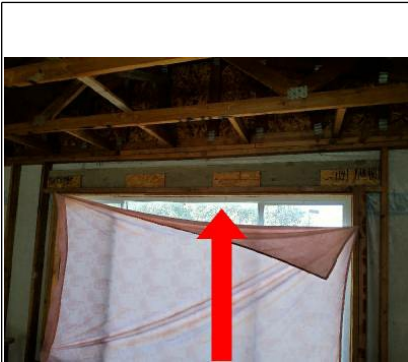
Header is needed above window.

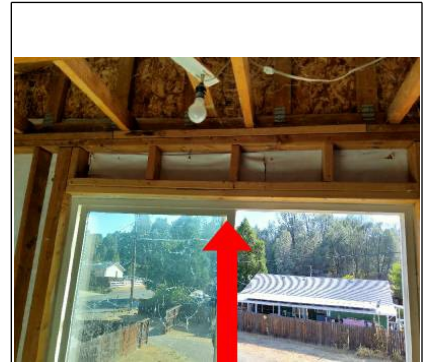
Header needed abice window
