# Home Inspection Report

8242 Point Dr, Kelseyville , CA 95451

Monday January 25, 2021

4445

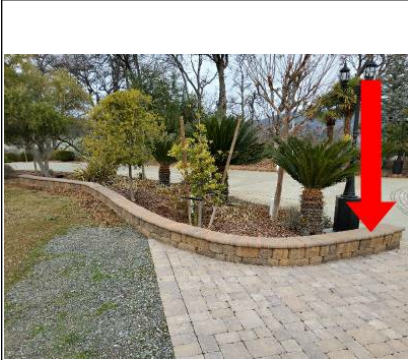
Referenced (Location) where joint needs to be remortared. (Next Photo)

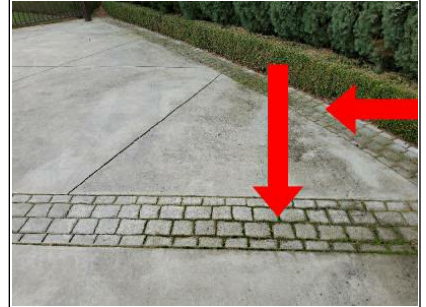
Moss build up is very common and can be sprayed with Wet & Forget to kill the growth

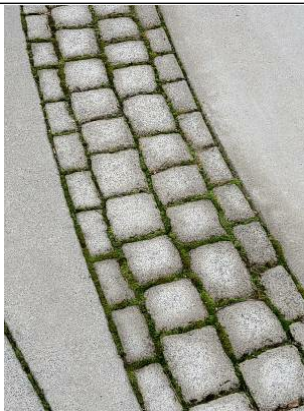
Moss build up is very common and can be sprayed with Wet & Forget to kill the growth

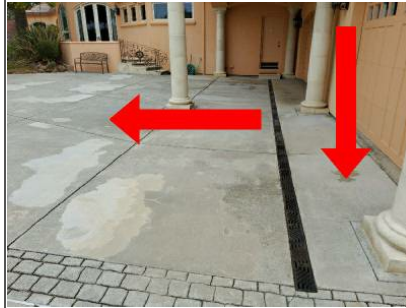
Refer to next slide of "Level" showing correct pitch to drain tile

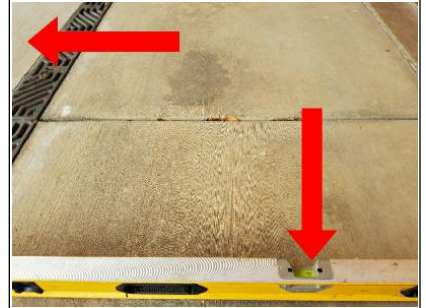
This shows proper fall to the drain tile. This is another example of attention to detail, the pitch of (Left Arrow) driveway is pretty shallow that the concrete contractor could have made this flat because the drain tile would still collect water run-off.

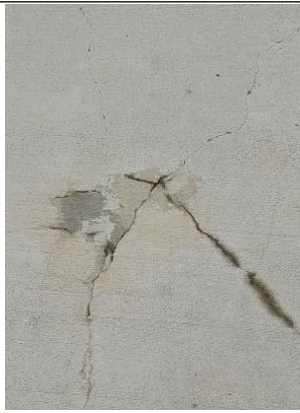
Non-Piercing Settling Crack

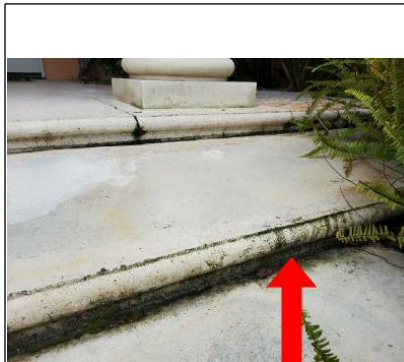
Moss build up is very common and can be sprayed with Wet & Forget to kill the growth

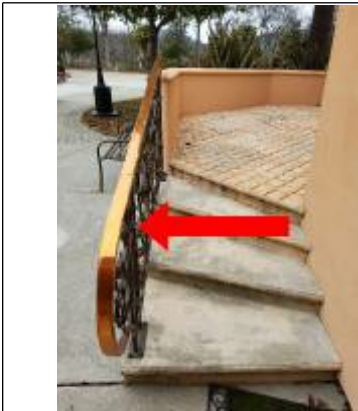
Handrail can be tightened. This is an esthetic piece of art as code does not require handrail above 42 inches for safety concerns.

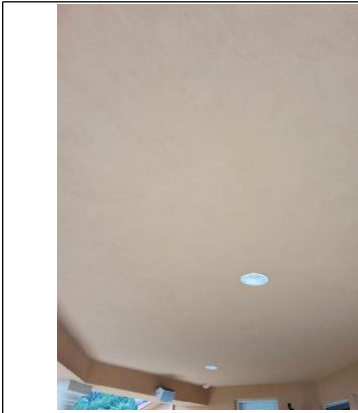
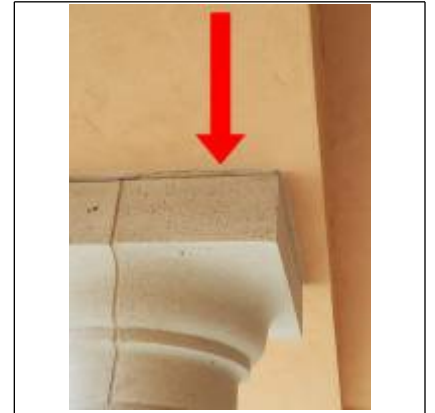
Crack can be regouted

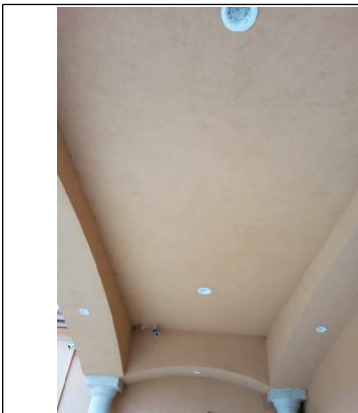
(Right Column) Crack can be regouted

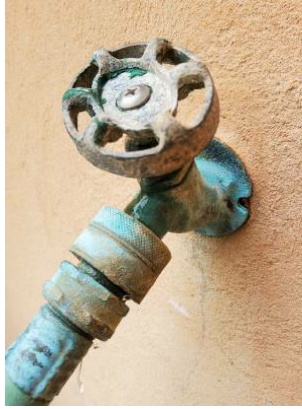
Replace Hose Bib its Leaking  
(location between right porch and garage )

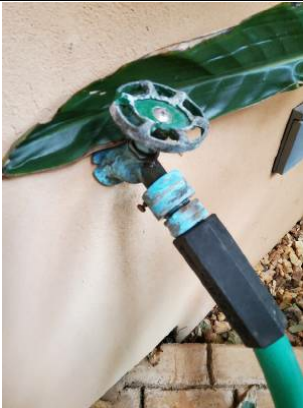
Replace Hose Bib its Leaking  
(Location front porch)

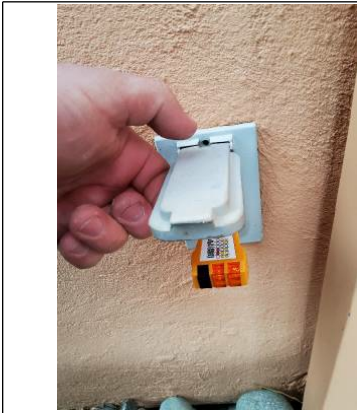
Proper GFCI Connection

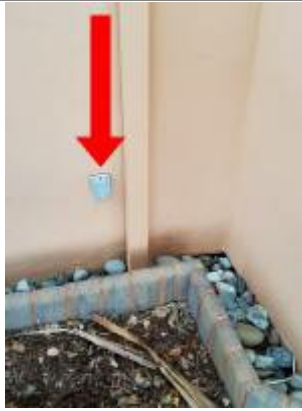
Refasten left side of main back doors to plate

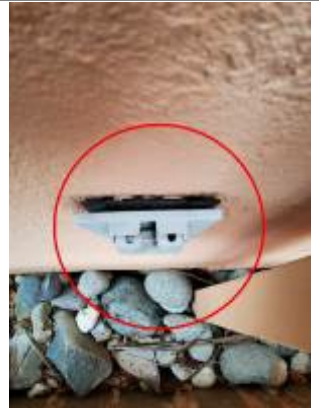
Reference to previous photo

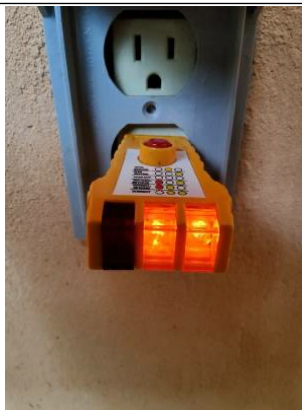
Proper GFCI Connection

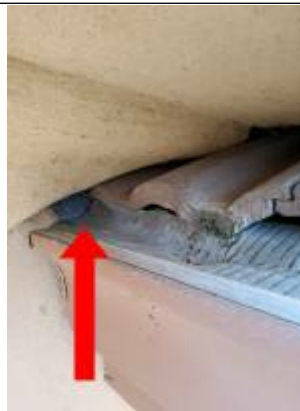
Tucked away flashing good to point out as this is an extra measure to show complete flashing cover to gutters

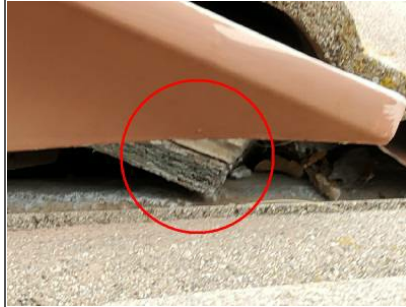
Valley above right porch needs to be flashed. This is exposed wood.

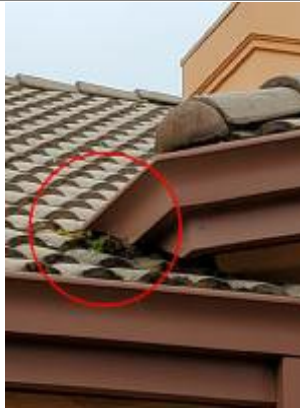
Moss build up is very common and can be sprayed with Wet & Forget to kill the growth

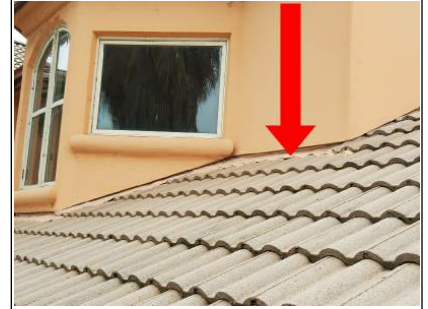
This is all well flashed

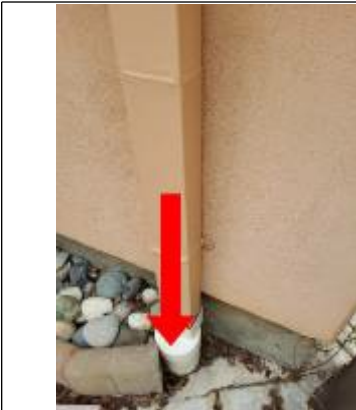
Schedule 40 drain tile

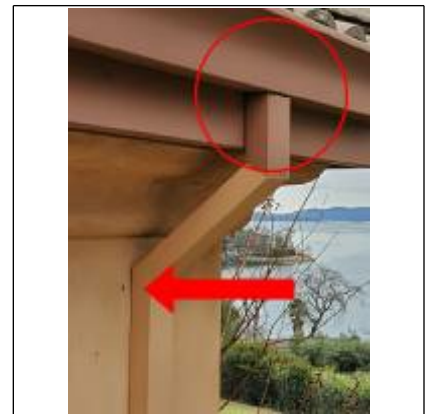
Missing Bracket for downspout  
and can be refasted to gutter

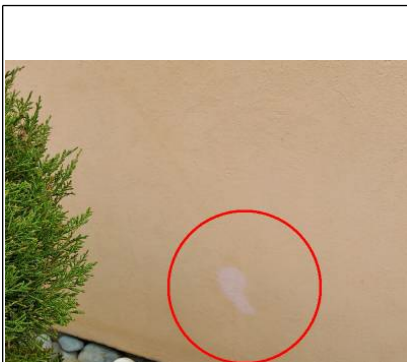
Confirmed with owner this was color sample

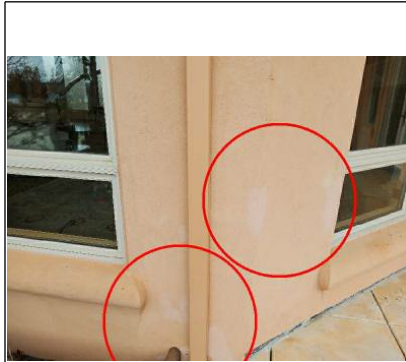
Confirmed with owner this was color sample

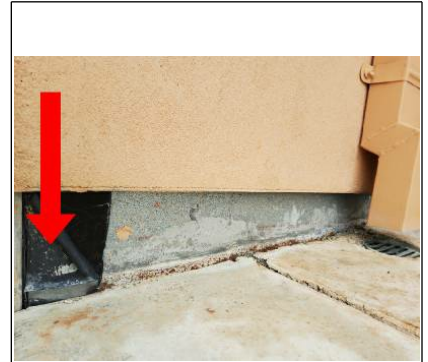
Exposed felt (Location: Back corner wall on garage before AC-Units)

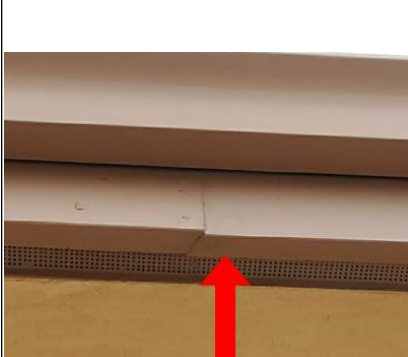
This is the only fascia 2x6 that's not completely flush together, this is very minor but can be fixed by clamping together and running a counter screw from back side after predrill (arrow)

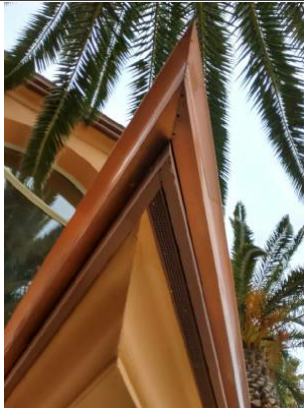
This is an absolute masterpiece from the gutter installer, stucco artist, and contractor who did the fascia.

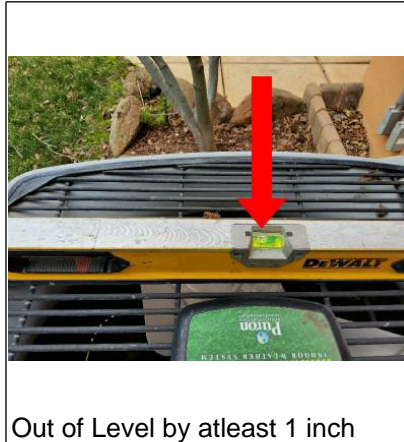
Out of Level by atleast 1 inch

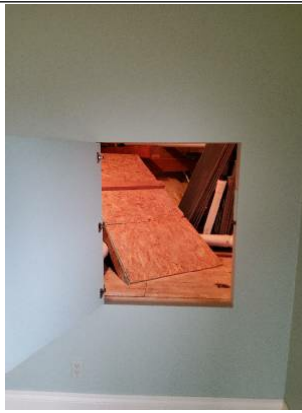
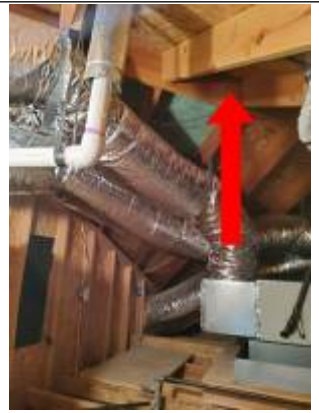
Cut and Stack rafter to ridge

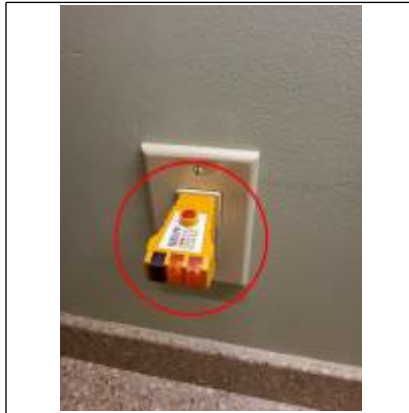
Proper GFCI

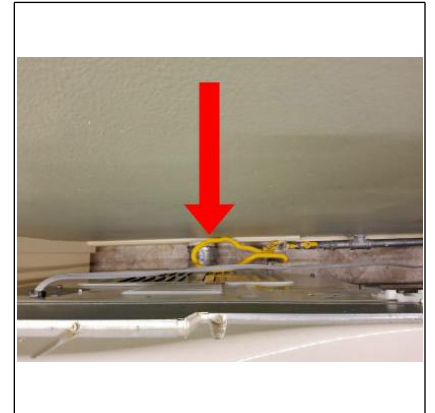
Dryer Vented to wall properly with proper material

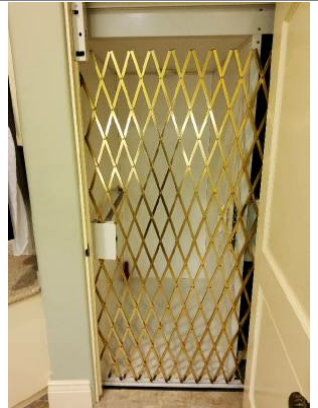
Elevator was not examined

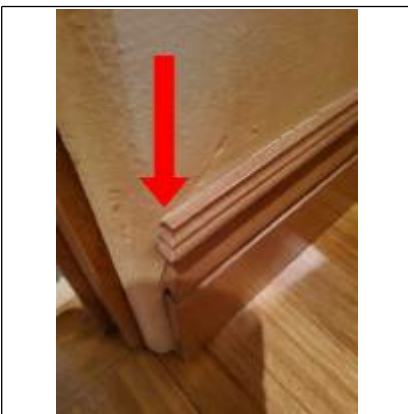
Excellent carpentry on this 45 degree end cut with a micronailer

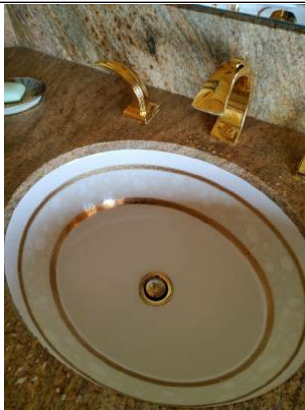
- Drainage** ☒ Satisfactory ☒ Marginal (For One Noted Sink) ☐ Poor
- Water flow** ☒ Satisfactory ☐ Marginal ☐ Poor
- Moisture stains present** ☐ Yes ☒ No ☐ Walls ☐ Ceilings ☐ Cabinetry

Drano can be used to help clean slow drain

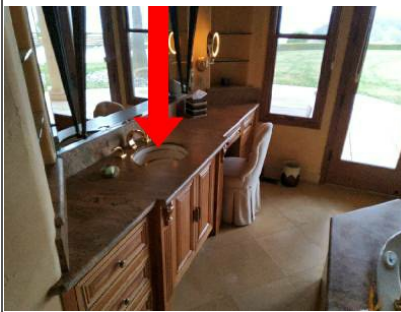
This is in reference to the sink that drains slowly.

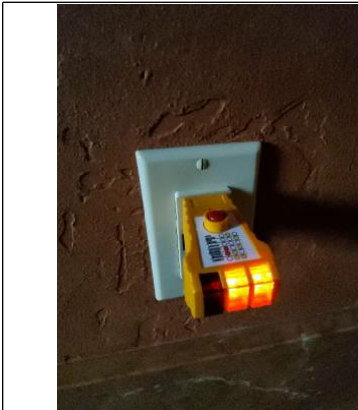
Tap down

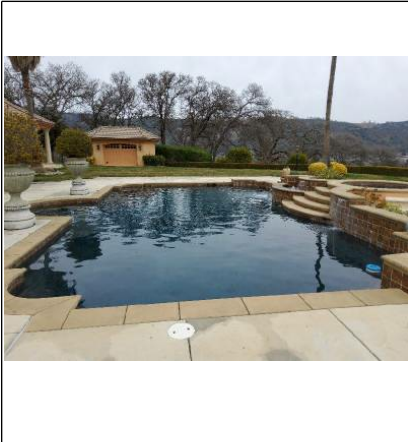
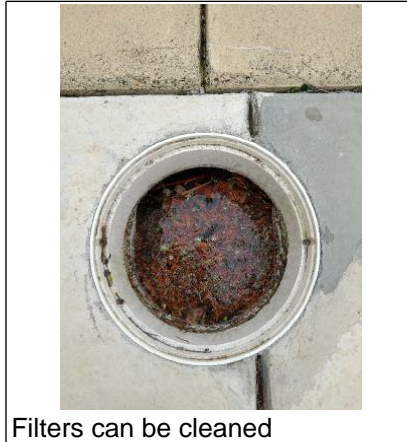
Filters can be cleaned
