Home Inspection Report

20462 Powder Horn Dr., Hidden Valley Lake, CA 95467

Tuesday June 23, 2020

Dustin J. Wallace Construction and Home Inspections
16496 Main St.
Lower Lake, CA 95457
(707) 293-6307
dustinjameswallace1985@gmail.com

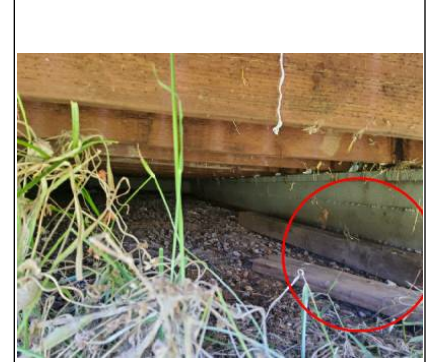
Nails need to be sunk.

Debris

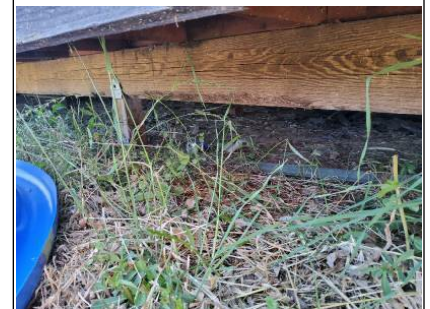
Girder not fastened

not properly nailed to girder. needs 1 1/4 tekko nails

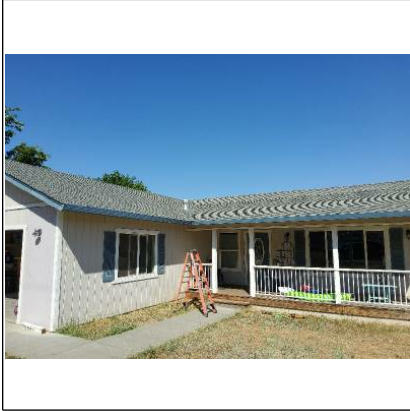
Roof inspection was limited to inspecting from the eaves due to weather. Too hot to walk on the shingles

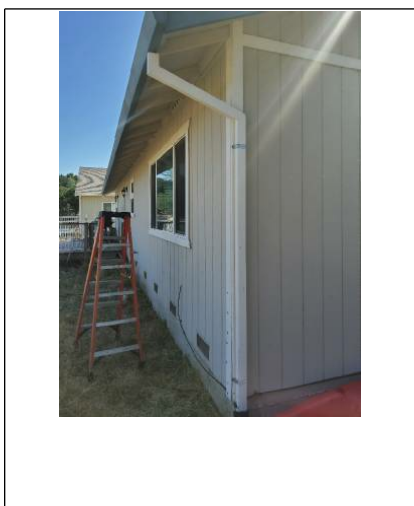
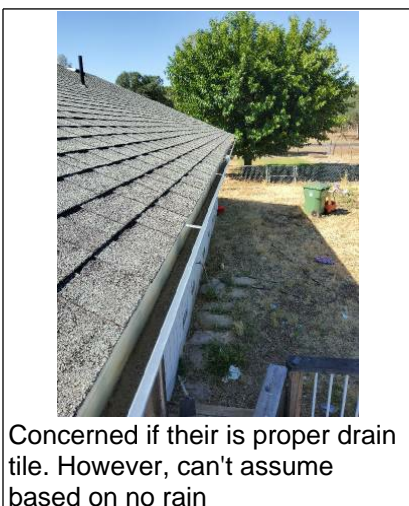
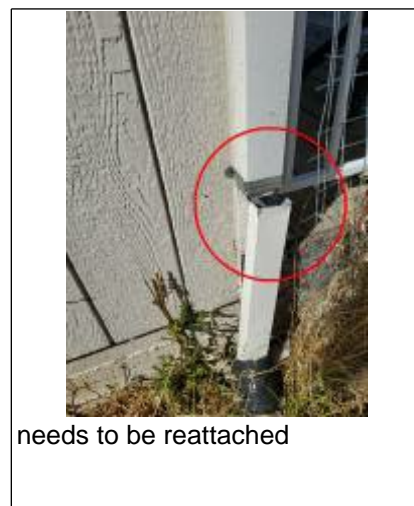
Comments Concerned of proper drain tile in the leach field. However cannot assume based on lack of rain and runoff

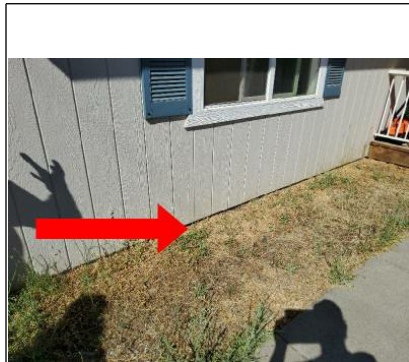
Siding below six inches. must have minimum six inches of clearance of ground.

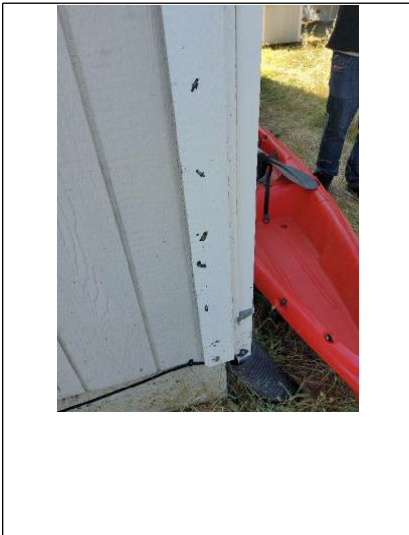
Some damage on bottom sill. also need to rechalk around the trim on inside butting the frame of slider.

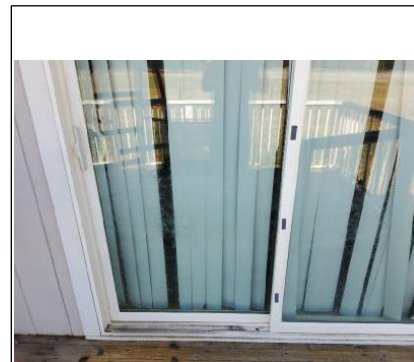
Bottom sill damage on back patio door

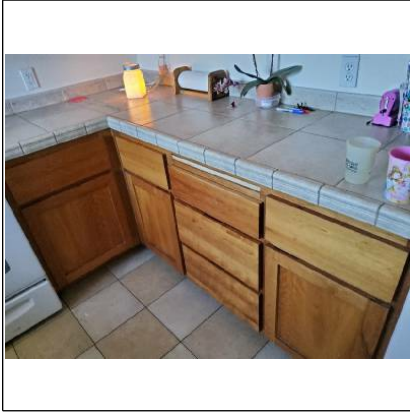
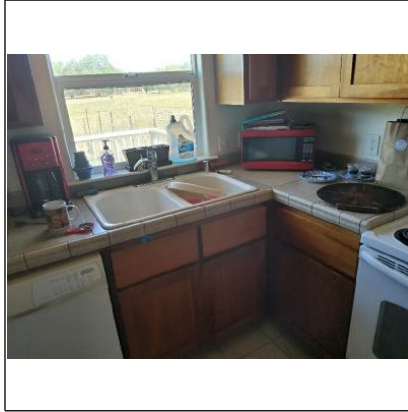
Comments Counter top has normal wear.

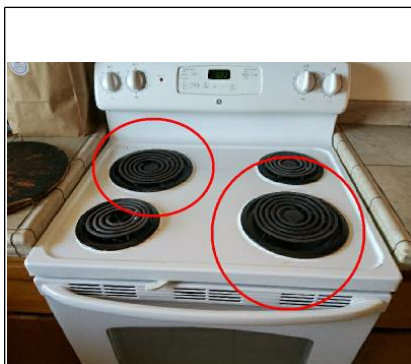
Does not work

Must replace microwave.
Unacceptable

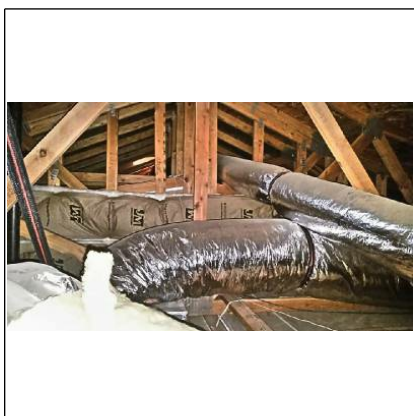
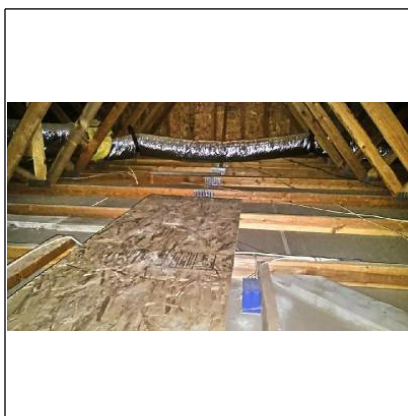
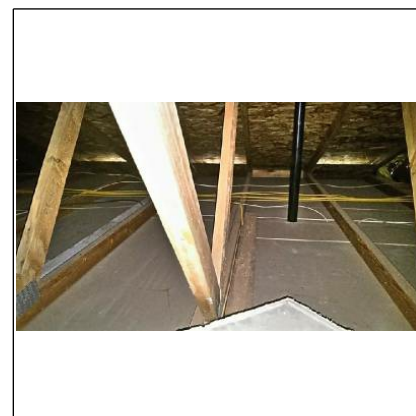
- Comments** No Insulation in attic and most likely in the entire house completely unacceptable.

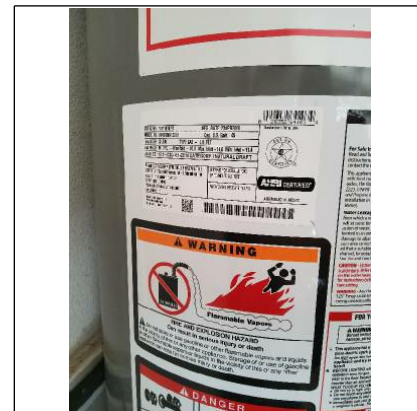
No over flow pan. This is an electrical hazard

A pan is needed below all hot water heaters

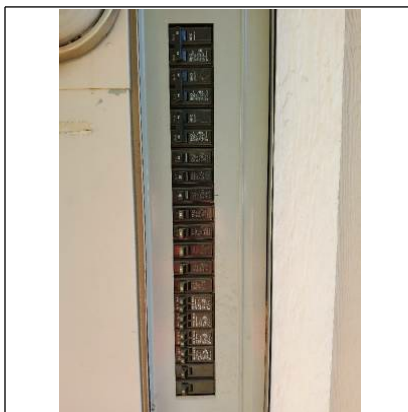
Comments Panel size appeared to be compatible to service size.

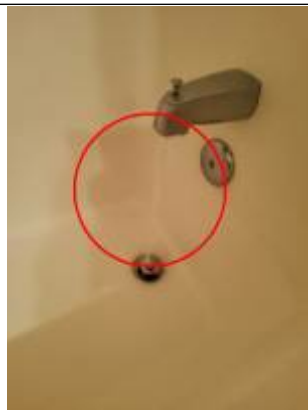
Low water pressure

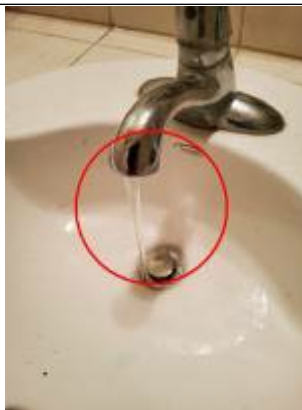
Low water pressure
