**DUSTIN WALLACE**  
Home Inspections  
& Construction

## Home Inspection Report

706 Ketch Court, Clearlake Oaks, CA 95423

Saturday October 10, 2020

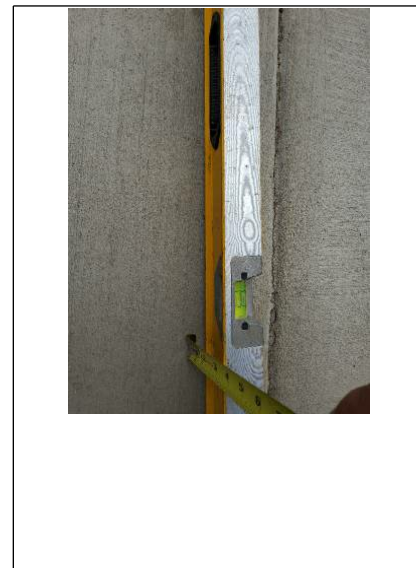
over an 1 1/2 inch fall at four feet towards the houuse. This will erode the hardie lap siding especially since the skirt board has no sheer.

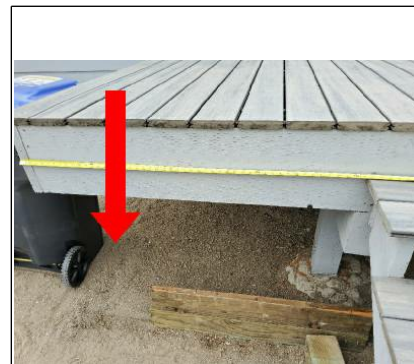
Deck joists cannot cantilever more than 24 inches beyond a support beam or girder. This tape measures out to over 4 ft of no support. Another girder and post are needed at the end of this deck for needed structural support.

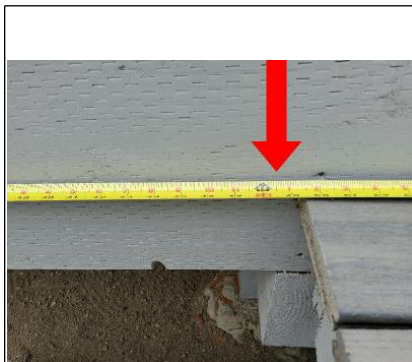
Cantilever past four feet not code.

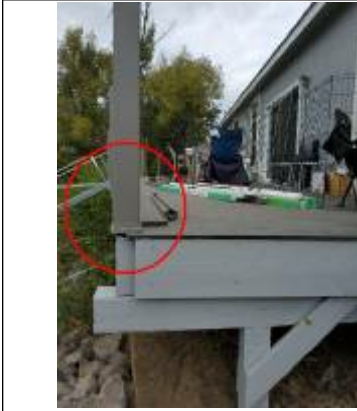
this is a rain cap. as you can see this is made to cover the jigsaw cuts on the planks on inside of the rim so it could cover the cuts, not be on the outside of the rim.

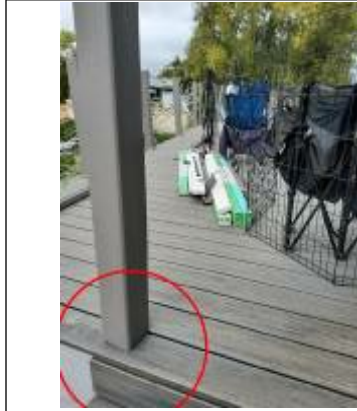
This is the proper way to put a post in, use this as reference when it comes to cutting the deck treads.

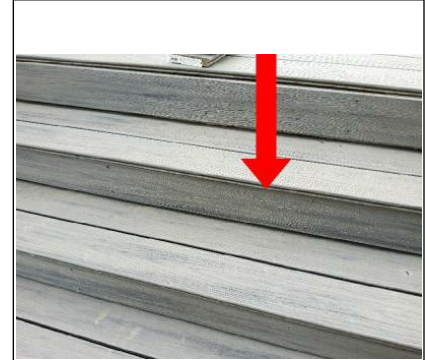
These are treads for the deck portion these are not to be used for the stair treads. The female ends which you see here are for latching mechanism of the hidden screws. not to be used for stairs. The stairs need to be screwed off as well on the face as these locking mechanisms are not meant for stairs.

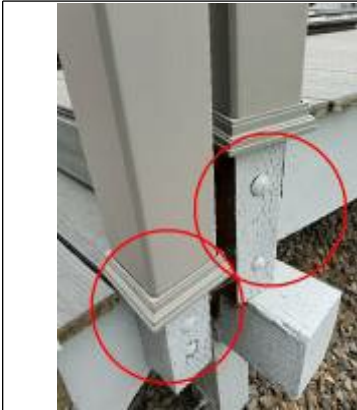
bolts and nuts should not be used when securing the 4x4 posts. should be the proper way to secure going from multiple sides to keep the posts plumb.

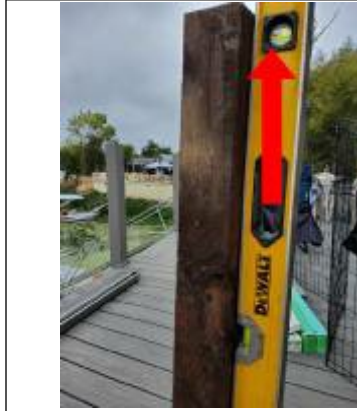
This is well over an inch out of plumb

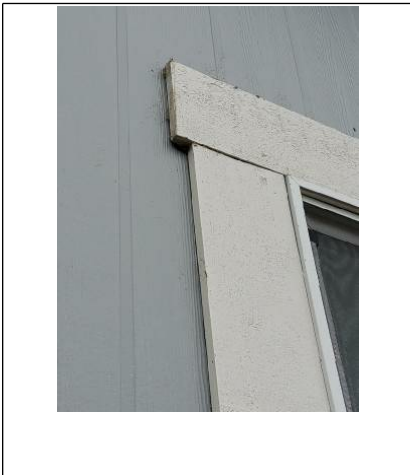
Wood trim is imbedded in the concrete, unacceptable!

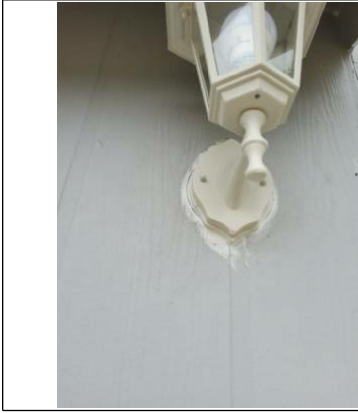
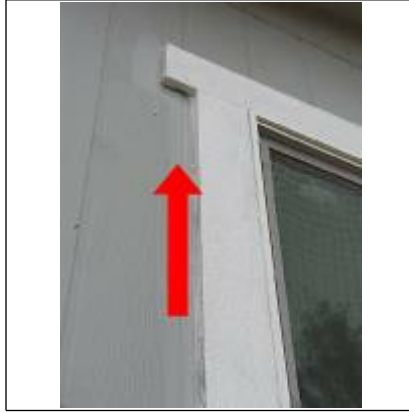
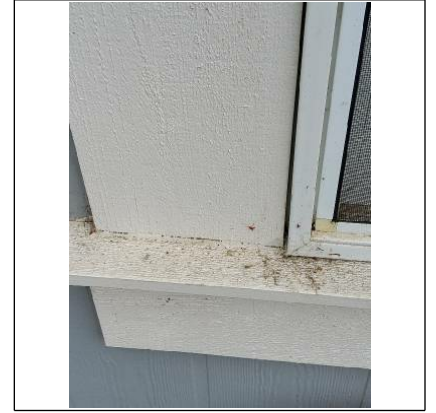
This is a cracked hardie plank that should have been replaced with a new sheet instead it was chalked and patched this will only look worse in the coming years.

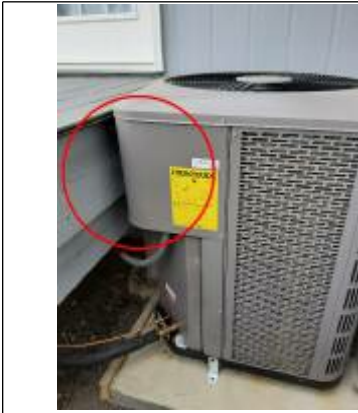
How can this unit be accessed, let alone see what the Serial and Manufacture number is for ordering parts?

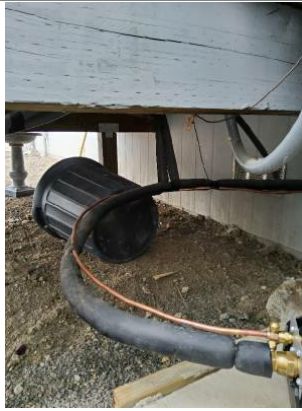
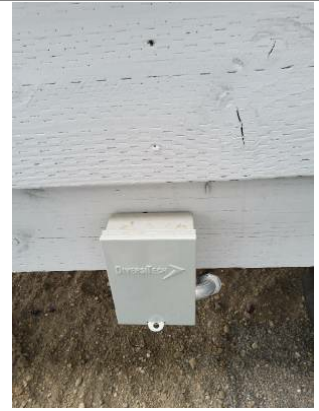
Model serial number all covered which makes service merely impossible along with inability to access unit.

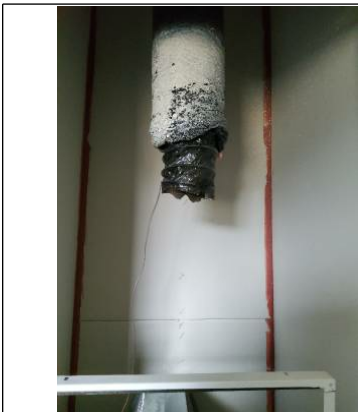
**Comments** Coils will freeze system will not operate.

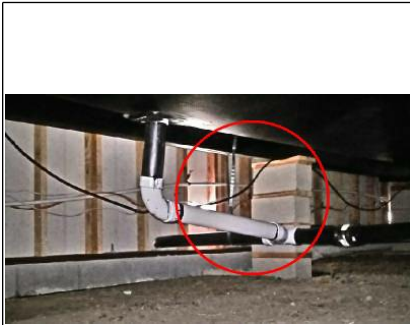
**Comments** They have PVC material spliced with ABS with ABS glue. Refer to photos for more detail issues.

Metal straps should not be used on ABS or PVC

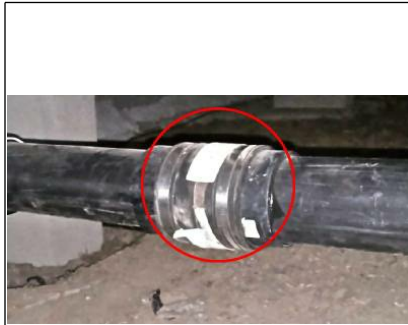
not correct cuppling used

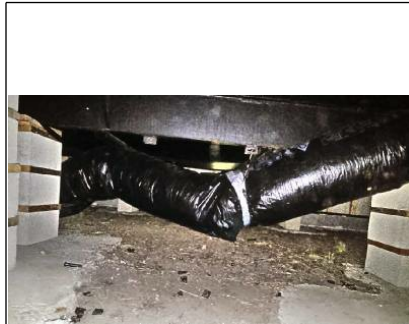
Duct tape and metal strap holding ducting not a correct way to install ducting.

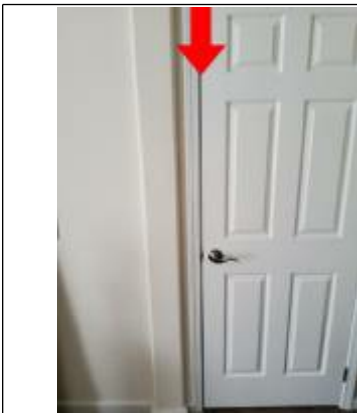
bad reveal

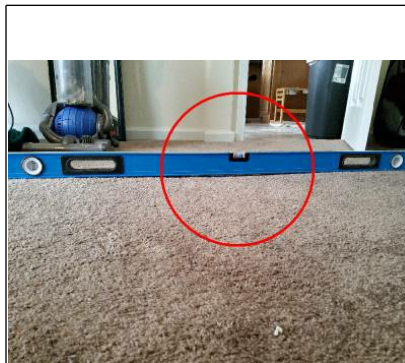
There is a huge dip where the two connected units meet as the level shows.

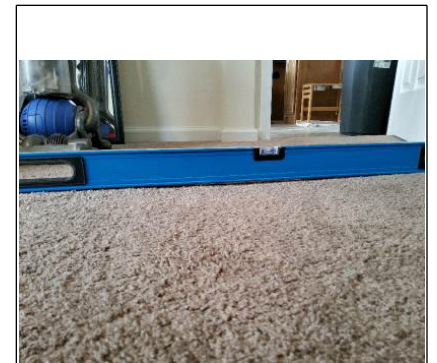
1/4 inch dip where the units meet.
