Home Inspection Report

Vednesday August 4, 2021

Dustin Wallace General Contractor Home Inspections
16496 Main St.
Lower Lake, CA 95457
(707) 293-6307
dustinjameswallace1985@gmail.com

3232

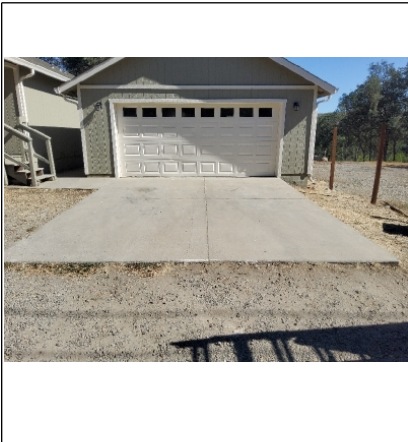
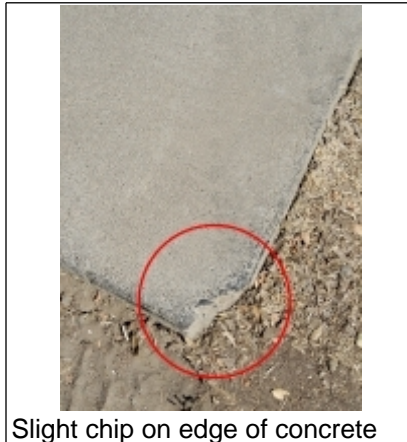
Slight chip on edge of concrete

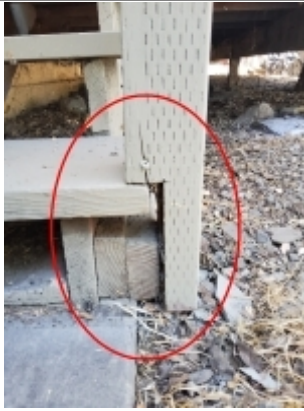
Not properly fastened column.
However, being Less then 30
inches from tread to ground level
does not require railing, column
or 4" ballusters

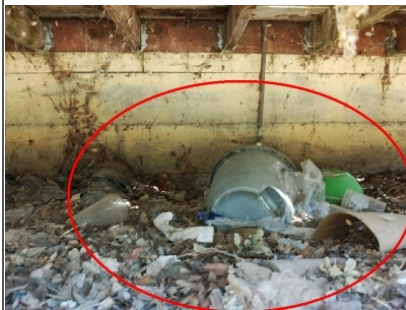
Various Debris underneath deck
should be cleaned

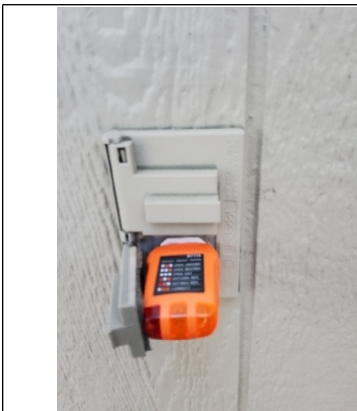
Dead outlet

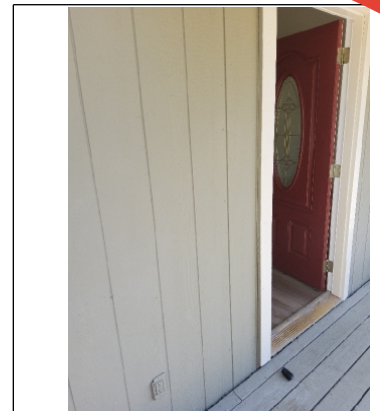
Gfci won't reset
Missing Electrical Cover

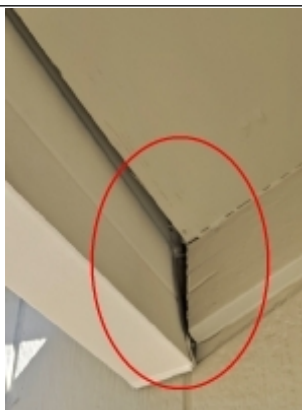
Reference to previous picture. Loose Attachment needs to be properly pitched to downspout.

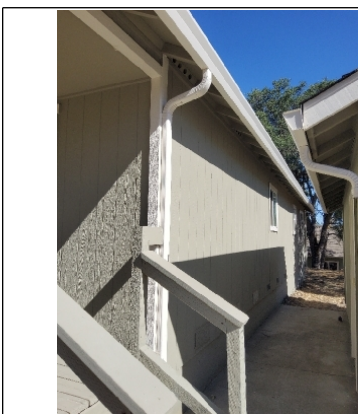
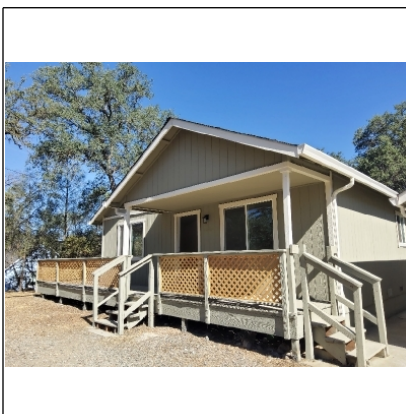
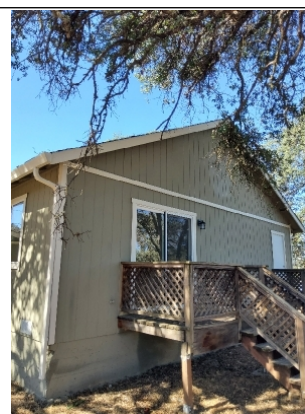
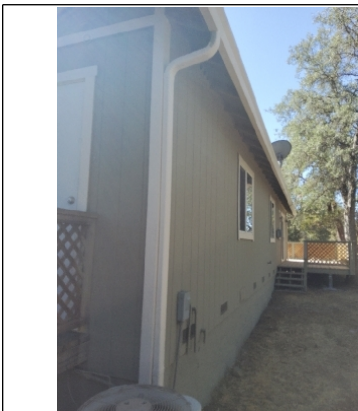
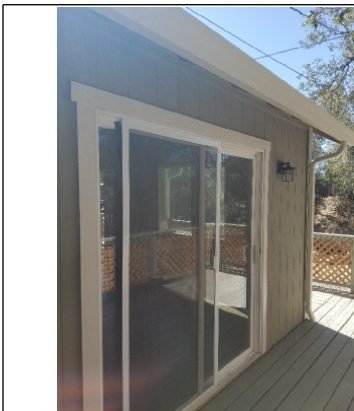
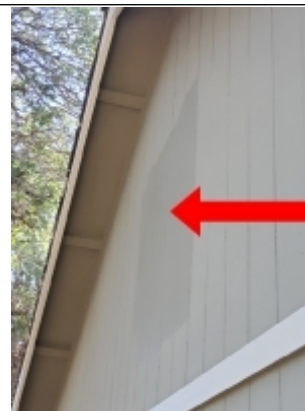
Paint looks to be Semi-Gloss does not match existing paint

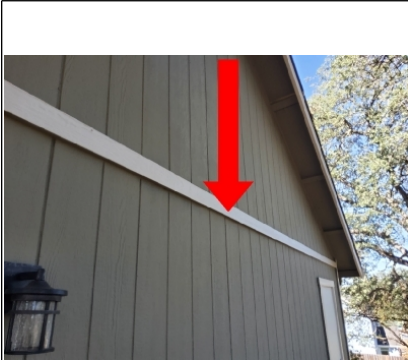
2x4 trim member is a good idea with regards to the T1-11 Siding especially in exposed sun locations. This will help keep the bottom portion of the siding above the Z-Bar from beveling out.

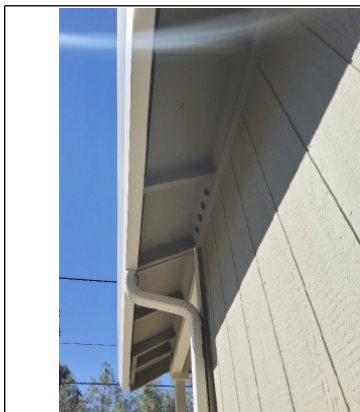
Important to note, blocking the gable ends are important when there is no wrapped around fascia keeps the gutters properly attached and fascia from bowing out.

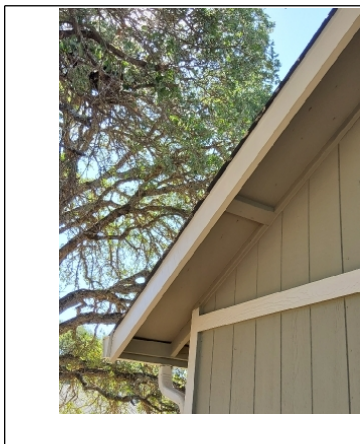
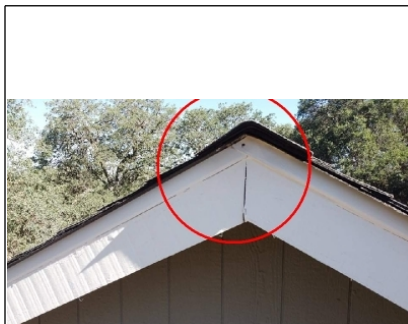
Chalk Between Fascia Members

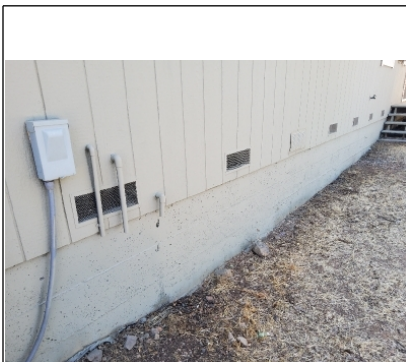
Repair is needed this was referenced in summary.

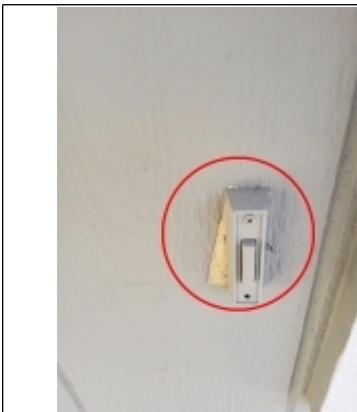
Refasten door bell and touch up paint

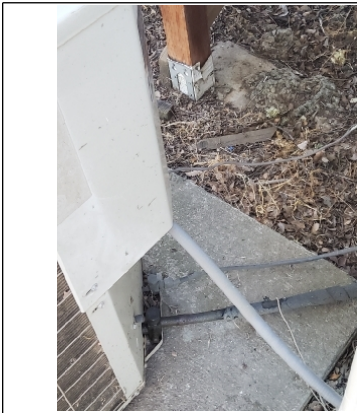
Replace Insulation

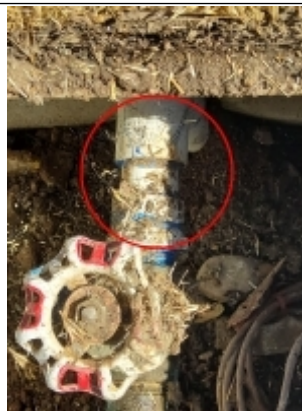
Slight leak on PVC Connection

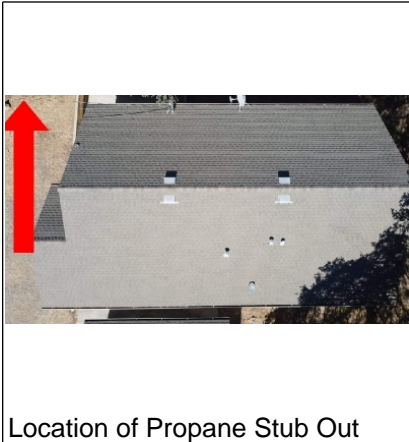
Location of Propane Stub Out

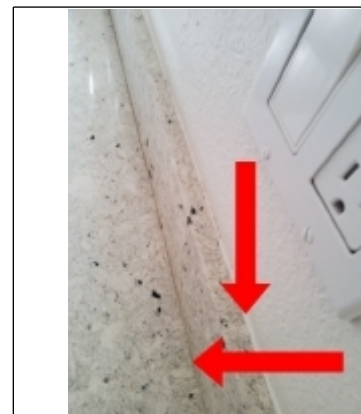
Rechalk above backsplash.
RegROUT between backsplash and countertop.

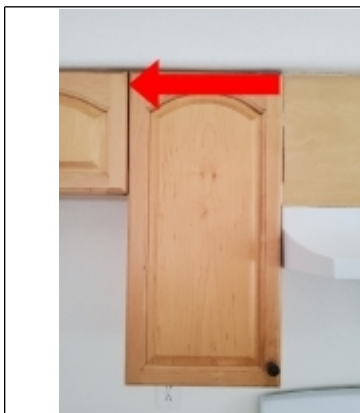
Readjust cabinet hinges

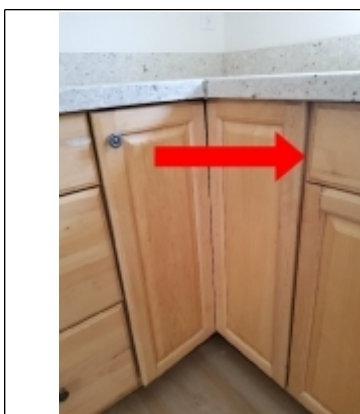
Adjust hinges

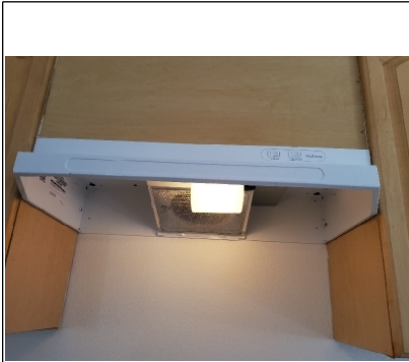
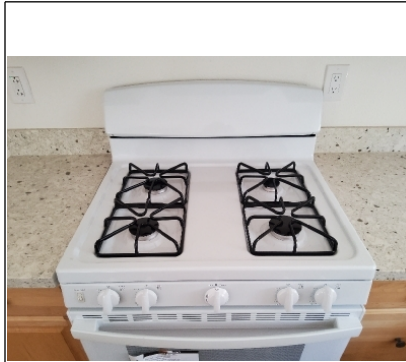
No propane to test

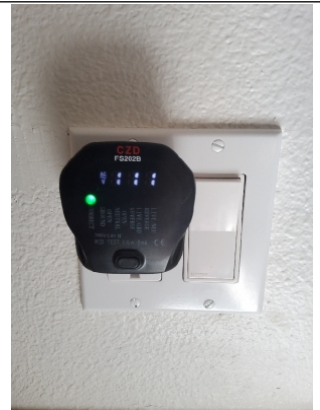
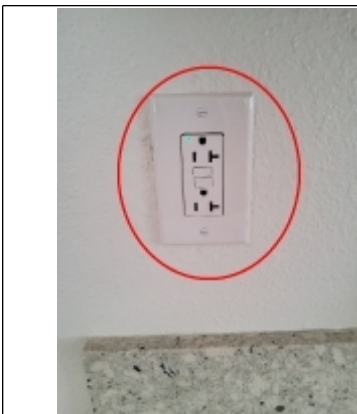
Upside down electrical outlet

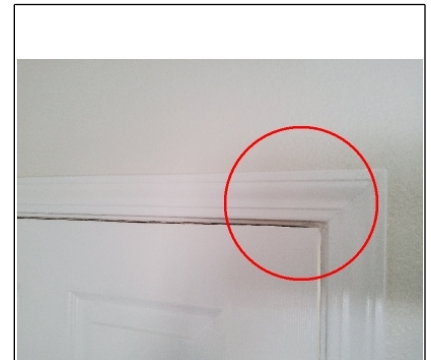
Door rubbing (Refer to Next picture for solution)

Replace existing screw center of hinge. Predrill and match the head at local lumber store, install a 3" screw after predrilling, this will tighten the jamb to the trimmer.

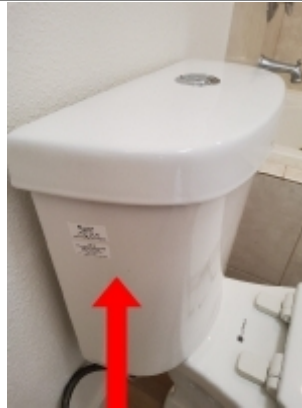
Loose Toilet Tank

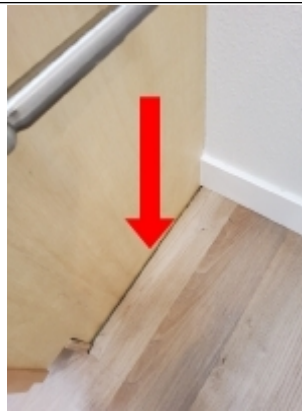
Missing trim member.
Recommend installing quarter round or baseboard.

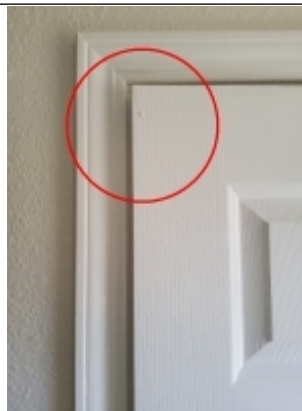
Door rubbing Jamb (Refer to Next slide for solutions)

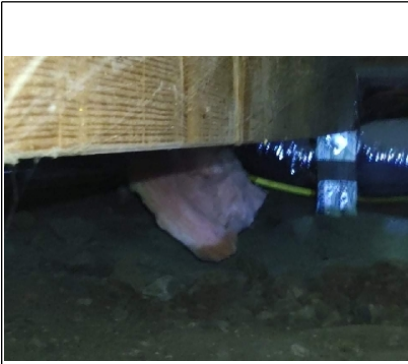
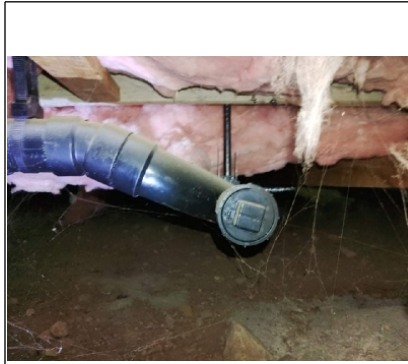
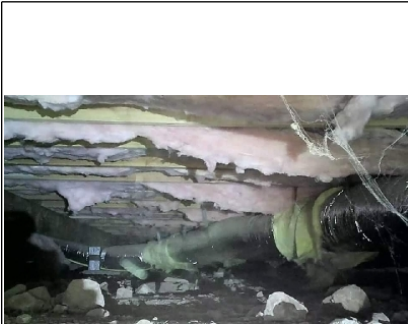
Crawl Space

Comments As noted prior insulation does need to be put back between joist members.

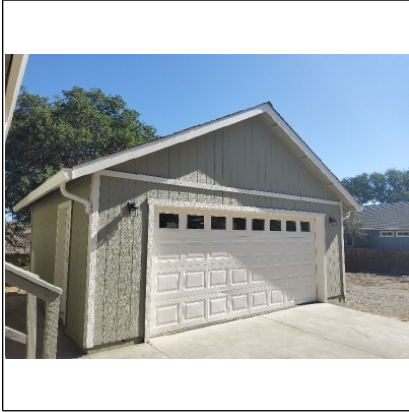
The smell in the garage smells like old paint and was recently painted and was not aired out during the time of the inspection.

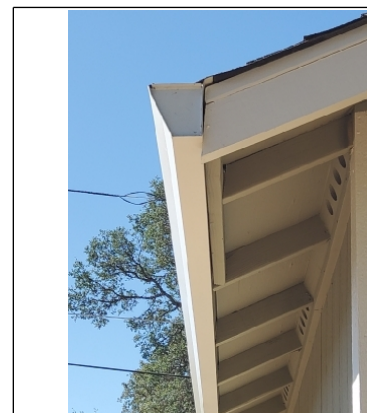
Loose Attachment
