Home Inspection Report

11925 Widgeon Way, Clearlake Oaks , CA 95423

Wednesday May 18, 2022

Dustin Wallace General Contractor Home Inspections
16496 Main St.
Lower Lake, CA 95457
(707) 293-6307
dustinjameswallace1985@gmail.com

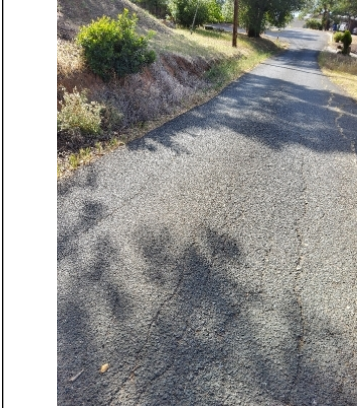
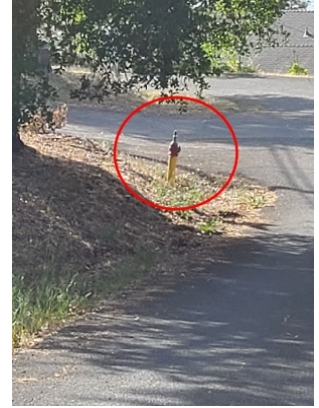
Fire hydrant is within 1000 ft. This is important information for insurance purposes.

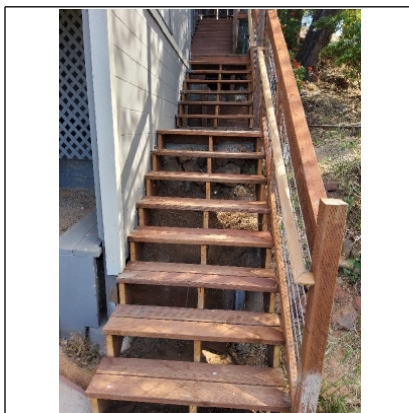
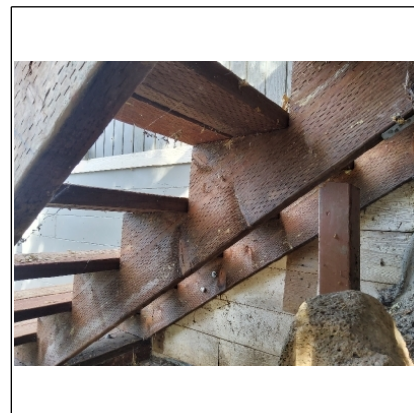
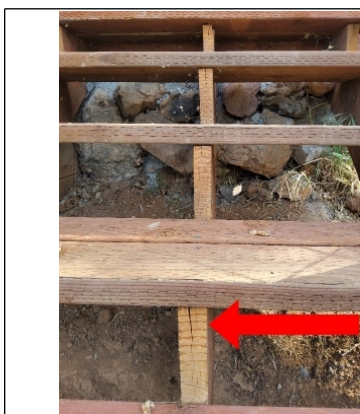
Left Staircase 1

Slight splits in the stair stringers.
The splits are not significant
enough to address right now.

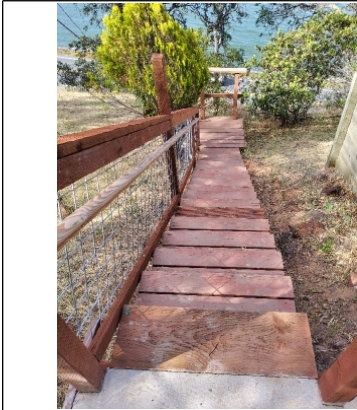
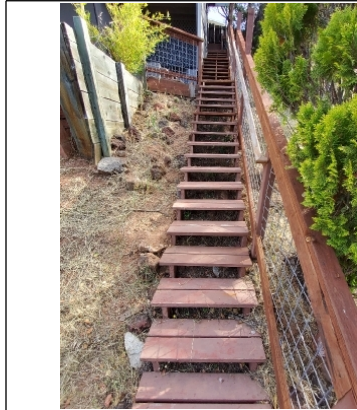
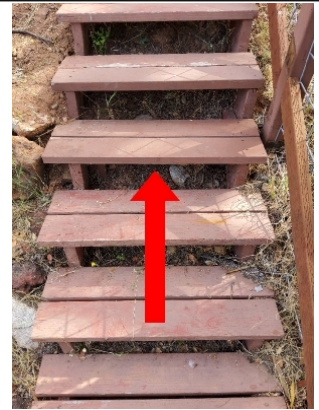
Left Staircase 2

Stringer span should not exceed 2' on center when 1-1/2" wood tread members are used. If a composite board is used spacing requirements should not exceed 16" on center stringer spacing.

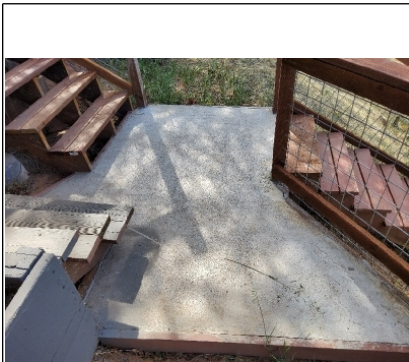
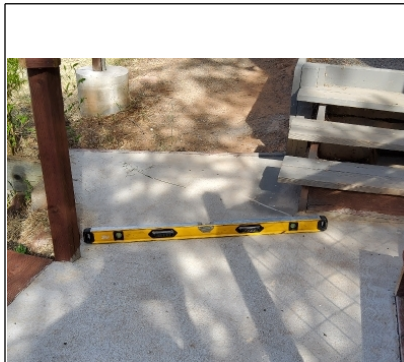
Level is placed to show proper pitch and fall for water run off (drainage)

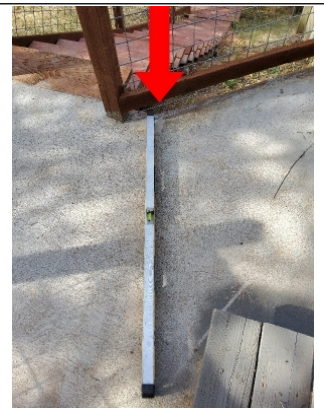
Level is placed on where the largest pitch is on slab for water run-off

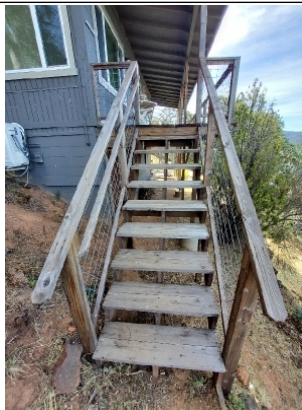
3. Rear Deck: **Loose posts. Recommend installing Simpson Strong-Tie L galvanized steel angle strap.**
4. Rear Deck: **Recommend lateral bracing each 4x4 post with 2x 2x6" pressure treated studs and connect from bottom of post to ledger.**

Recommend lateral bracing each 4x4 post with 2x 2x6" pressure treated studs and connect from bottom of post to ledger. This will help with movement on the base of the footing with relation to grade.

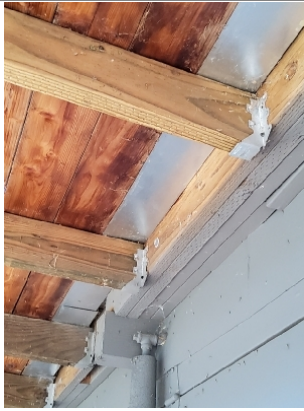
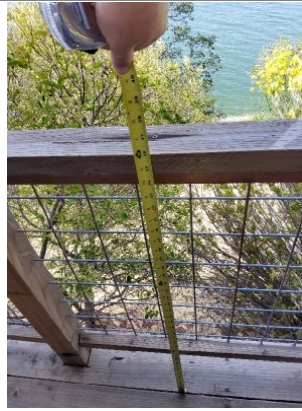
Railing meets code requirements for when it was built 36"

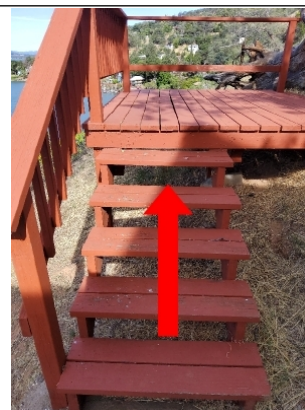
Stringer span should not exceed 2' on center when 1-1/2" wood tread members are used. If a composite board is used spacing requirements should not exceed 16" on center stringer spacing.

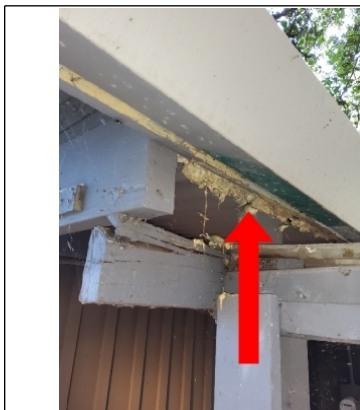
Spray foam was applied to reduce chances of insect intrusion.

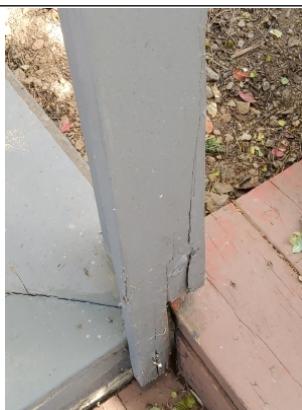
8. Porch Cover: Slight moisture damage is evident on 2x4 wood member.
9. Entry Fence/Gate: **Recommend changing gate to an outswing because there is no 36" wide landing and could be considered a safety concern. Having the gate swing the other way will be safer.**

Slight moisture damage is evident on 2x4 wood member.

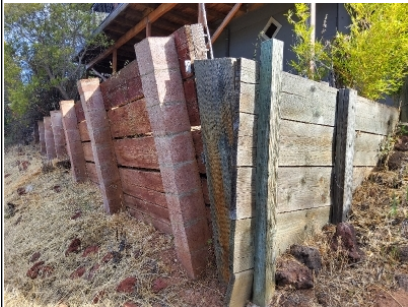
12. **Recommend trimming back tree branches especially over the chimney chase.**
13. Rear Retaining Wall 1: **Significant concerns are evident on this retaining wall. A new retaining wall is needed as there is significant concern that erosion from the possible failure of this retaining wall will compromise the footings of the deck columns and possible house itself. This also needs to be engineered as it exceeds 4' height (1' below grade, which will need to be more than 1' based on the given slope.)**

There is a significant concern with the conditions regarding the retaining wall. The retaining wall is leaning significantly and should be addressed immediately. The retaining wall will require engineering as the span exceeds 4' with (1' min footing) and should be constructed only by a Licensed General Contractor. It is important to note the retaining wall is around 7' away from the most concerning 4x4 deck post. If that retaining wall does go it will significantly compromise the deck which is attached to the house. There are no engineered set of plans to show deep the footings are below the 4x4 posts but standard is 2'x2'x2'. I am concerned that if the retaining wall continues to give away that the footings below the pier blocks will be susceptible to erosion. The retaining wall is the single most important concern with regards to this home. I would recommend having lateral braces (2x6 pressure treated members on each side of post) installed at the bottom of each 4x4 post and then tied to the ledger board on the house this will help with movement with regards to erosion. The top retaining wall also needs some repairs, the repairs on the top retaining wall can be done by a handy man with skills in carpentry as the repairs are more of strengthening the existing 2x10 planks.

Significant concerns are evident on this retaining wall. A new retaining wall is needed as there is significant concern that erosion from the possible failure of this retaining wall will compromise the footings of the deck columns and possible house itself. This also needs to be engineered as it exceeds 4' height (1' below grade, which will need to be more than 1' based on the given slope.)

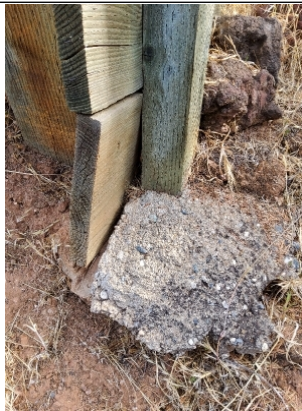
Most concerning area of retaining wall is 7' from the last pier cylinder.

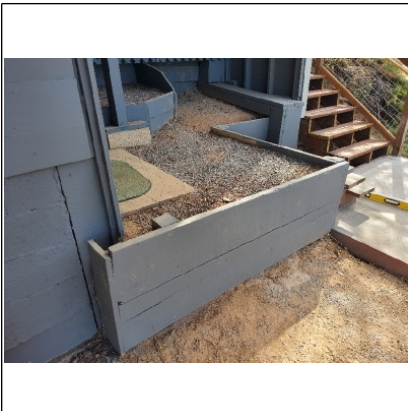
Comments New retaining wall is needed. Concerned it will undermine the footings for the deck needs to be addressed immediately

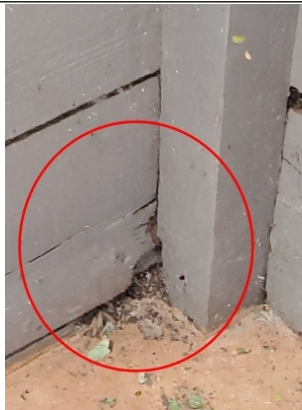
Moisture damage is evident on bottom of wood member. Recommend installing additional 2x8 pressure treated wood member and tie in existing 4x4 member.

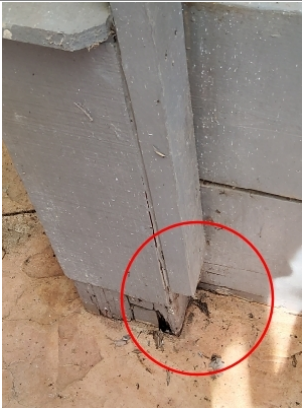
Moisture damage

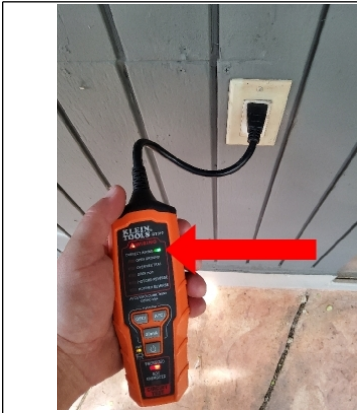
Electrical outlet shows proper grounding and polarity.

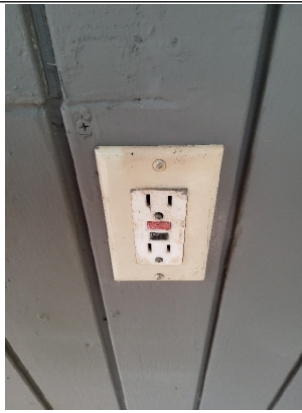
Electrical outlet is missing proper exterior outlet cover.

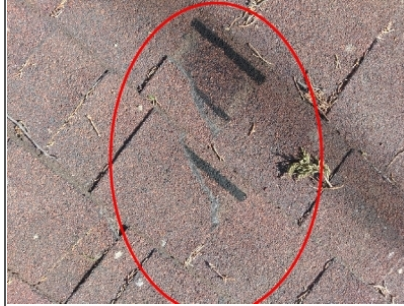
Damaged shingles

Based on the present conditions of the roof I estimate that the roof will need to be replaced within the next 3-5 years.

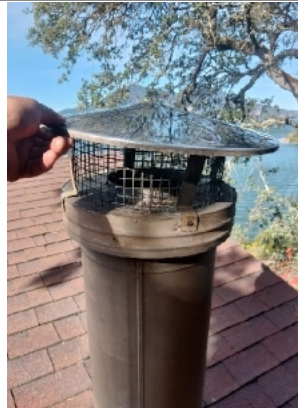
Rain cap / Spark arrestor is loose.
Recommend having properly fastened.

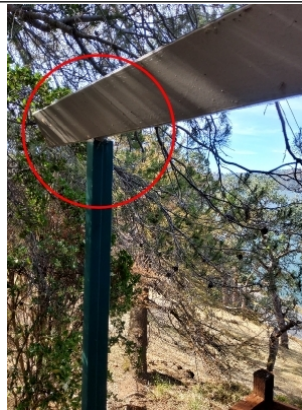
Improper pitch gutter to downspout referenced to prior slide.

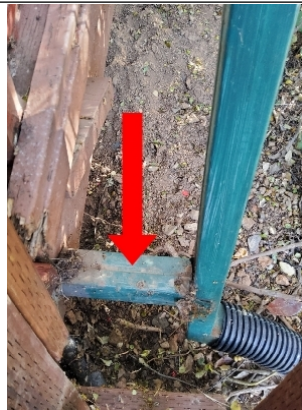
Loose attachment

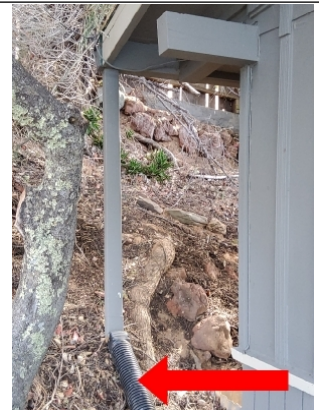
Downspout has proper drain tile extension to keep run-off away from perimeter foundation wall.

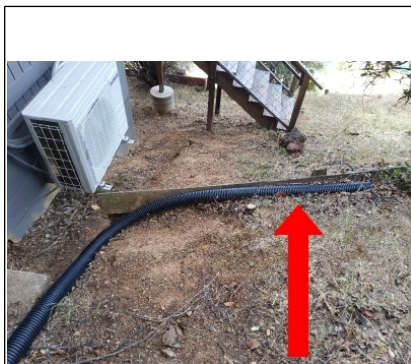
Corrugated drain tile is properly diverting water run-off away from the perimeter structure.

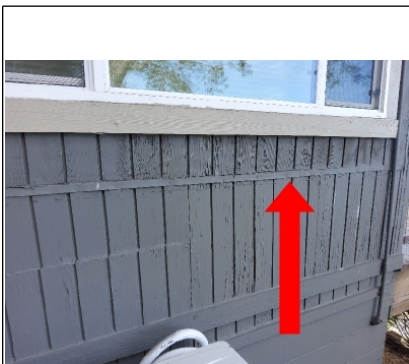
Sun damage is evident on the siding. Recommend having sanded and repainted.

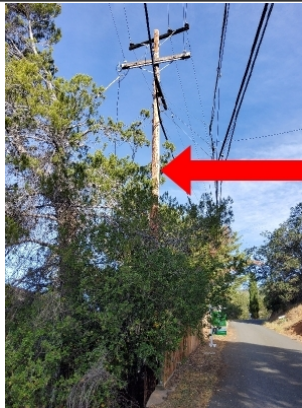
Service pole is leaning. This most likely is fine, however would contact PGE to further examine the pole.

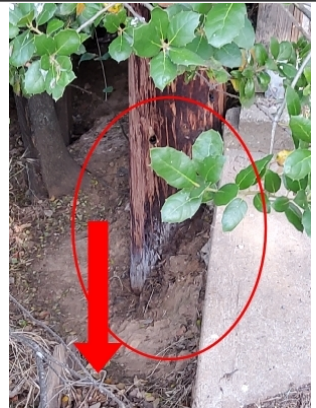
Unknown how deep the power pole is.

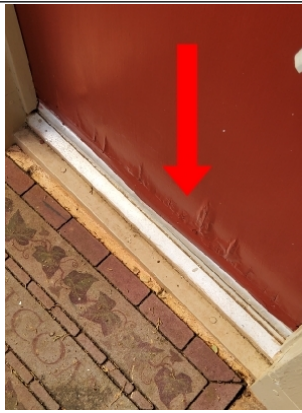
Damaged door slab. Recommend having exterior door replaced.

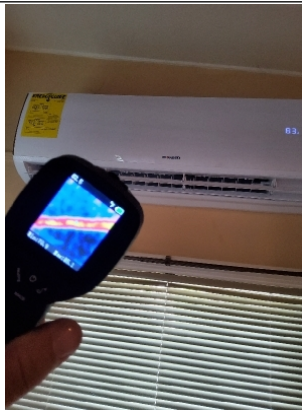
Thermal Imager shows proper HEAT distribution

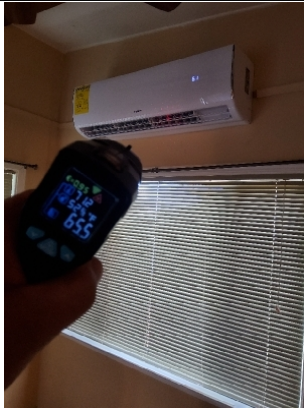
Thermal Reader shows proper AC distribution

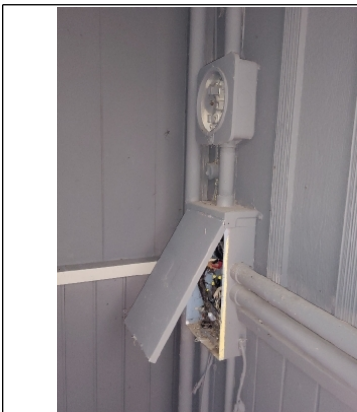
Disconnected (Original Panel Box)

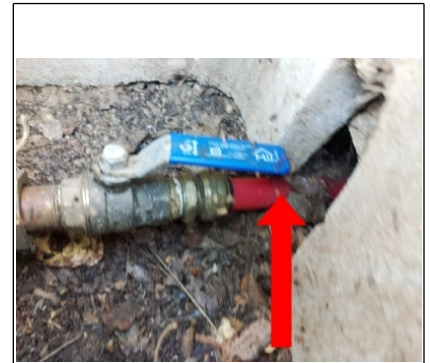
Water entry material is PEX Plastic

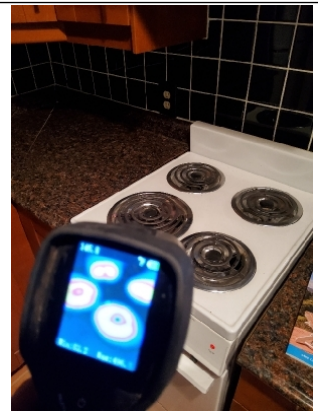
Thermal Imager shows burners properly work.

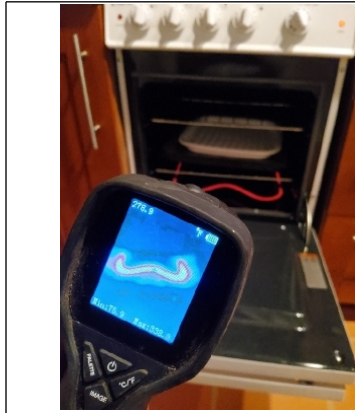
Thermal Imager shows oven properly works

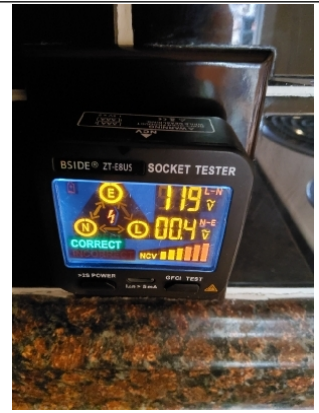
Electrical outlet shows proper grounding and polarity.

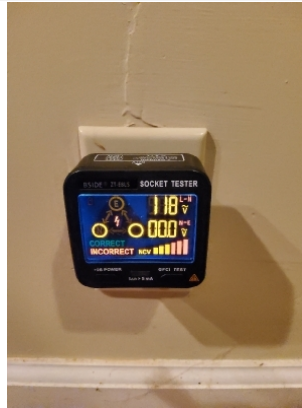
Open ground electrical outlet.
Refer to next slide for reference
of outlets.

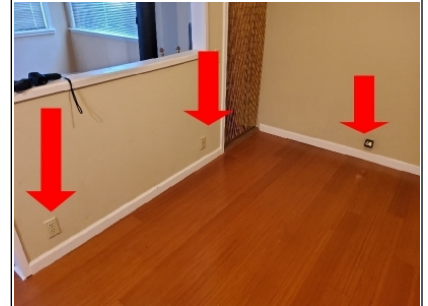
All three outlets are open ground.
However, concerns are minimal
as they are not close to a water
source location.

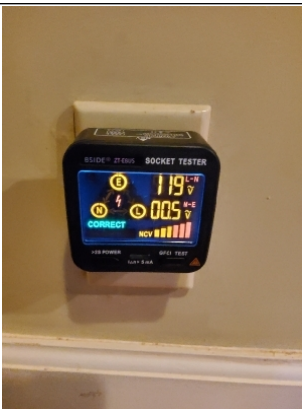
Electrical outlet has proper
ground and polarity.

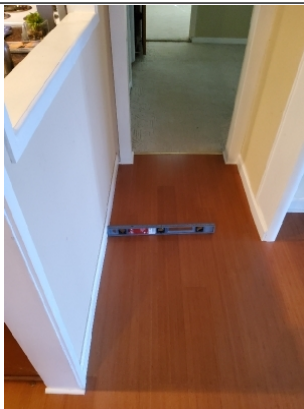
2' Level shows slope on floor.

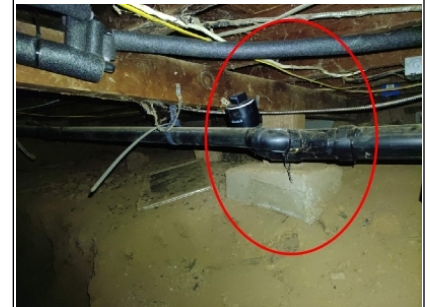
Girder member and footing are the reason for the slope.

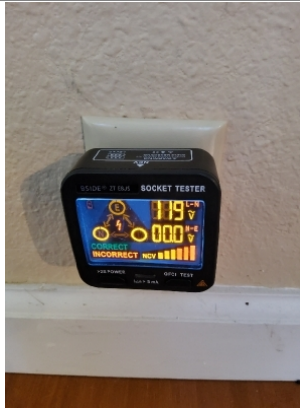
Open Ground Electrical

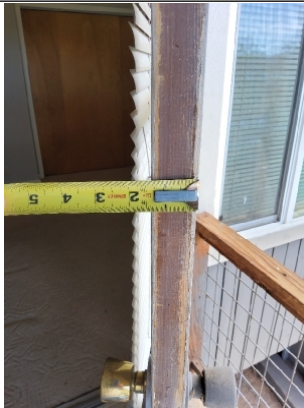
The current exterior door is not an exterior door. This is an interior door it is 1-3/8" while exterior doors are 1-3/4".

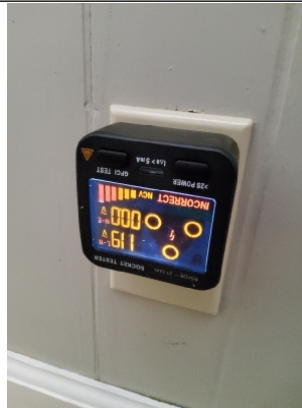
Open ground electrical outlet

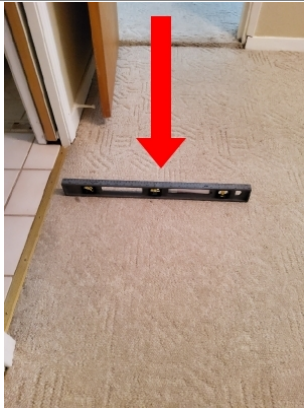
Dip is in relation with girder member that was mentioned in the Living Room portion of the report.

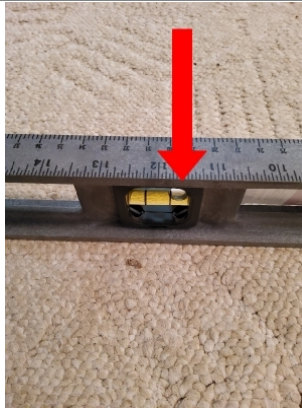
Arrow points to the center of the bubble in relation to slope of floor.

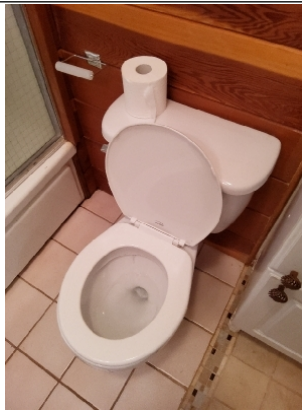
Slightly cracked tiles

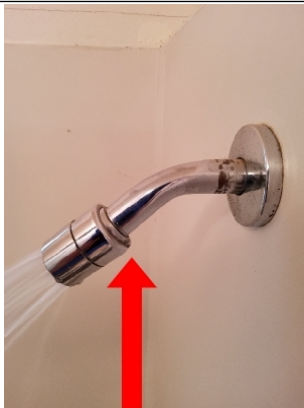
Shower head leaks

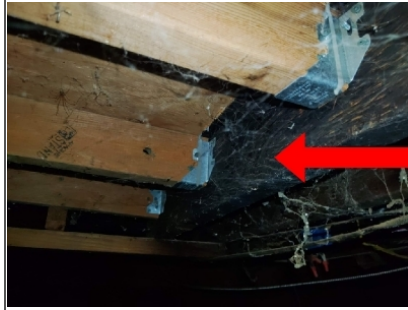
Possible electrical fire damage.
