Home Inspection Report

13823 Lemon Ln, Clearlake Oaks, CA 95423

Sunday August 29, 2021

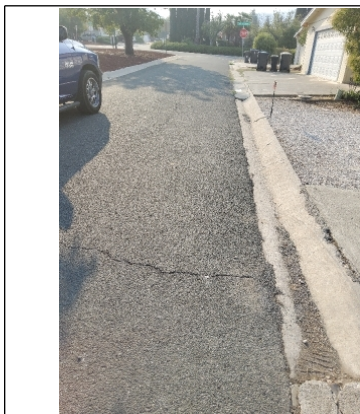
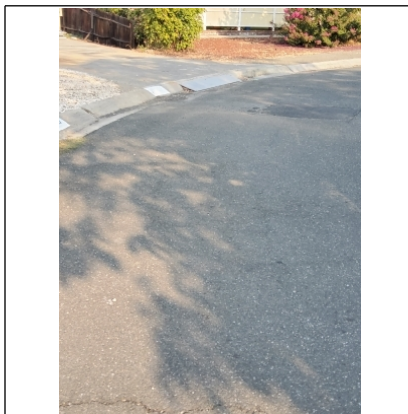
Driveway/Parking

Clear out debris in abs pipe and
recommend patch work on
disconnect concrete.

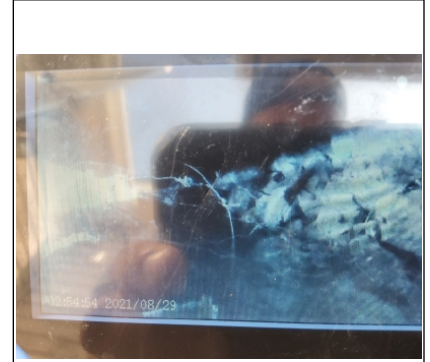
Porch Deck

Rope Camera was scoped in various locations on the porch deck

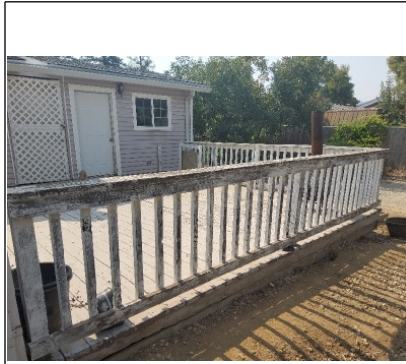
Rear Deck

Scope camera was used to check conditions throughout the deck.

For now before removing deck. Change out bottom bracket and replace with straight galvanized bracket to tie in rim board.

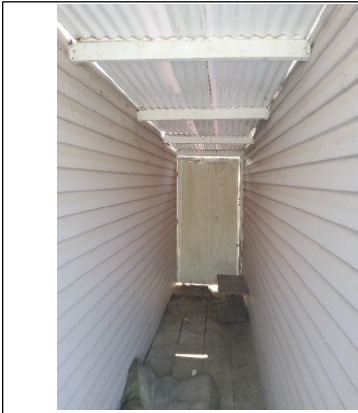
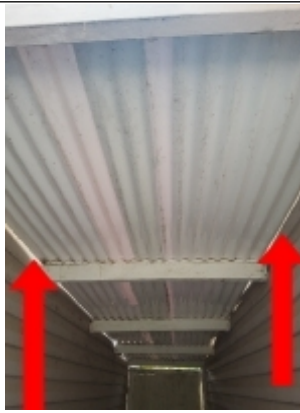
Covered Breezeway

With overhangs from both roofs on gable ends little to no chance of water to get in between openings. With corrugated roofing the water will be going through the valleys not at the edges. (Daylight)

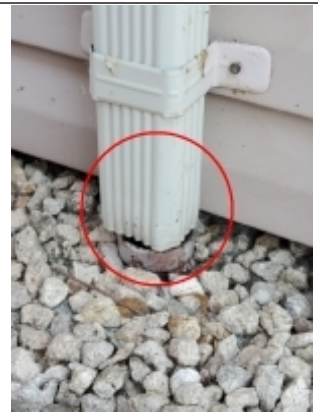
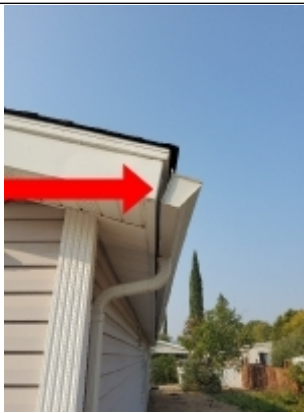
Loose gutter

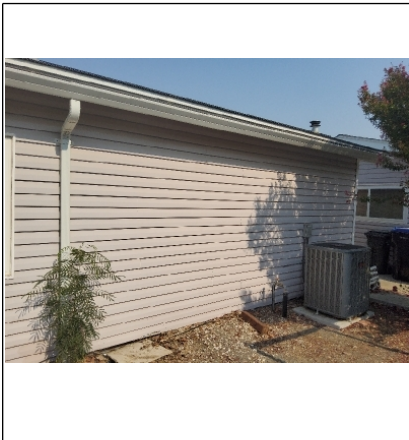
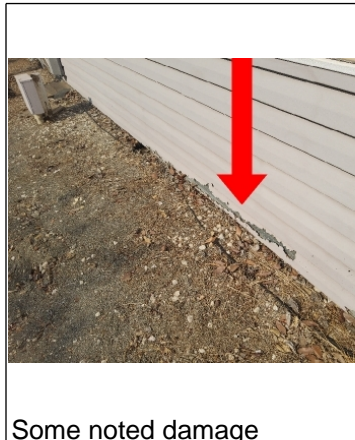
Some noted damage

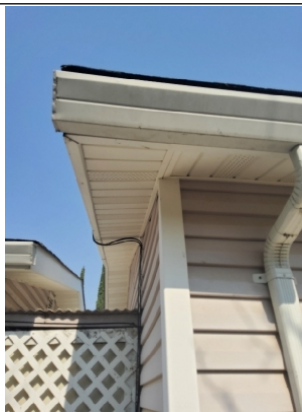
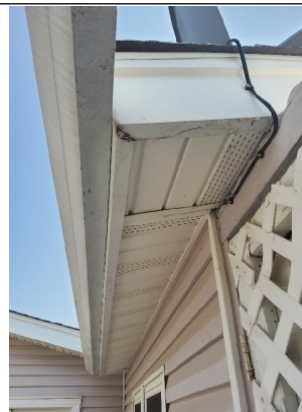
There is a slight dip on the overhang. I did test this and found no structural concerns.

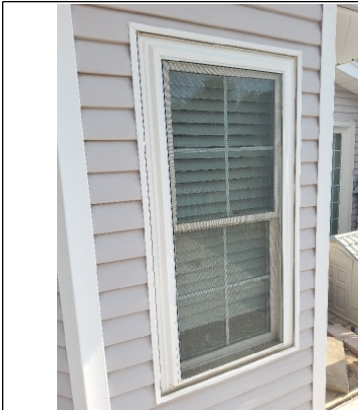
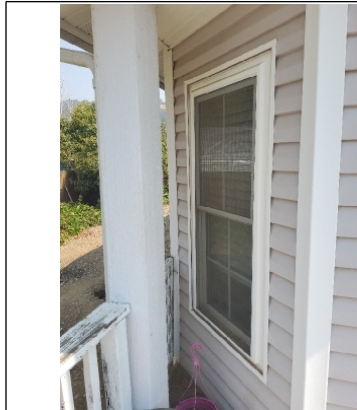
Bent Screen

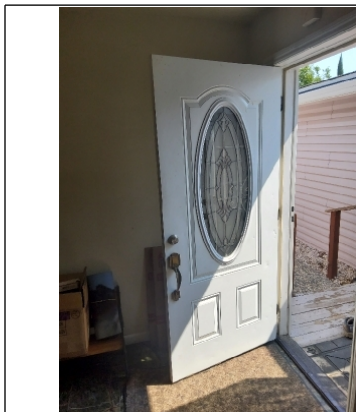
Replace sweep

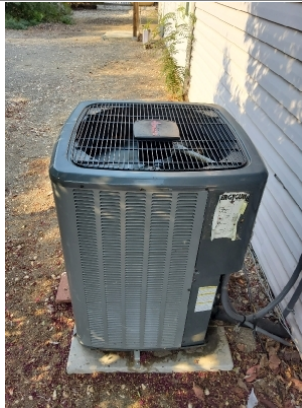
Perfectly normal this is defrost.
The hotter the exterior tempature
the most defrost will be evident
this is a new unit that is less then
4 years old.

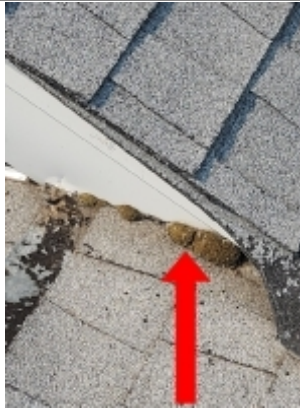
Moss

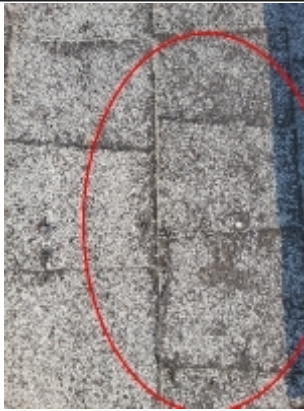
This is a closer look on worst conditioned shingles on the house.

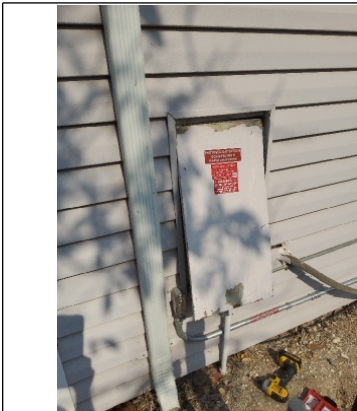
Branch wire condition ☐ Satisfactory ☐ Poor ☒ Recommend electrician replace breaker ☐ Romex ☐ BX cable ☐ Conduit ☐ Knob/Tube ☐ Double tapping ☐ Wires undersized/oversized breaker/fuse ☐ Panel not accessible ☐ Not evaluated
Reason:

Double tapped wire. Recommend either pigtailing or replacing the 15 amp breaker with a tandem breaker.

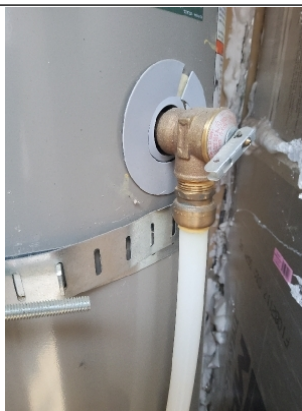
Pex is perfectly fine for relief valve material as it does reach temps of 200 Degrees F

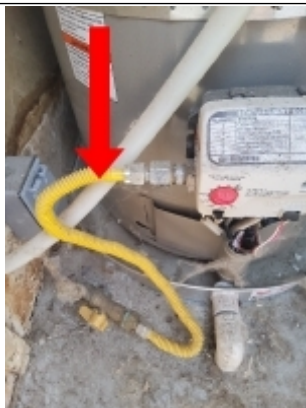
This 1/2" Flex Gas Line is perfectly fine to use on a hot water heater.

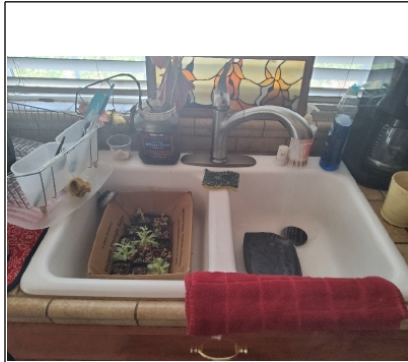
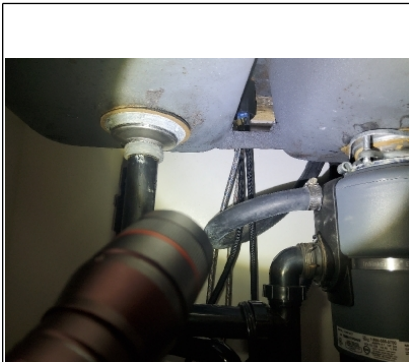
Missing Dishwasher Air Gap Cover

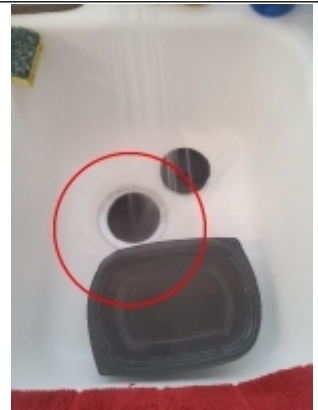
Grinding sound most likely debri trapped in chamber

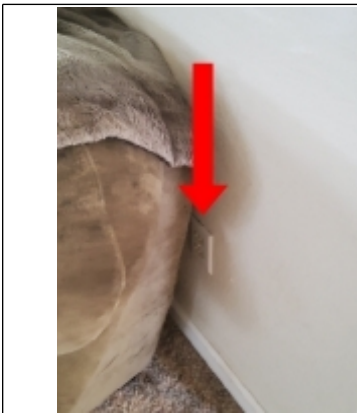
Tighten outlet cover

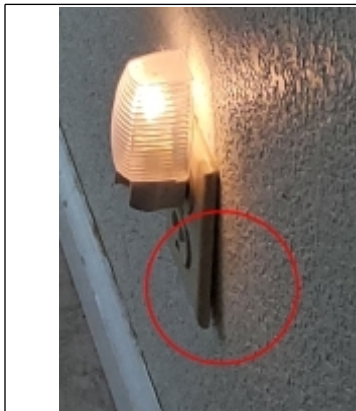
Remove cover and flush outlet box to drywall and possibly add side screw to the frame member.

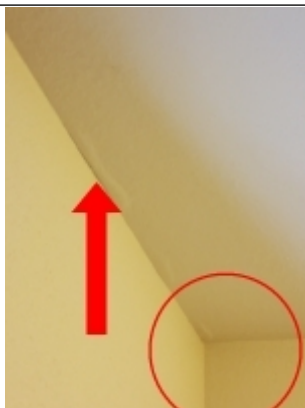
Bubble on tape joint not a leak

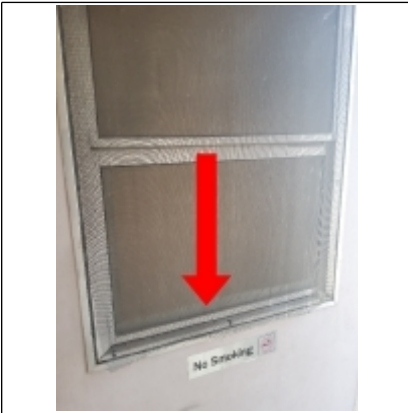
Ripped Screen

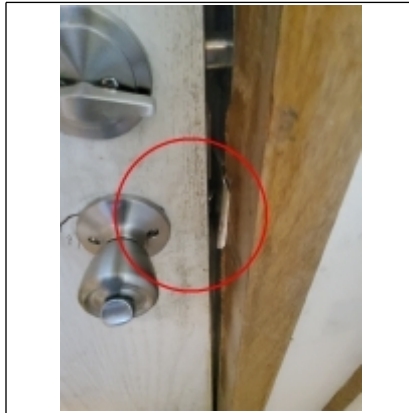
Adjust Striker Plate

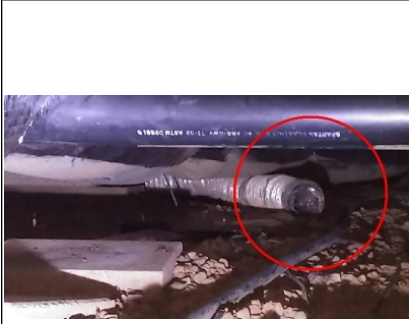
Laundry Room

Disconnected Dryer Vent

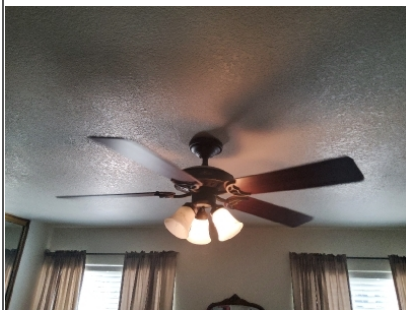
Fan does operate slower then normal recommend replacing.

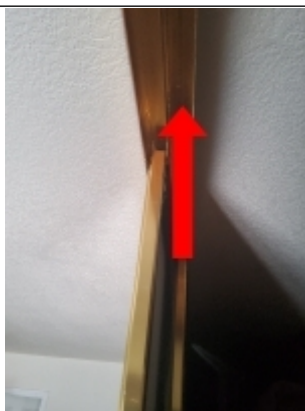
Lubricate closet door track

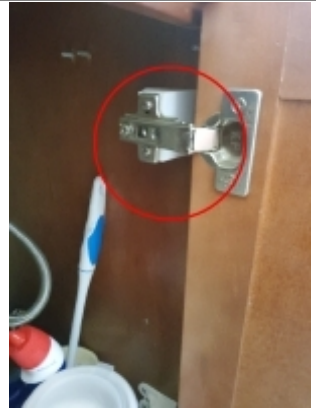
Loose cabinet hinge

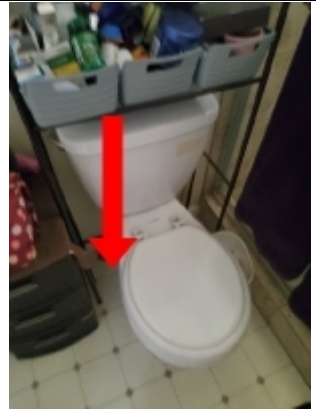
Toilet is a hair loose on the base can easily be tightened

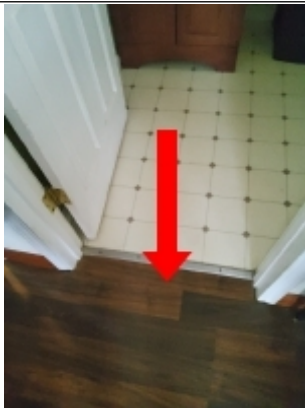
Squeaks are very common on manufactured homes.

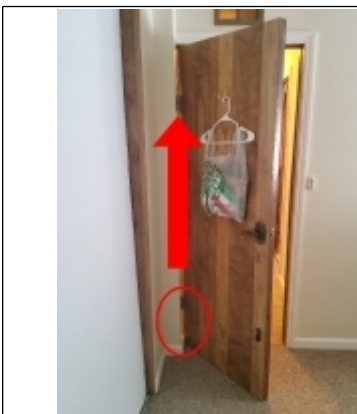
Door stop needed. Making bottom hinge pull away

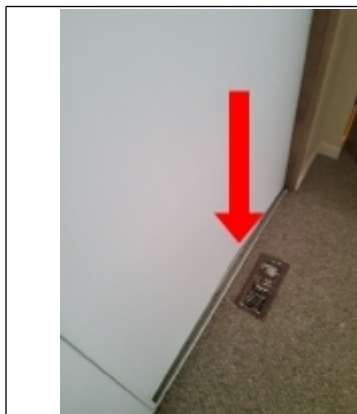
Slightly bent closet door

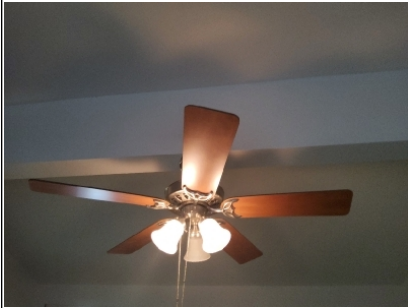
Fan not operating

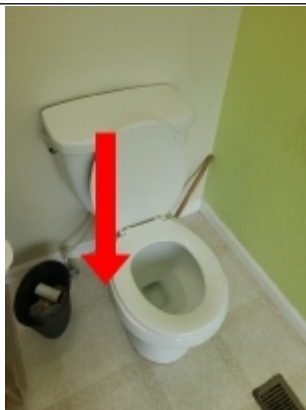
Toilet Bowl loose: ☒ Yes ☐ No Operable: ☐ Yes ☐ No ☐ Cracked bowl ☐ Toilet leaks

Refasten toilet at the base

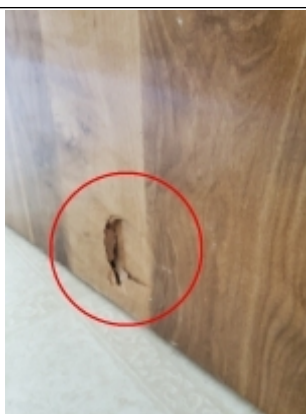
Damaged Door

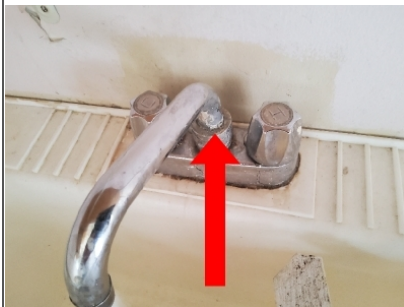
Leak

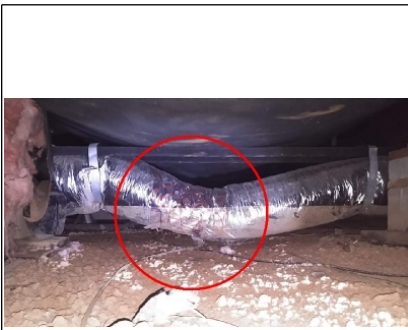
Ducting repairs are noted in inspection report.

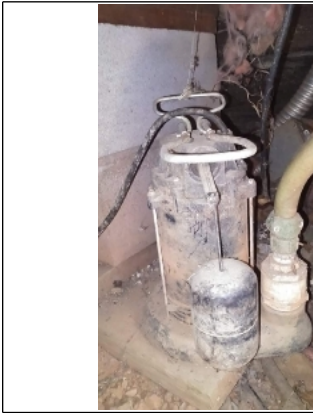
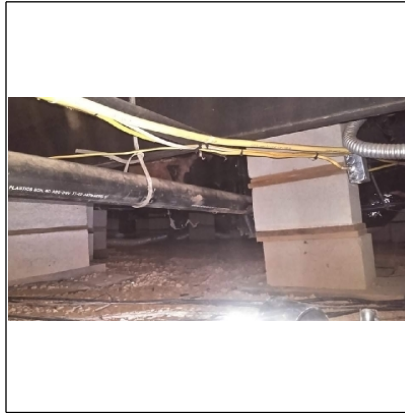
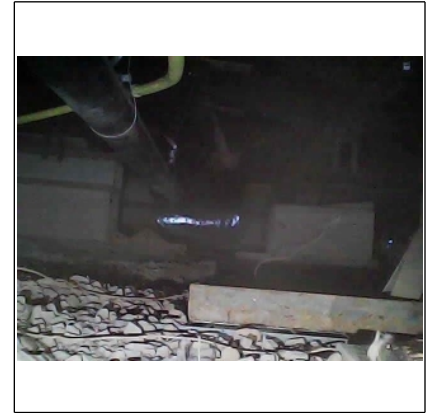
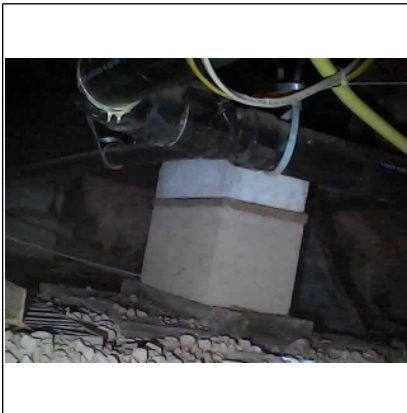
Comments Pump was not turned on during inspection. I find it very unlikely that there will be evidence of moisture in the crawl space during the winter months from water run-off as there is proper drainage around the property. The location of the sump pump is also not in the location that would be considered a moisture problem. The recommend extensions that are noted for gutters are on the opposite side of the home of the sump pump location. Making its operation useless.

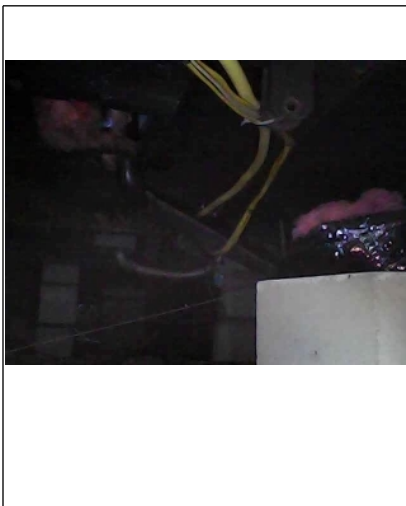
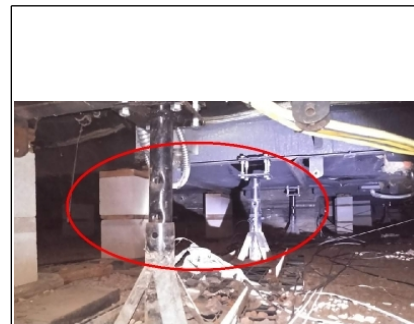
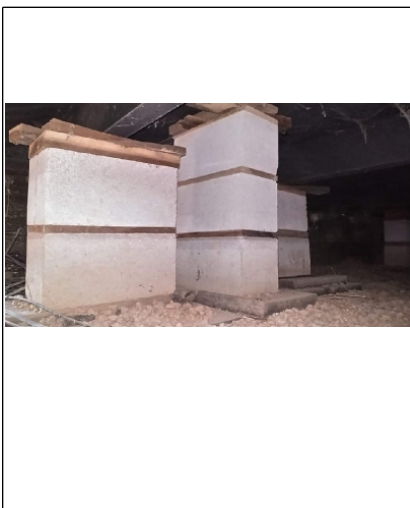
Crawl Space

These are the required attachments for the 433A Civil Engineer Certificate
