Home Inspection Report

19064 Coyle Springs Rd , Hidden Valley Lake, CA 95467

Sunday August 6, 2023

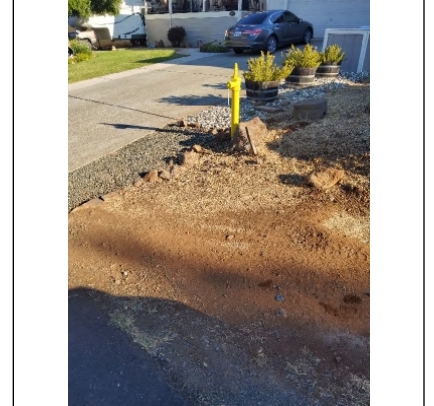
There is a fire hydrant in close proximity to the home (less then 1000ft). This is important information that can be provided for insurance quotes.

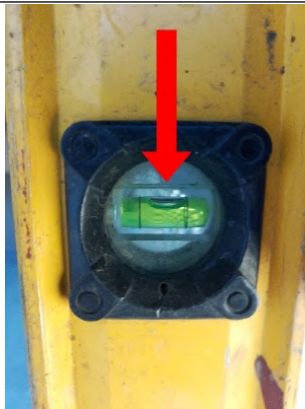
Arrow points to center of bubble with reference to prior slide.

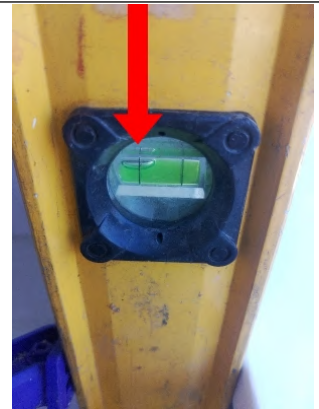
Arrow points to center of bubble with reference to prior slide.

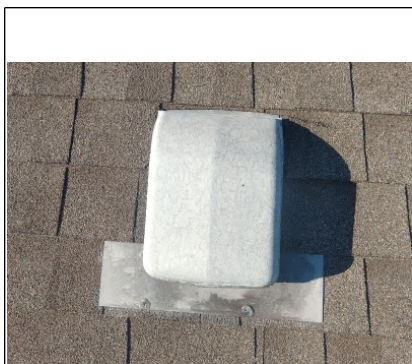
1. Roof Ventilation

Comments *1. There is 3-point ventilation on this roof. First, roof vents. Second, Gable Vent which is standard for gable end roof design. Third, Eve block vents which again are standard. Thus, there is a 3-point ventilation system on this home which is better than a 2-point ventilation on a Hip and Valley roof design.*

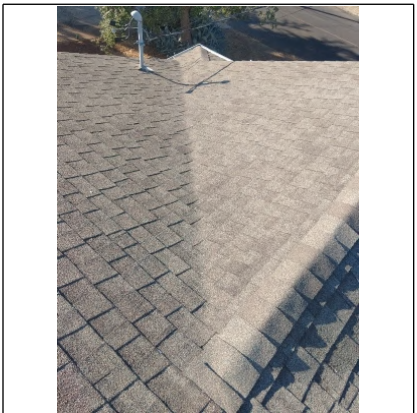
This is known as a weave design or others call a California Weave which is a much better way to roof a valley when doing a closed valley practice. This method is the best of the two styles while the other is known as a Closed Cut. With regards to protection from water protrusion through the seams between the roof sheathing. The other method is not a weave method. On this the roofers run a full starter down the valley and then snap a line and cut the shingles which only leaves one point protection from water protrusion through the sheathing. This way provides not only two layers of protection as a starter roll is used as well in the valley but with the weave has significant overlap that is not seen by the naked eye.

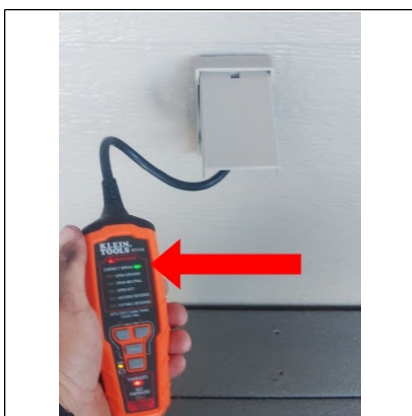
Electrical outlet shows proper operation, grounding and polarity.

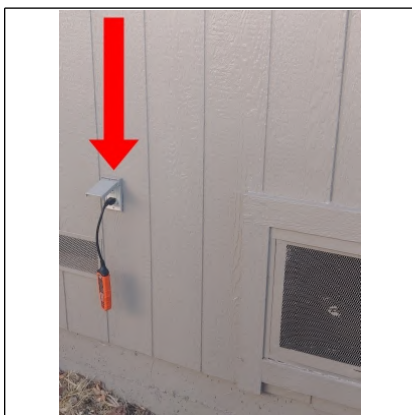
GFCI is inoperable. Recommend having replaced by a Licensed Electrician.

Reference location for prior slide.

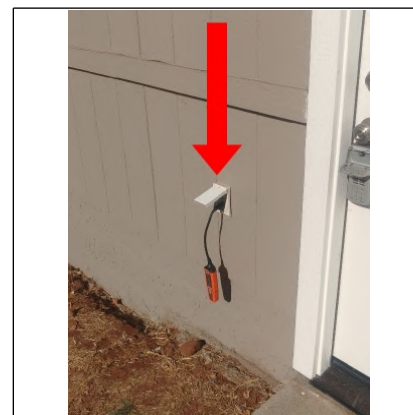
1. GFCI is inoperable. Recommend having replaced by a Licensed Electrician.

Reference location for prior slide.

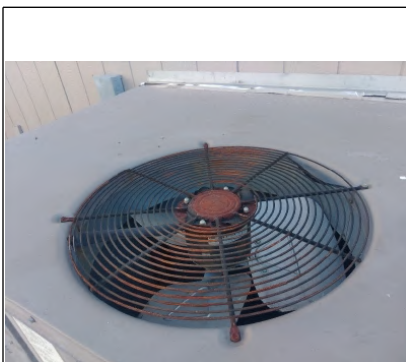
Rust is evident on grill cover. Recommend having replaced by a Licensed HVAC Contractor.

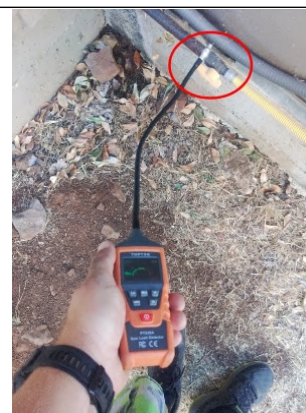
No leaks were detected on shut off valve.

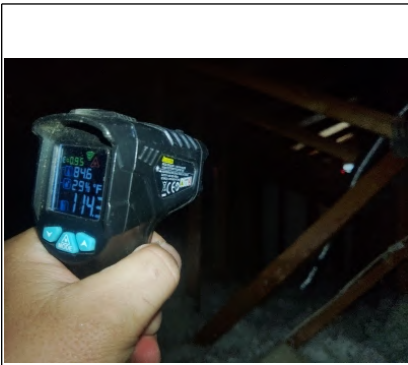
Thermal Reader shows 114.3 Degrees F at the gable vent location this shows there is proper ventilation and a moderate heat index.

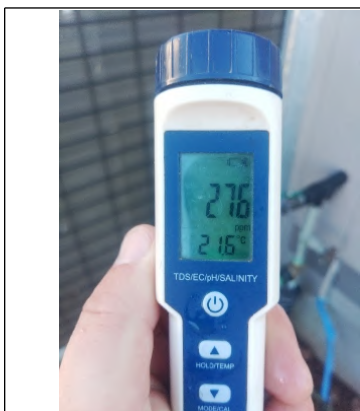
Water level shows 276 PPM which is considered to be in the "Average Tap Water" level range.

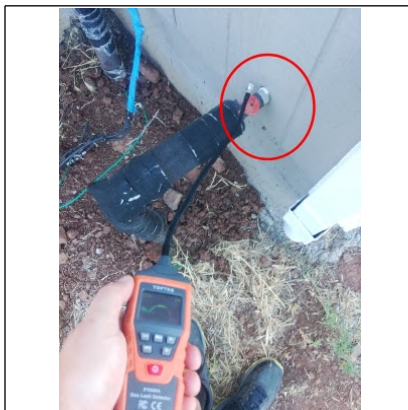
No leaks were detected on shut off valve.

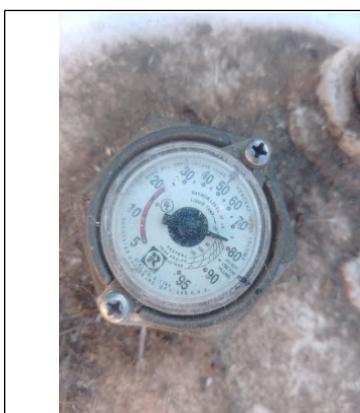
Propane tank is 77 percent full during time of inspection.

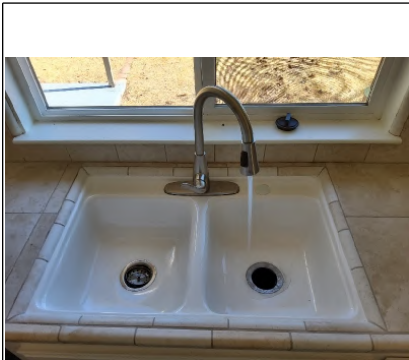
Comments **1. Hot and cold water lines are backwards. Recommend having a Licensed Plumber switch flex line water supply lines to correct locations.**

Hot and cold water lines are backwards. Recommend having a Licensed Plumber switch flex line water supply lines to correct locations.

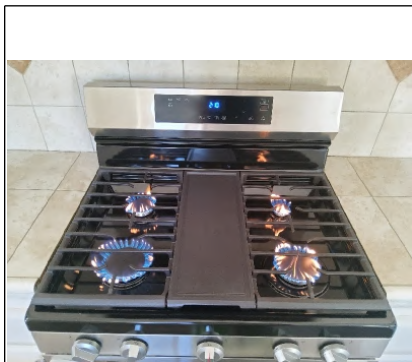
Comments **1. Oven and Stove top are considered a fire hazard at their current state. Recommend having a Licensed Plumber further evaluate the gas shut off valve conditions as well as determine the cause of the excessive flaming.**

Stove top is considered a fire hazard at its current state. Recommend having a Licensed Plumber further evaluate the gas shut off valve conditions as well as determine the cause of the excessive flaming.

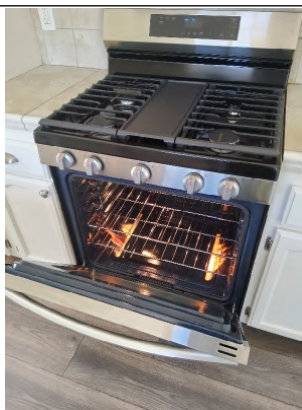
Oven is considered a fire hazard at its current state. Recommend having a Licensed Plumber further evaluate the gas shut off valve conditions as well as determine the cause of the excessive flaming.

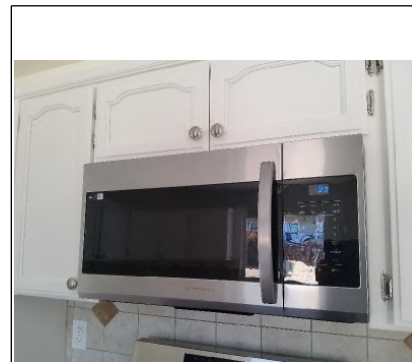
Microwave shows proper operation.

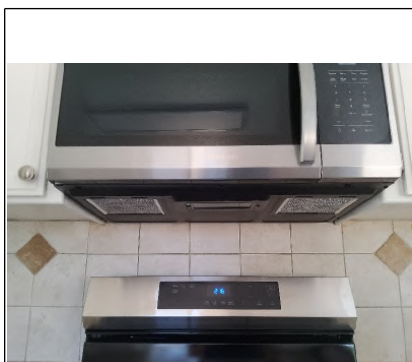
Exhaust fan shows proper operation.

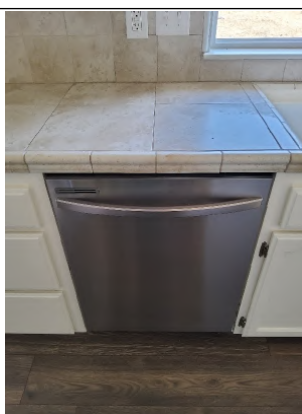
Dishwasher shows proper operation.

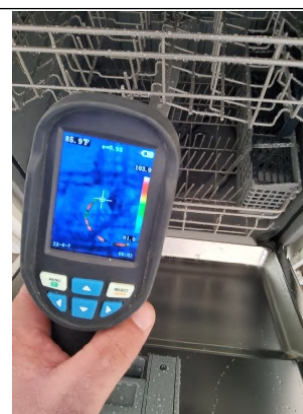
Thermal Imager shows proper operation on rinse cycle.

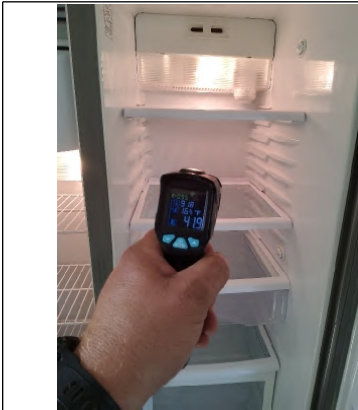
Thermal Reader shows refrigerator properly operates. (41.9 Degrees F).

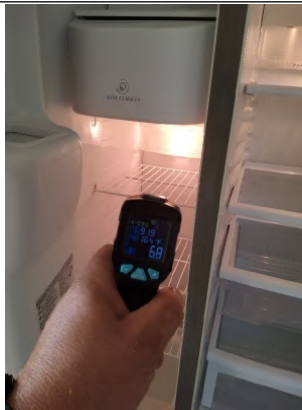
Thermal Reader shows refrigerator properly operates. (6.8 Degrees F).

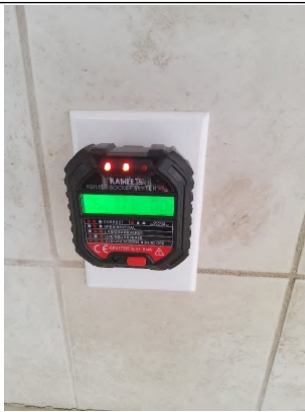
Electrical outlet shows proper operation, grounding and polarity.

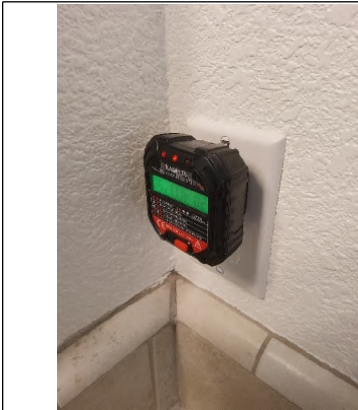
Electrical outlet shows proper operation, grounding and polarity.

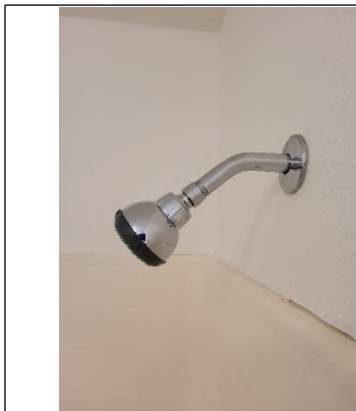
Thermal Imager shows hot water is present through spout.

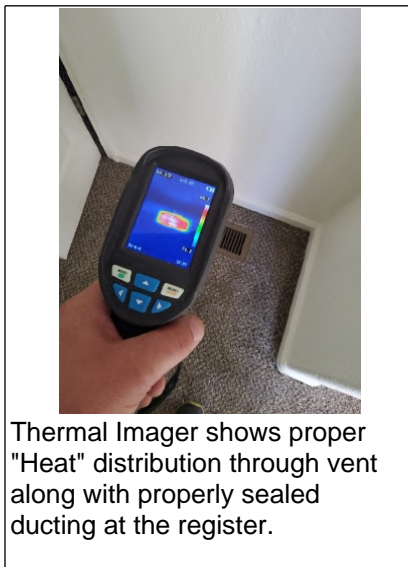
Thermal Imager shows proper "Heat" distribution through vent along with properly sealed ducting at the register.

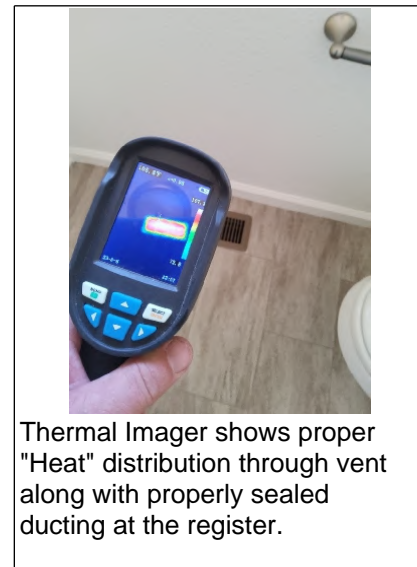
Thermal Imager shows proper "Heat" distribution through vent along with properly sealed ducting at the register.

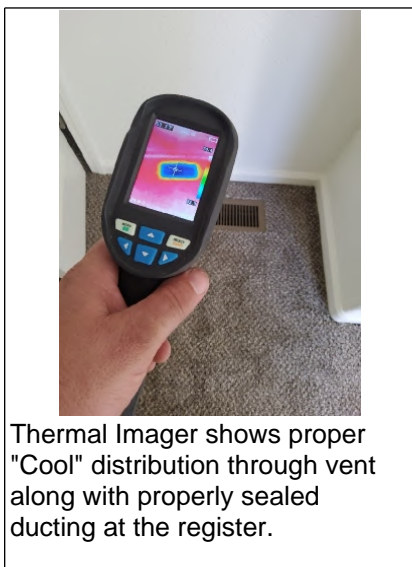
Thermal Imager shows proper "Cool" distribution through vent along with properly sealed ducting at the register.

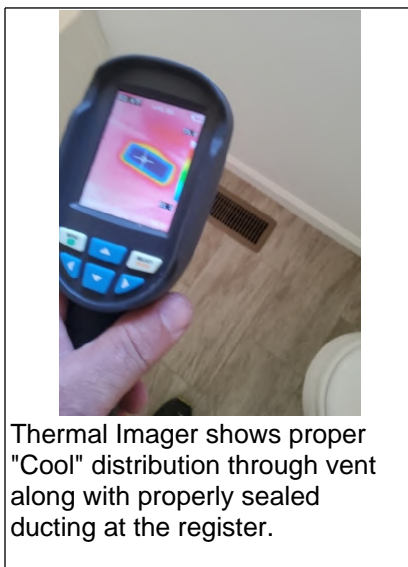
Thermal Imager shows proper "Cool" distribution through vent along with properly sealed ducting at the register.

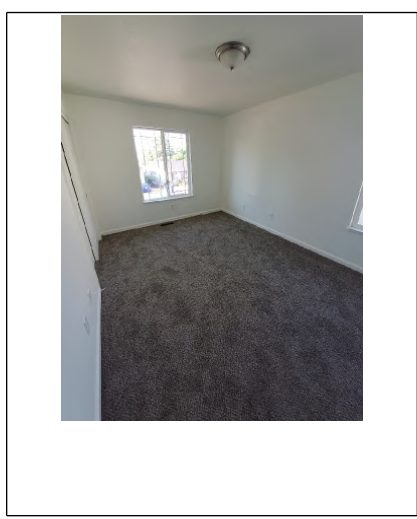
Laser level shows that the floor is properly level and is structurally sound.

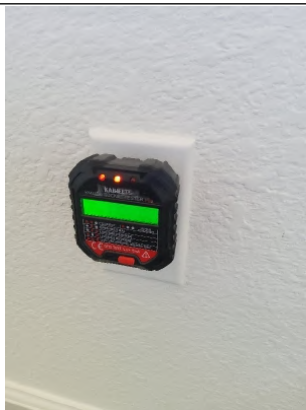
Electrical outlet shows proper operation, grounding and polarity.

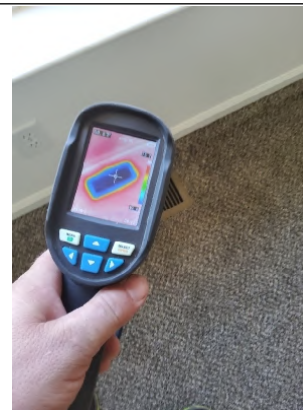
Thermal Imager shows proper "Cool" distribution through vent along with properly sealed ducting at the register.

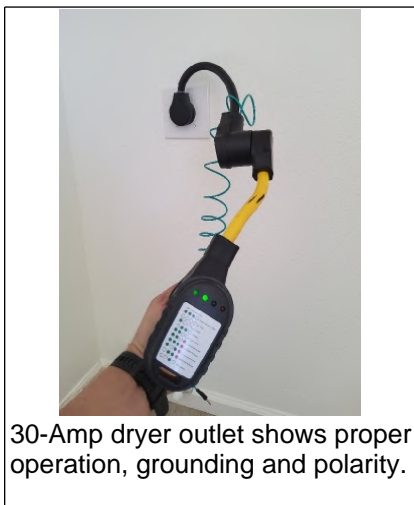
30-Amp dryer outlet shows proper operation, grounding and polarity.

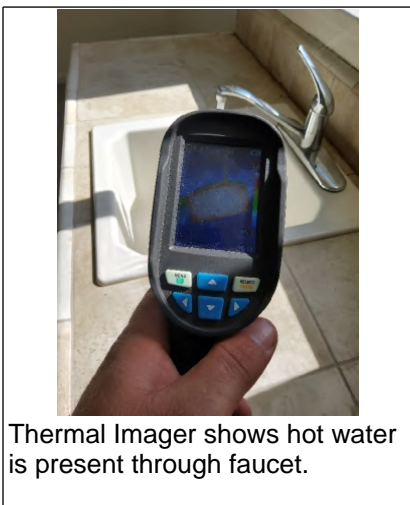
Thermal Imager shows hot water is present through faucet.

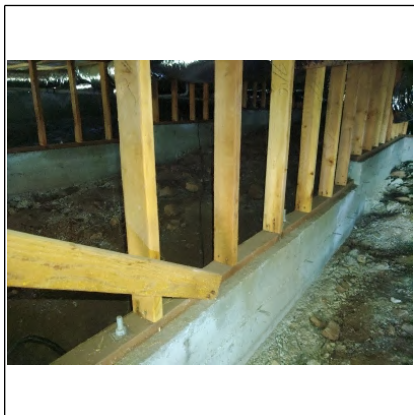
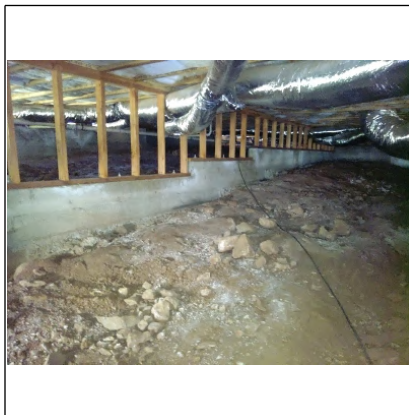
Cripple Stem Wall

Comments *The best interior design for structural support is a full cripple wall with its own footing spanning from each end of the perimeter wall and this home has that. With a girder post interior wall you often get sags and if not crowned correctly (crowned down) you will often see a sag in the floor which at times could create a sag in the roof line depending on the truss or rafter layout and type of roof. With a full interior cripple wall you have a 16" on center cripple spacing with 2x4 s. By string living from end to end you get a perfect level floor. Some will say full concrete interior walls are better but the argument can be made they lack ventilation. Reality is with girder members you cannot ever expect all 16 to 20 girder members to come straight from the lumber yard and 90 percent of the builders will not return the bad lumber. A crowned girder will create unlevel floors and at times dips in the ridge line. Lastly, the dead load weight is spread out throughout the span from end to end where as post and girder is focused on the weight load on the columns and footings.*

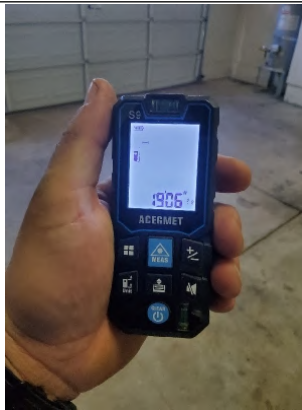
Garage Floor measures 19'06" wide.

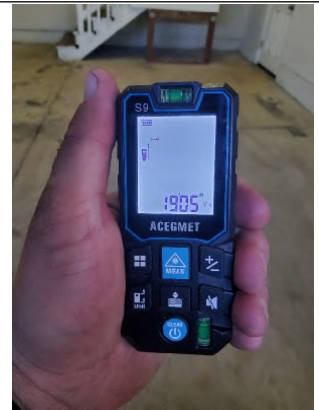
Garage Floor measures 19'05" long from garage door to staircase.

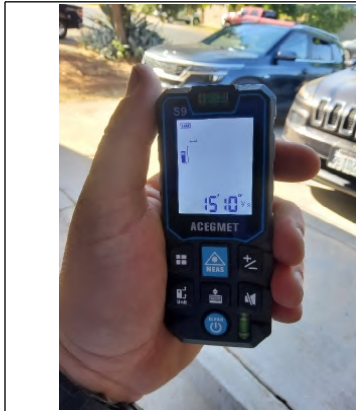
Garage Door opening measures 15'10" wide.

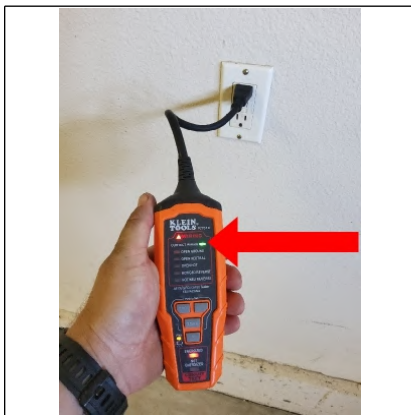
Electrical outlet shows proper operation, grounding and polarity.
