Home Inspection Report

3911 Villa Ave, Clearlake , CA 95422

Saturday September 19, 2020

Dustin Wallace Home Inspections & Construction
16496 Main St.
Lower Lake, CA 95457
(707) 293-6307
dustinjameswallace1985@gmail.com

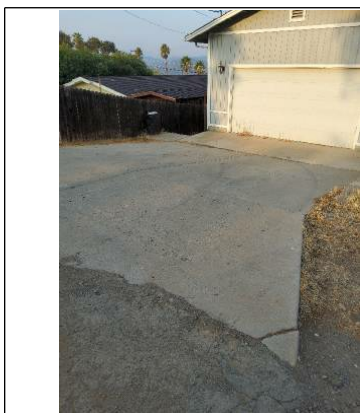
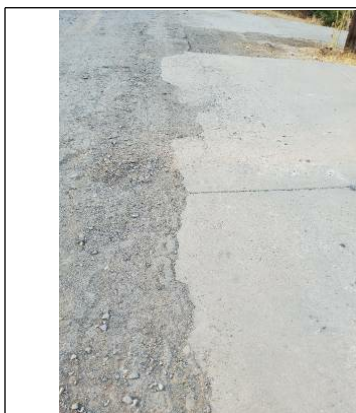
I could not notice is there was proper drainage in front of the garage door but should not be a major concern as the slope degree is not to vertical to cause any water to get into the garage.

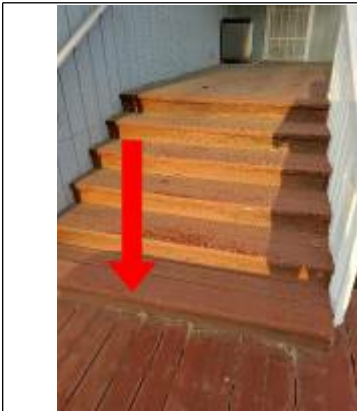
Bottom tread needs to be refastened.

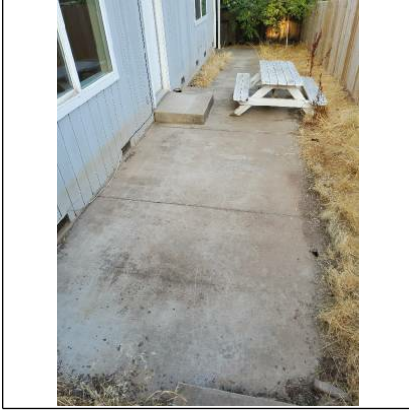
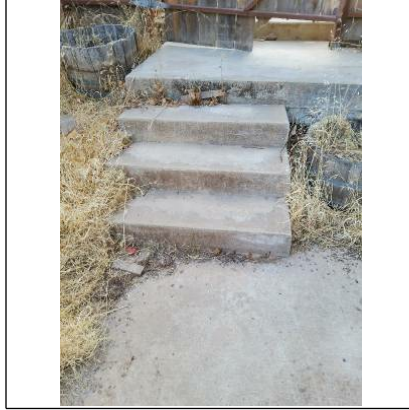
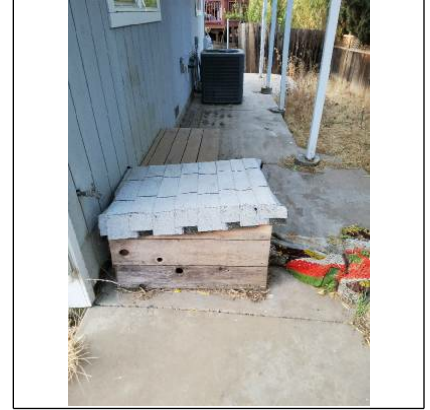
Slab is in still good shape

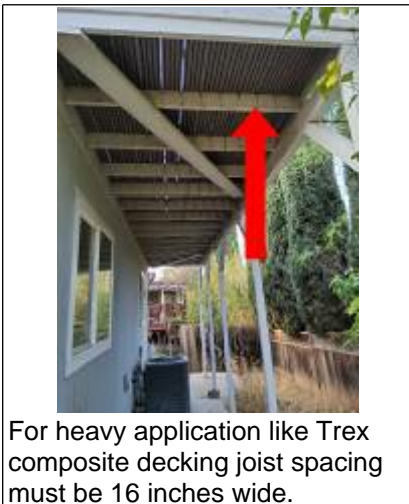
The only issue I have is if that for composite "Trex" planks the joist spacing must be 16 inches and not 24 inches therefore if potential sagging is shown more joist support must be installed.

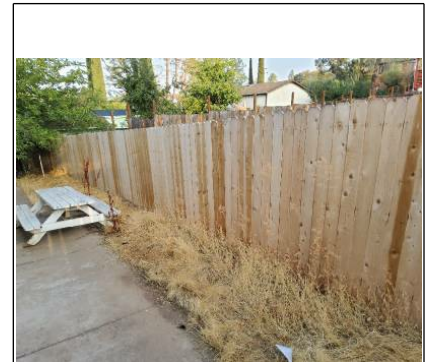
Fence needs to be fixed possible damage from neighbor dog.

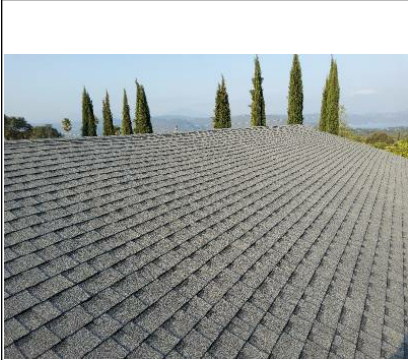
This section is showing moss build up this is a simple fix if done right. Do not spray the roof with a hose as this erode the shingles. Instead apply something like "Wet-and-Forget" Moss killer you can get at walmart or order online spray it on and carefully use a chisel or knife not sharp and pick off the moss.

I would recommend putting "Wet-and-Forget" Moss killer on the section of the house that has moss buildup I have myself used a flat screwdriver and knife and carefully picked off the moss so it doesn't grow back especially since we are approaching colder months.

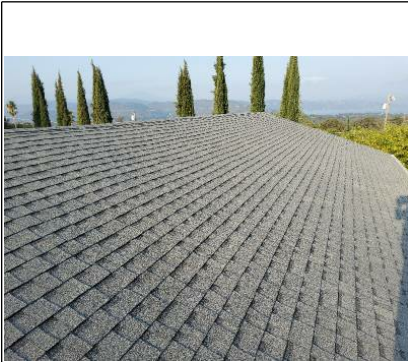
This is a very common incident where the girder of garage and gable meet and with no sun you see moisture buildup and that creates green stain on shingles just apply the same formula on the moss on this and it should start clearing up in a few weeks.

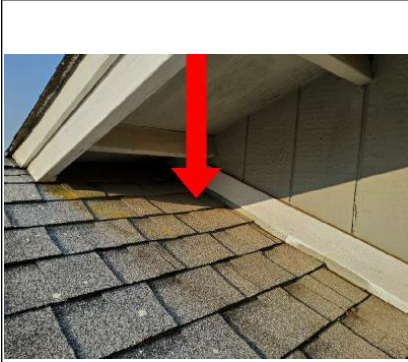
Even my roof has this problem this is just an issue that happens where one gable (house) meets the girder (garage) luckily there is plenty of good flashing so water is not petruding into the home.

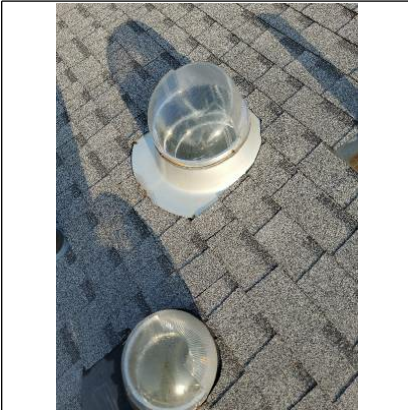
Not issues or cracking observed.

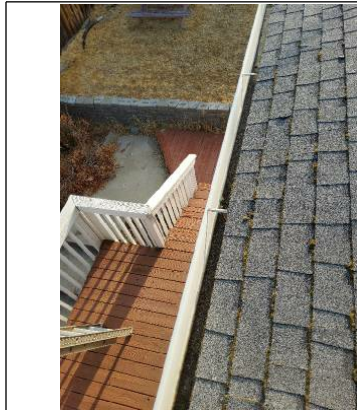
Comments Gutters were in overall adequate condition. Because there are no trees in the vicinity gutter covers really wont make much of a difference.

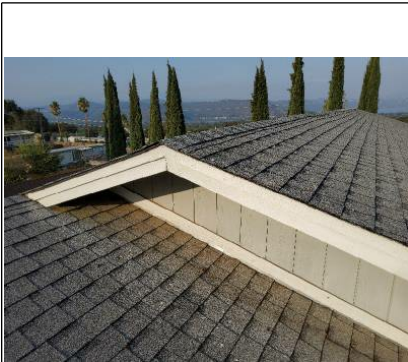
Comments Trim had some deterioration recommend repair and painting

Wood to dirt contact this cause the trim side to rot.

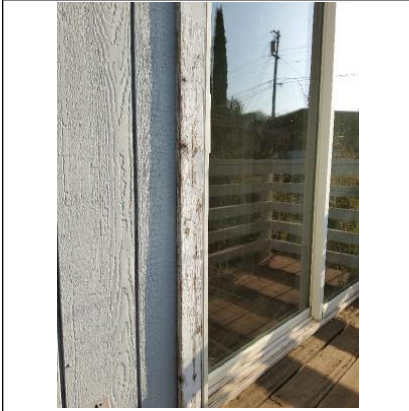
Trim needs to be resanded and repainted.

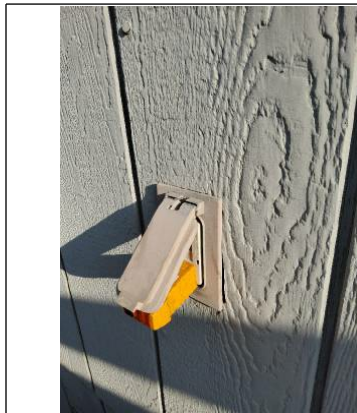
Open neutral on side of house.

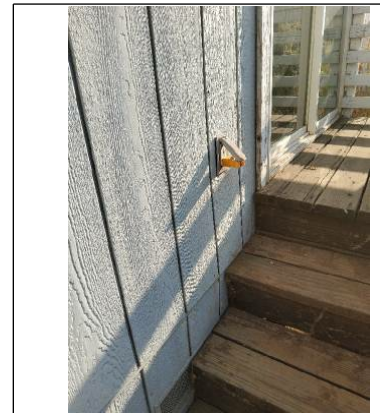
Open Nuetral on outlet detected.

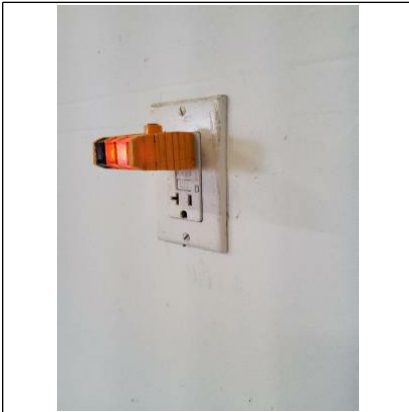
Comments GFCI is properly working.

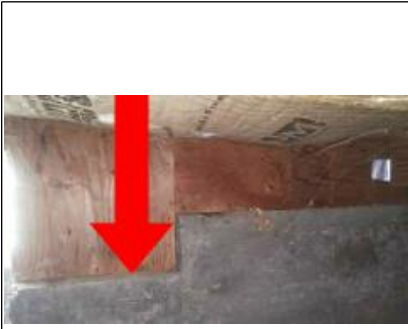
Crawl Space

areas of wood that are not treated that are in direct contact with concrete should be treated with copper-green.

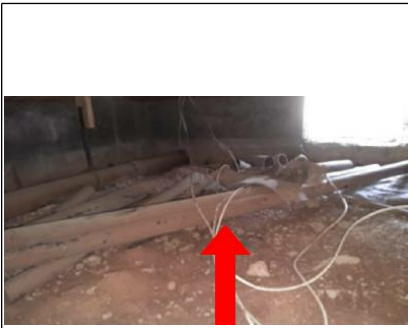
debris needs to be removed.

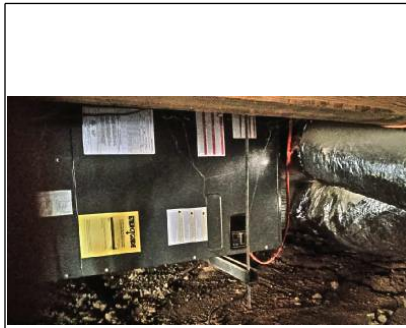
Clean mechanical work on the Forced-Air unit

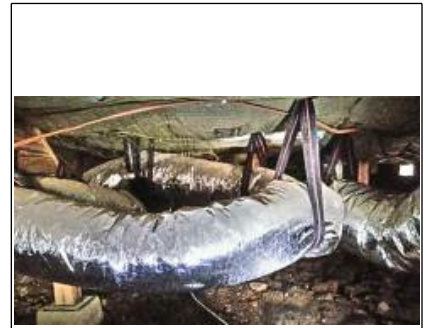
Proper insulation and well strapped ducting.

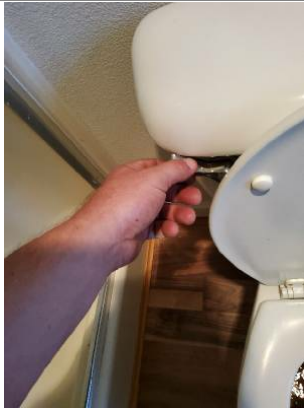
Master Bathroom

I shut off the valve so the toilet
wouldnt keep running.

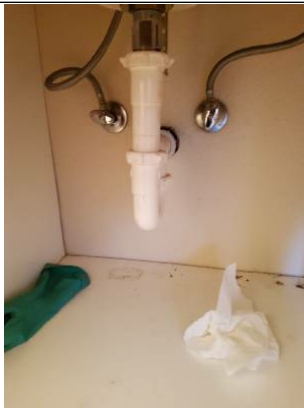
Comments Recommend replacing the flex lines. Replacing the toilet.

I have adjusted flex lines underneath to be turned on and still no water. Recommend when having hot water heater replaced have plumber check this out. Could be clogged o ring

Recommend replacing toilet.

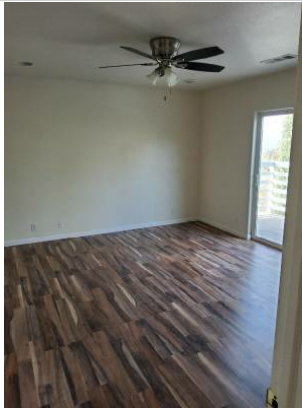
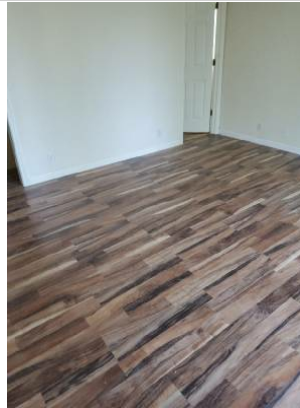
Missing light fixtures in two openings.
