# Home Inspection Report

16289 Ponderosa Dr., Cobb, CA 95426

Saturday February 29, 2020

Dustin J. Wallace Construction and Home Inspections  
16496 Main St.  
Lower Lake, CA 95457  
(707) 293-6307  
dustinjameswallace1985@gmail.com

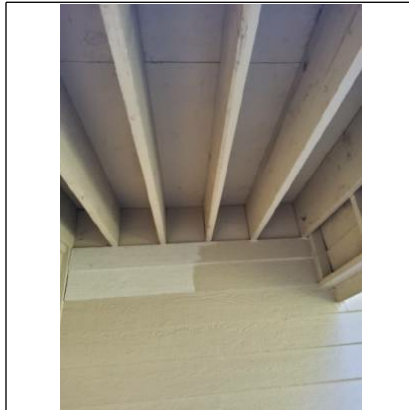
**Comments** Excellent structural support. Railing in good shape.

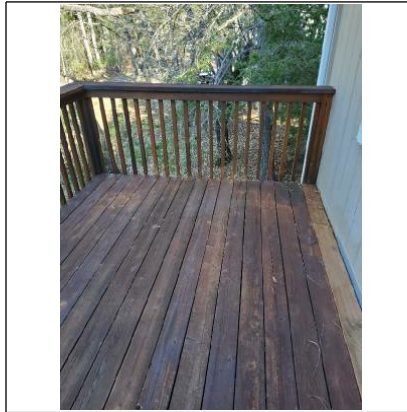
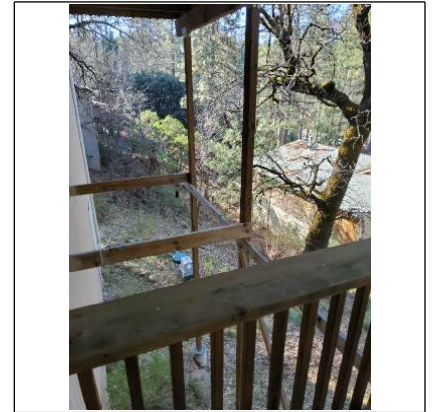
**Comments** Some squeeks. Recommend painting or treating wood. Small repairs. Railing could be fastened better. Bracing is showing structural support for posts. Which is critical.

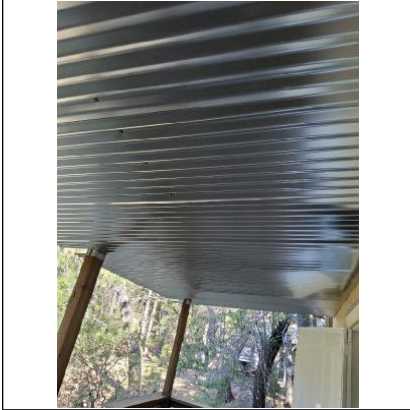
**Comments** Good condition

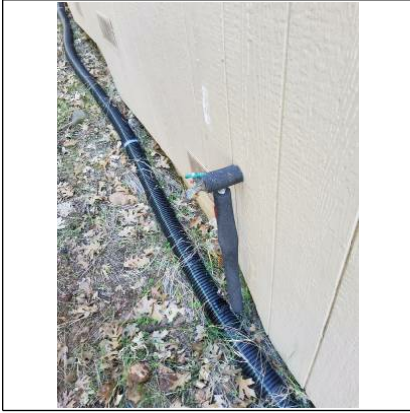
**Comments** Loose hose bib. Minor

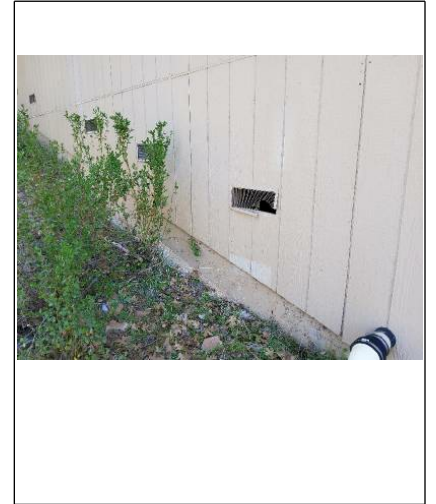
No Possible Drain Tile?  
recommend a diversion away  
from the foundation of the house

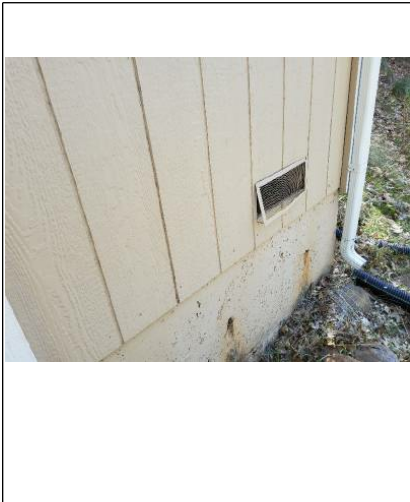
Steps are needed for access

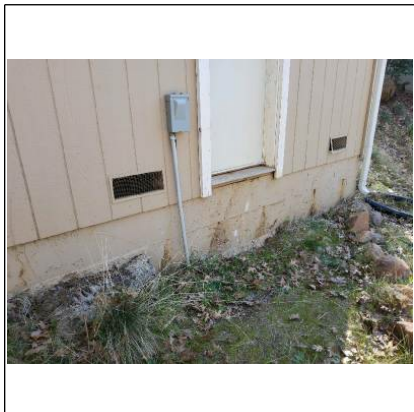
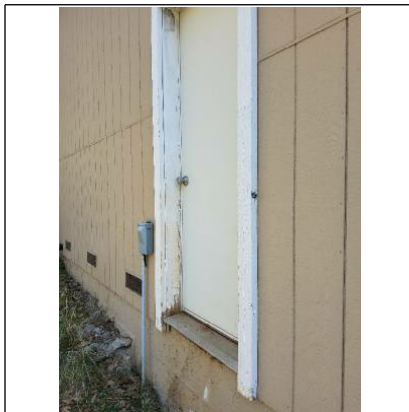
**Comments** Just paint and chalking

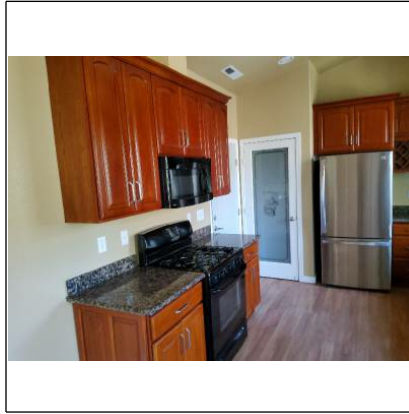
**Comments** Cabinets in excellent condition

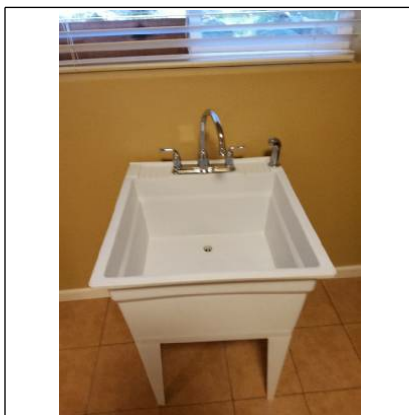
**Comments** Recommend support to wall on sink

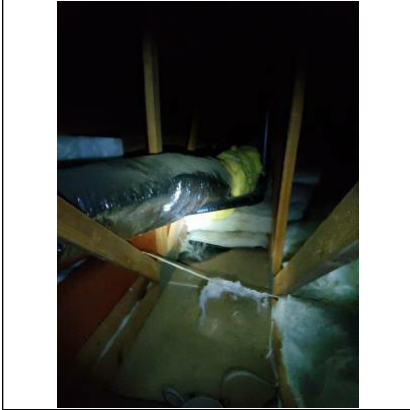
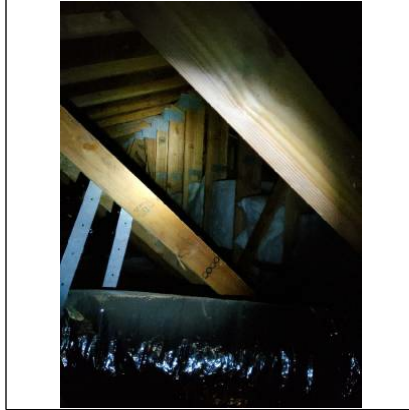
**Comments** Need switch at access and a light for attic

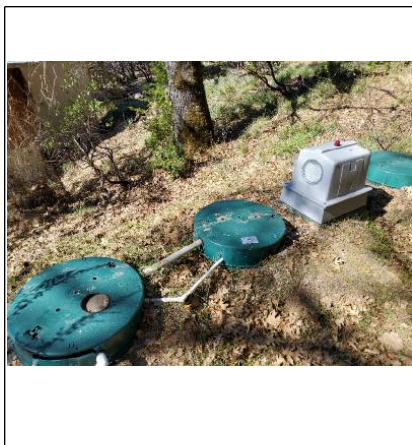
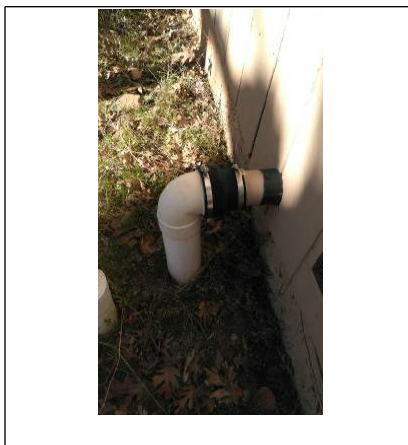
Crack on the side

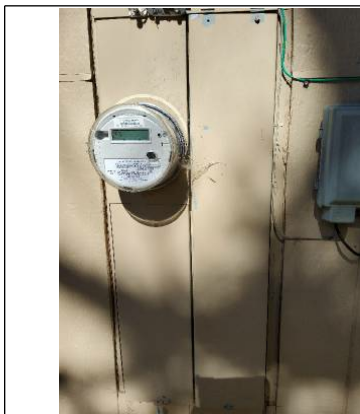
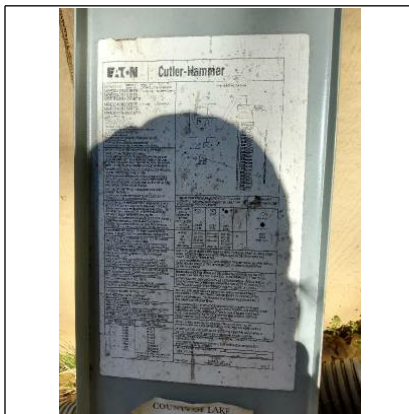
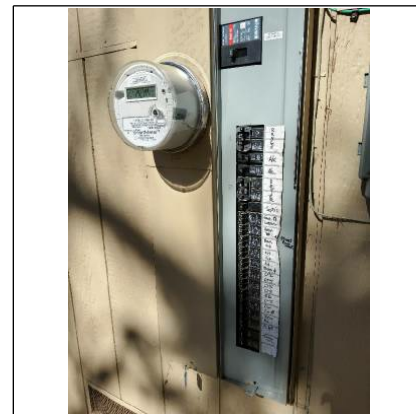
**Comments** The Main Panel box must be sealed from outside elements. From the crawl space view clearly you can see daylight through the top and bottom of the panel box. Recommend proper trim and chalking

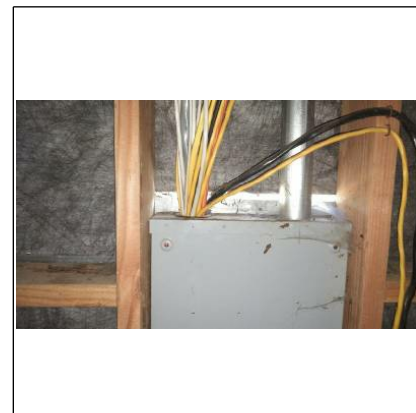
this is open light behind the panel box in the crawl space this needs to be addressed

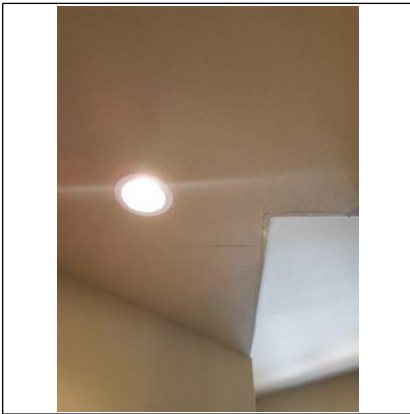
**Comments** Crack in drywall entry into living room

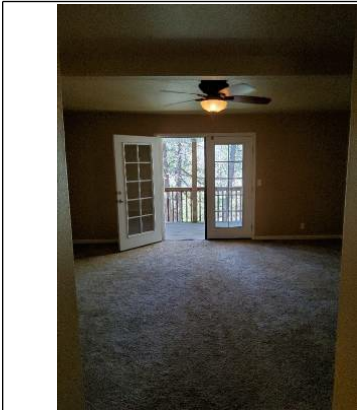
**Comments** Some drywall repairs needed

Drywall Damage

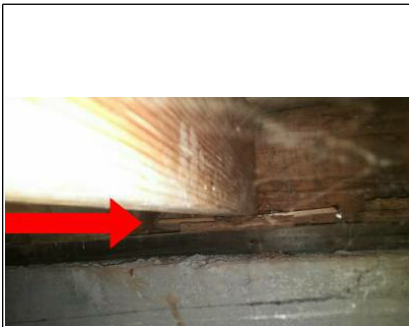
Double OSB shimmed with a painters shim between the joist and mudsill. As a licensed Contractor this completely unacceptable.

Painters shim

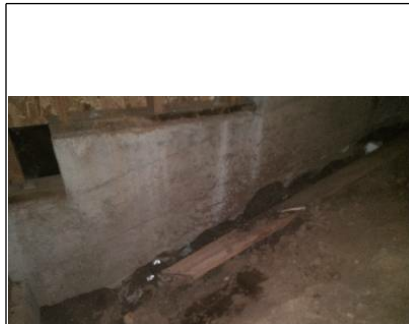
Debris

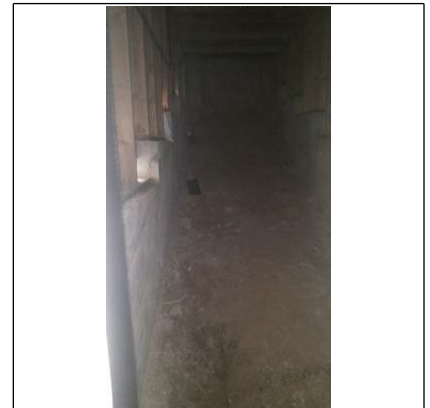
Debris

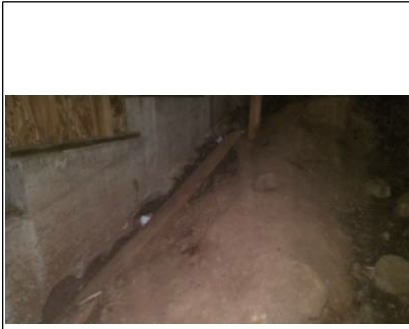
Debri

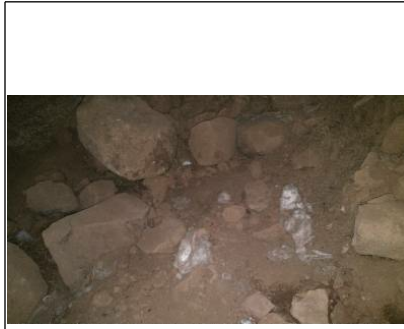
Debri (lots of Debri on the floor)

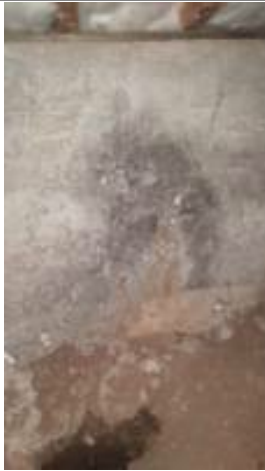
There is a serious issue with this location of the foundation wall. Water damage is noted on the foundation.

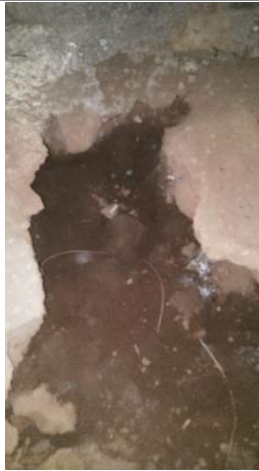
This is the result of either no drain system installed or clogged drain pipe. Either way a proper drain in front of the foundation must be installed.

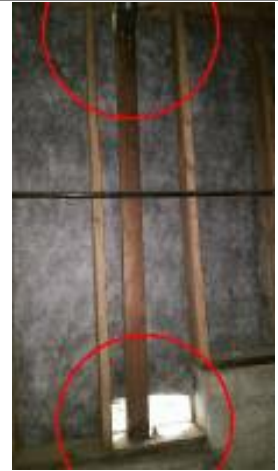
This is a structural support leaned out of square by more than two inches that supporting the girder to the front entry porch. This needs to be addressed by a structural engineer. This was installed "hack job" to avoid the anchor bolt.

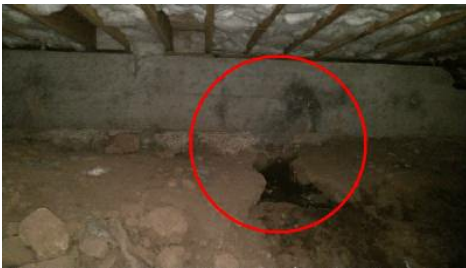
Water damage from lack of drain tile or clogged. General Contractor has structural liability for 10 years notify if a drain tile was installed during the new construction. However this home being built in 2009 would release liability.
