Home Inspection Report

18279 Hidden Valley Road, Hidden Valley Lake , CA 95467

Monday August 14, 2023

Dustin Wallace General Contractor Home Inspections
16496 Main St.
Lower Lake, CA 95457
(707) 293-6307
dustinjameswallace1985@gmail.com

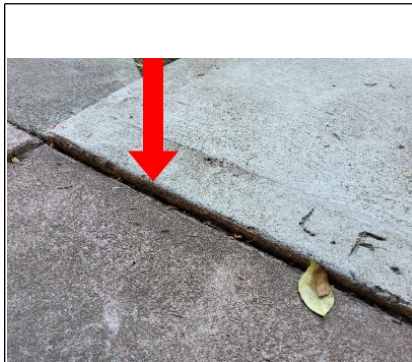
Tripping hazard

Comments 1. There are noted tripping hazards between different pours at the expansion joint locations. These areas should be resurfaced by a Licensed Contractor .

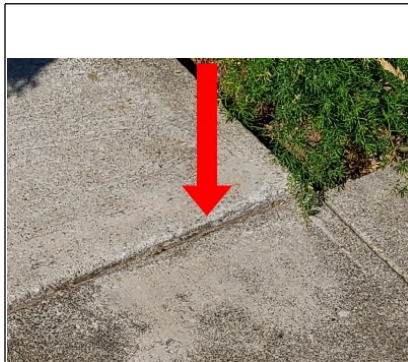
Tripping hazard

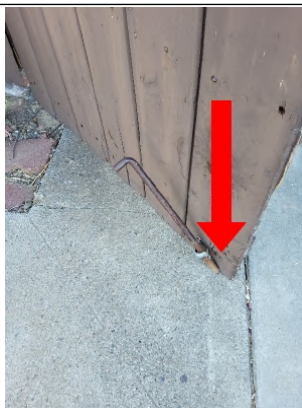
Gate is rubbing concrete slab. Recommend having gate properly releveled as well as having hinges replaced.

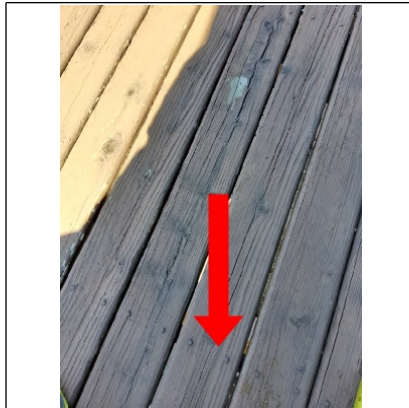
Plank members are loose. Recommend removing existing nails and refastening with 4" exterior screws.

2. Plank members are loose. Recommend removing existing nails and refastening with 4" exterior screws.

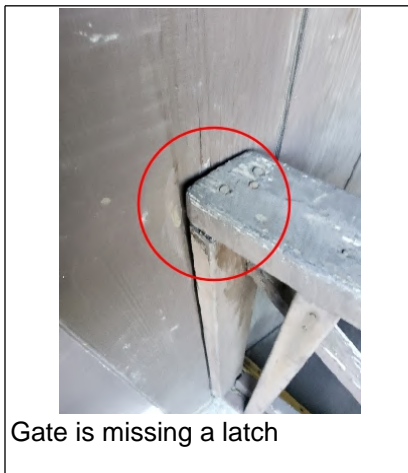
Gate is missing a latch

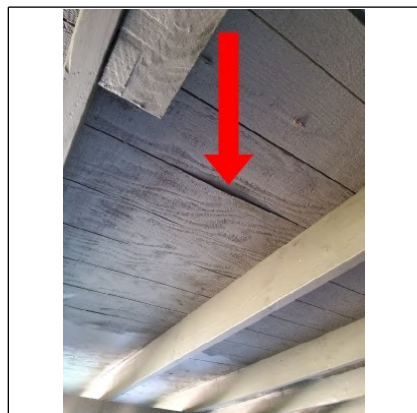
This is not of structural concern do not touch. This is T and G planking and the bottom female lip is just slightly damaged.

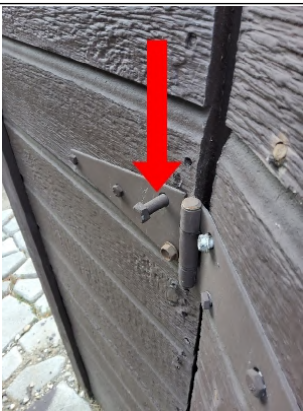
Loose lags

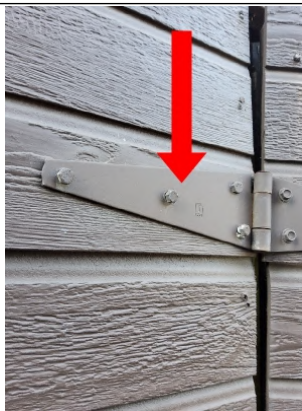
Loose hinge

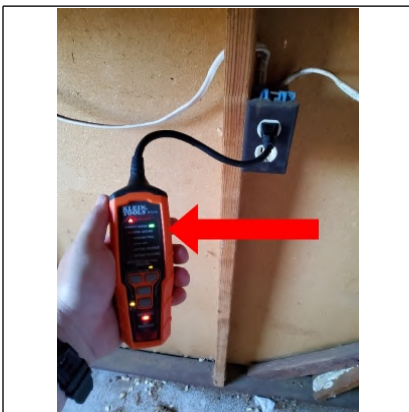
Electrical outlet shows proper operation, grounding and polarity.

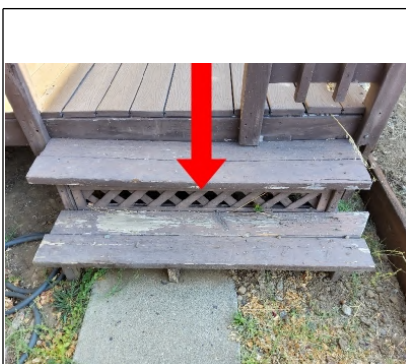
3. Recommend having steps replaced by a Licensed Contractor. Stringer space should not exceed 2' on center for standard wood tread members and is not installed or build correctly.

Recommend having steps replaced by a Licensed Contractor. Stringer space should not exceed 2' on center for standard wood tread members and is not installed or build correctly.

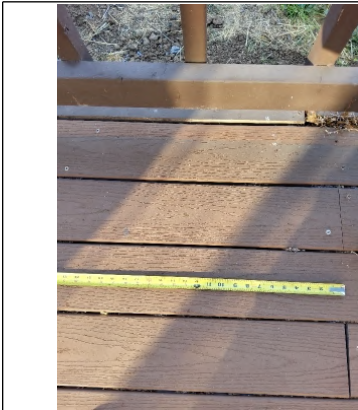
Joist layout is 2' on center.

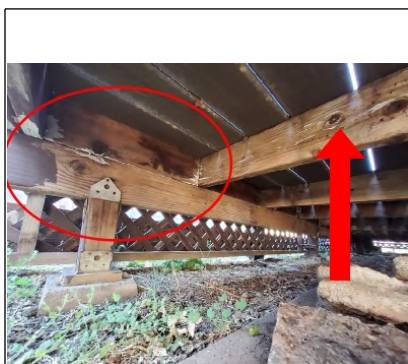
Fungus is evident on both joist and girder members. Recommend having properly treated and removed by a Licensed Pest Control Company.

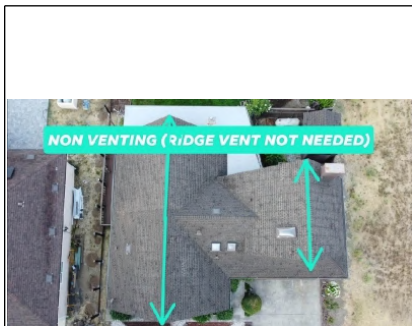
These locations are non venting locations at the ridge and are to not be vented.

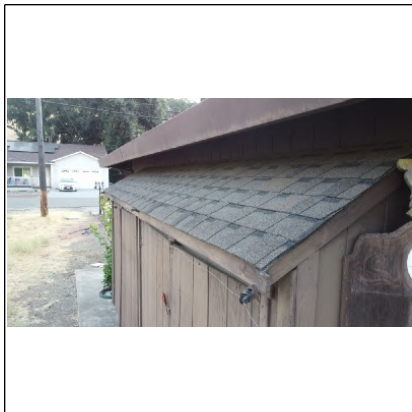
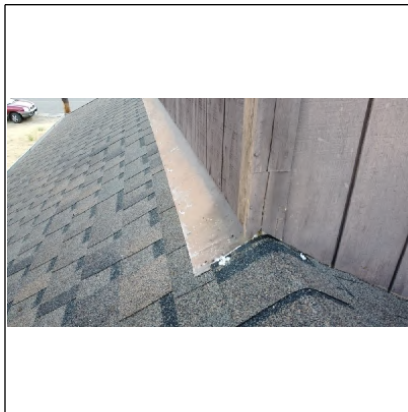
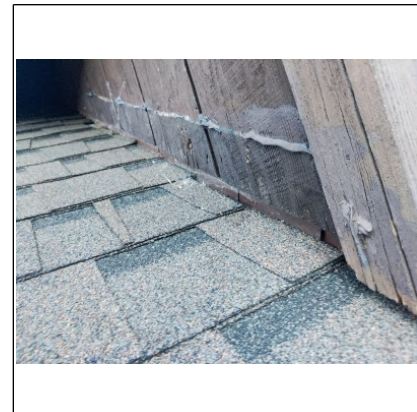
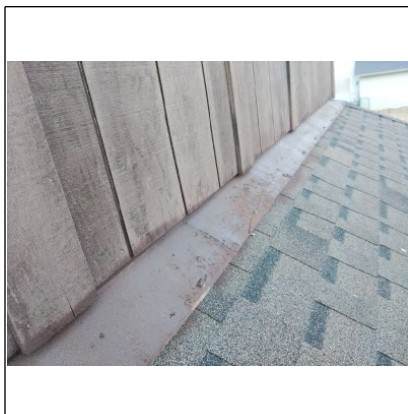
Comments **1. The roof shingles were never properly masked off. Overspray from spray paint is evident on shingles around the flashing. For now this is of no concern but will age the shingle locations significantly.**

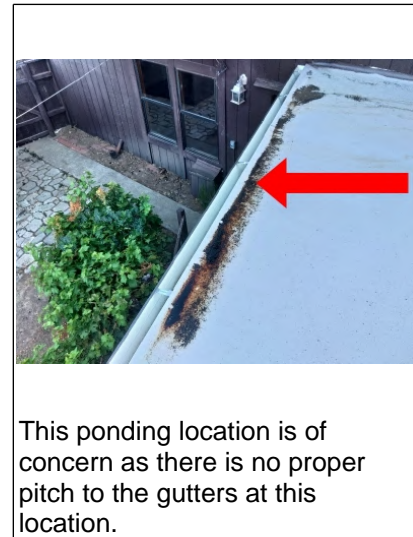
Comments **1. The ponding location that is noted in the pictures should be repaired by a Licensed General B Contractor or Licensed C39 Roofing Contractor.**

This ponding location is of concern as there is no proper pitch to the gutters at this location.

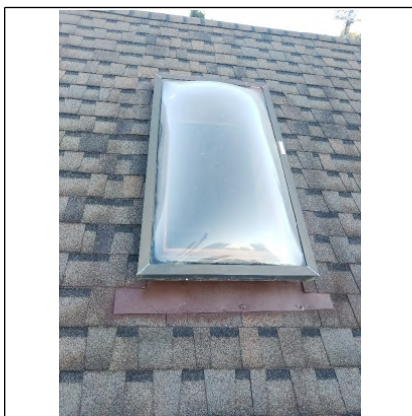
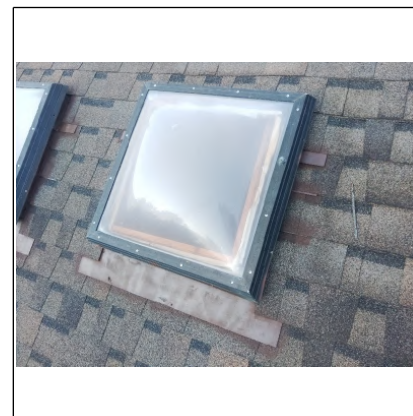
Comments **1. The roof shingles were never properly masked off. Overspray from spray paint is evident on shingles around the flashing. For now this is of no concern but will age the shingle locations significantly.**

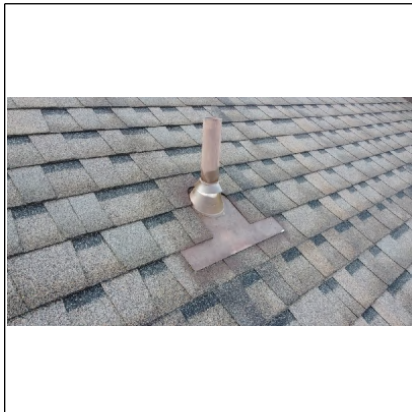
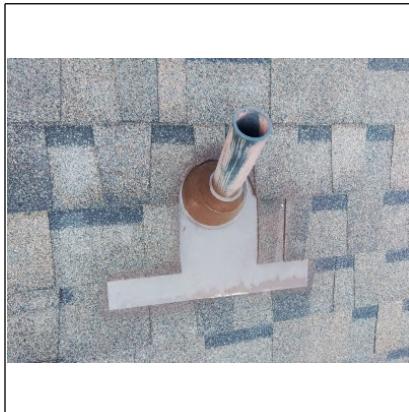
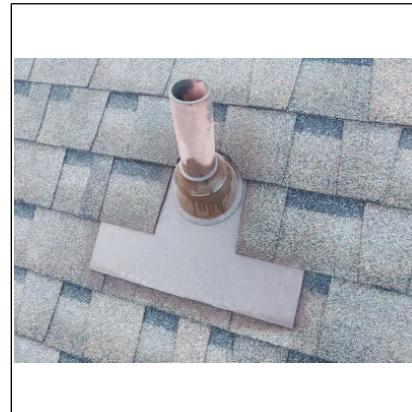
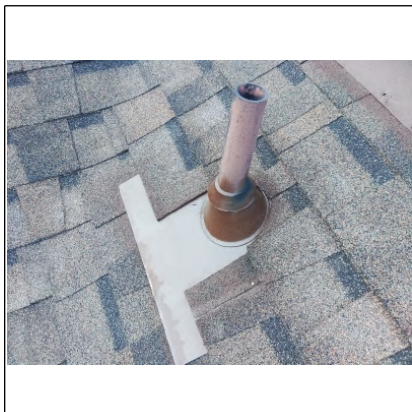
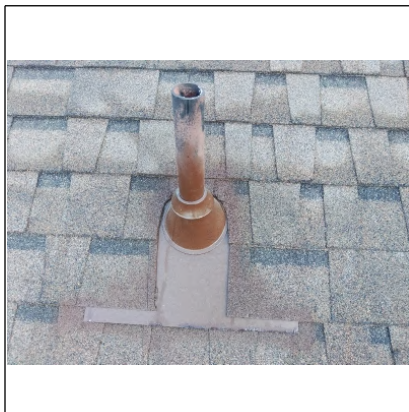
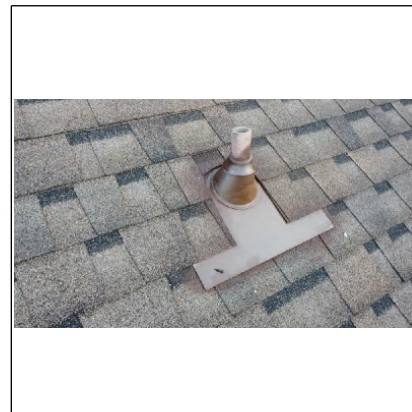
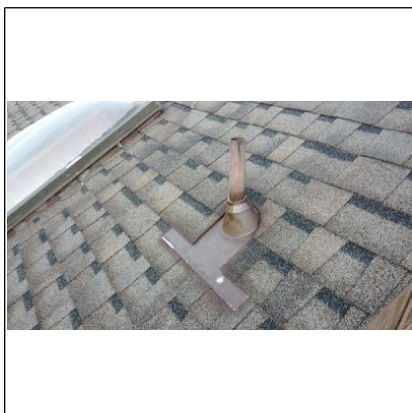
Comments cont. **shingles around the roof jacks. For now this is of no concern but will age the shingle locations significantly.**

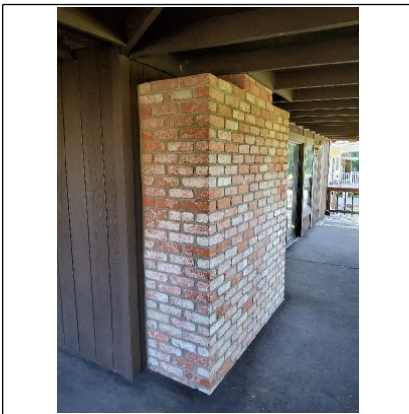
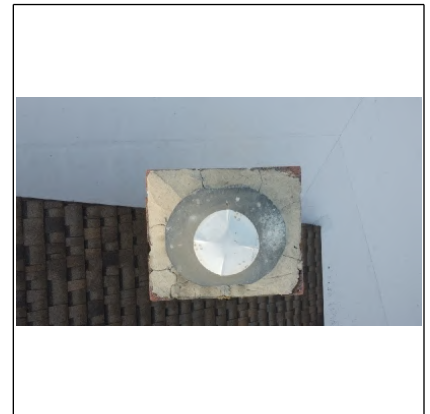
Comments **1. Mortar cracks are evident on chimney chase. Recommend having repaired by a Licensed Chimney Specialist.**

Mortar cracks are evident on chimney chase. Recommend having repaired by a Licensed Chimney Specialist.

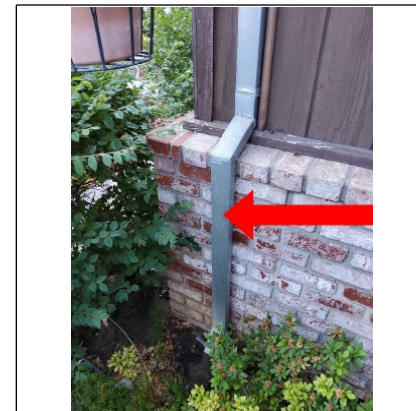
Loose downspout

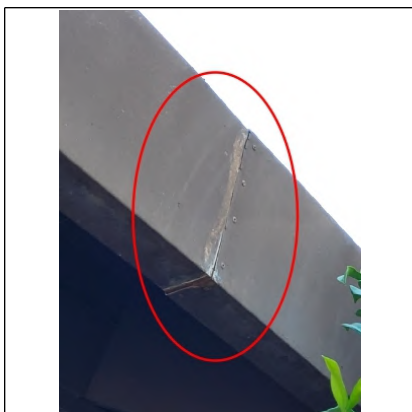
Active leak

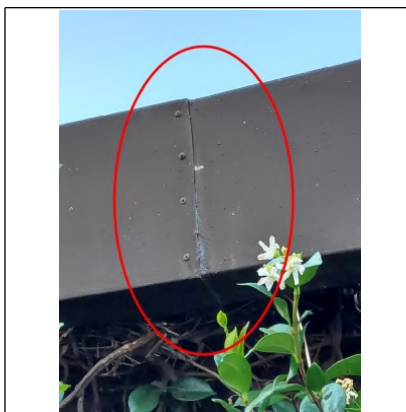
Active leak

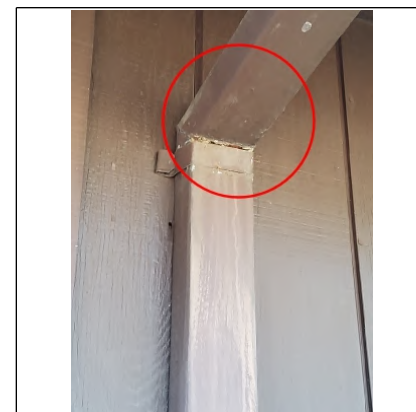
Active leak

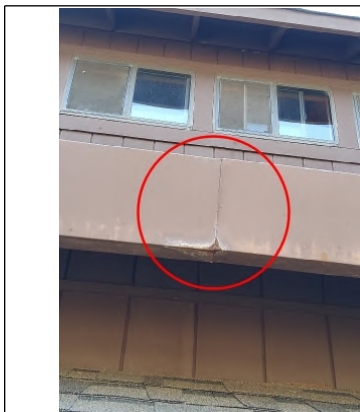
Active leak

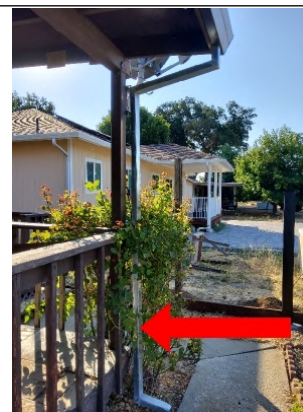
Loose downspout

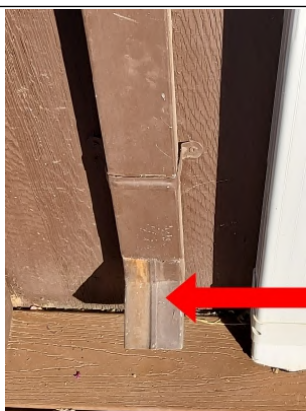
Damaged elbow

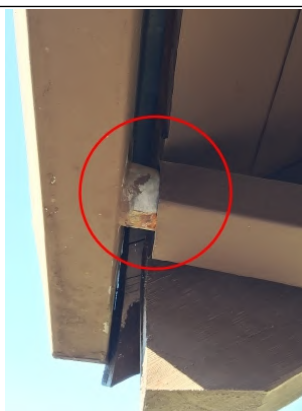
Loose downspout

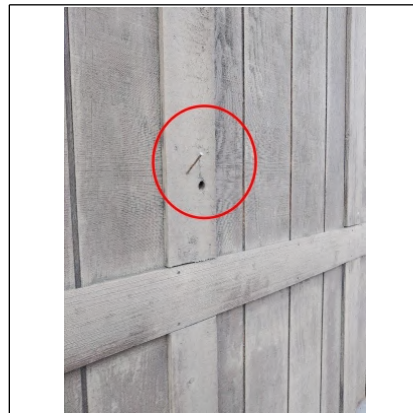
Recommend removing hangnail

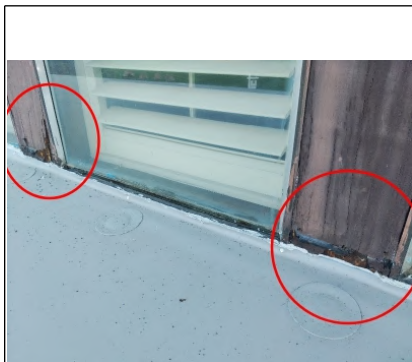
Moisture damage is evident at this section of siding.
Recommend cutting back damaged sections of siding place new z-bar and install a 1x4 bottom exterior trim member 1/2" off the TPO covering.

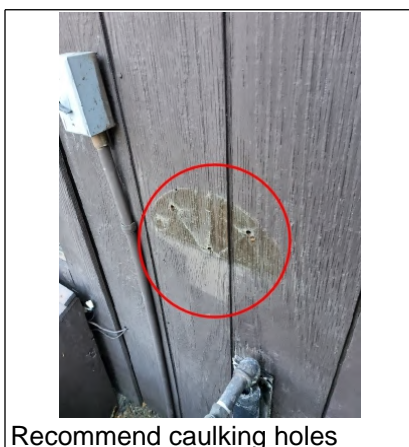
Recommend caulking holes

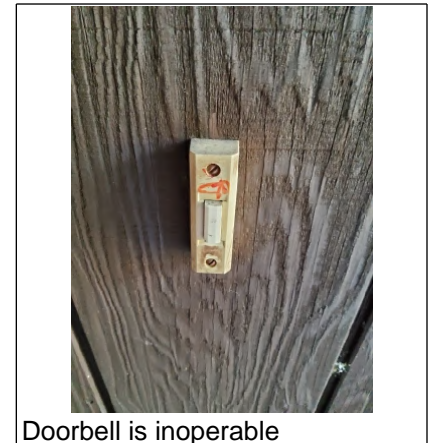
Doorbell is inoperable

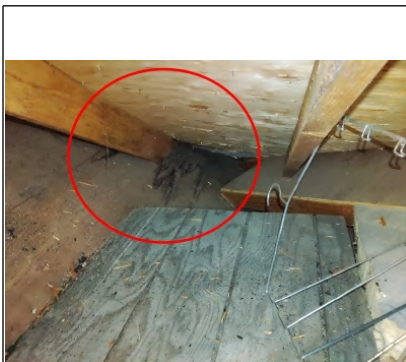
Old water stains from prior roof.

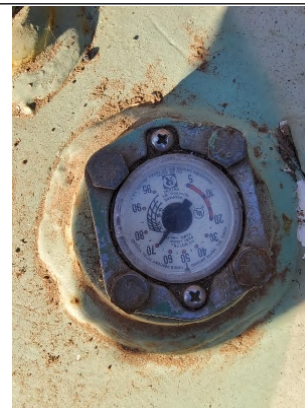
Propane tank is 70 percent full during time of inspection.

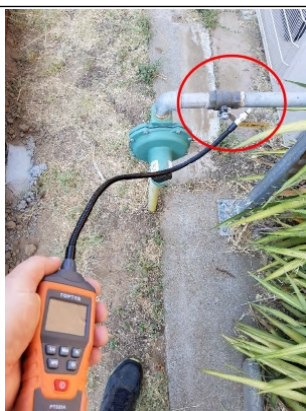
No leaks were detected on shut off valve.

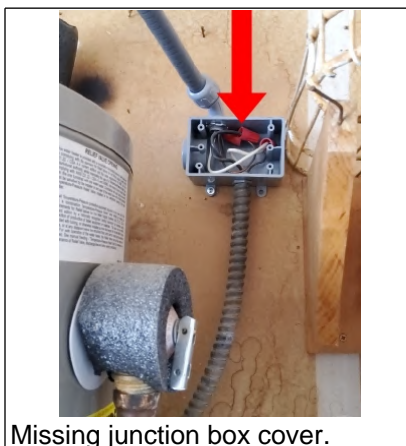
Missing junction box cover.

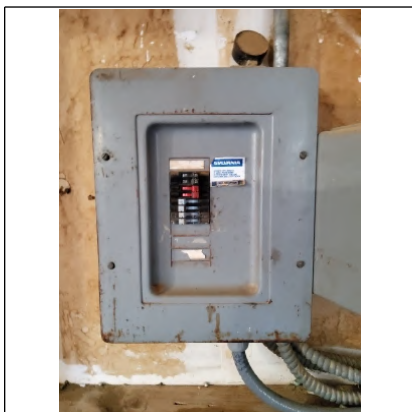
Condition Satisfactory Marginal **Poor**

Comments **1. Recommend having subpanel replaced by a Licensed Electrician.**

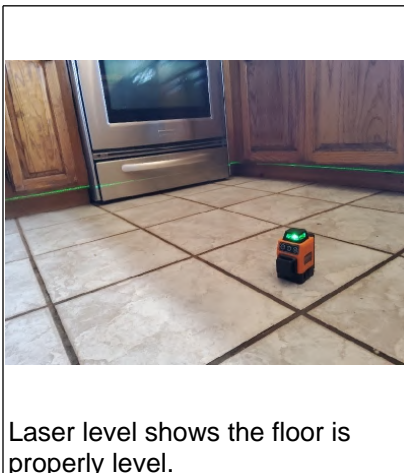
Laser level shows the floor is properly level.

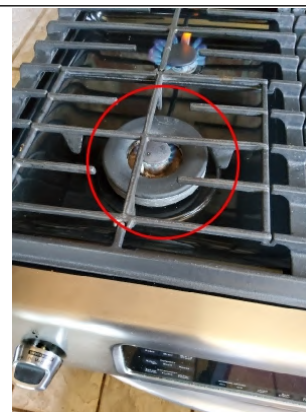
Comments **1. Noted burner has a low flame. Recommend having repaired by an Appliance Specialist.**

Noted burner has a low flame. Recommend having repaired by an Appliance Specialist.

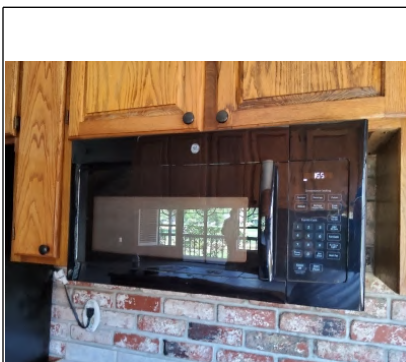
Microwave shows proper operation

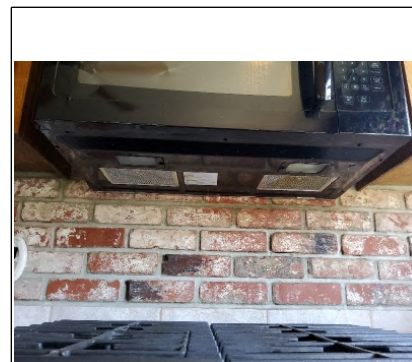
Exhaust fan shows proper operation.

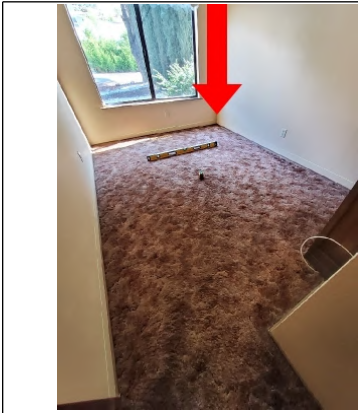
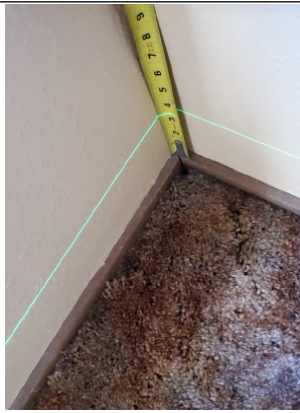
Laser level and 4' level were placed in the center of the room to show there is a 1" settling dip at the arrow location. There isn't much that can be done about that would bring any gain. Just get used to a slightly sloped floor.

Left side measures 3-1/4"

Right side measures 2-1/4"

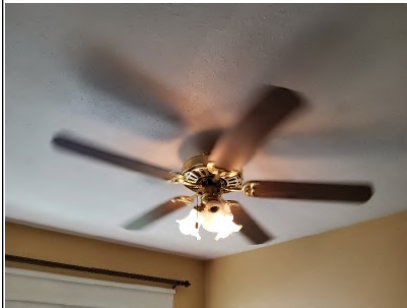
Comments 1. Ceiling fan is noisy. Recommend having repaired by a Licensed Electrician.

Ceiling fan is noisy. Recommend having repaired by a Licensed Electrician.

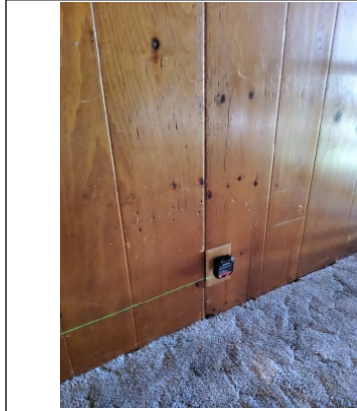
Electrical outlet is inoperable. Recommend having further evaluated and repaired by a Licensed Electrician.

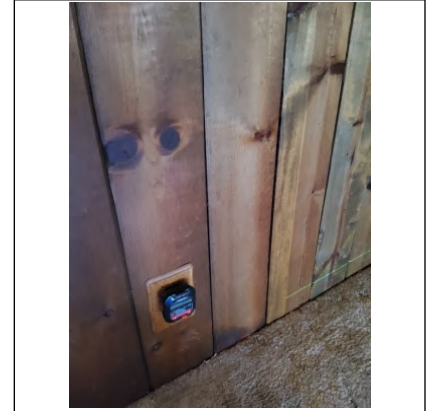
Comments 1. **Noted Electrical Outlets are inoperable. Recommend having further evaluated and repaired by a Licensed Electrician.**

Electrical outlet is inoperable. Recommend having further evaluated and repaired by a Licensed Electrician.

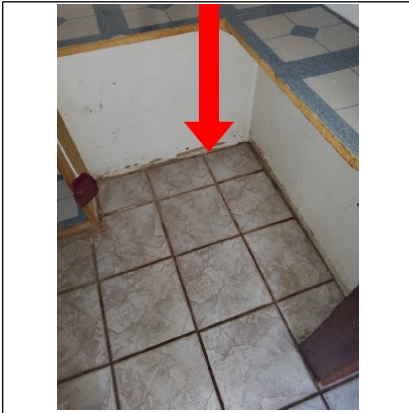
Missing baseboard

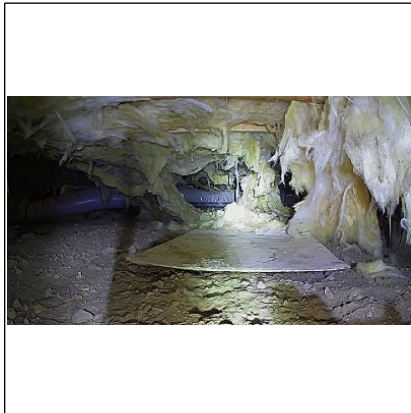
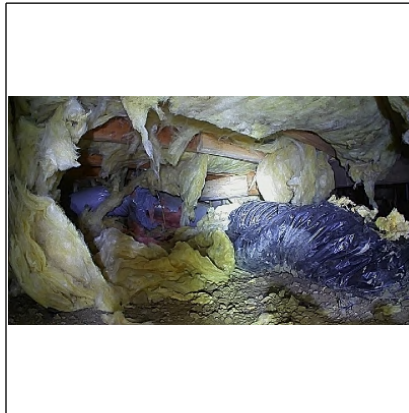
Comments 1. Recommend having all debri and loose insulation removed from the floor.

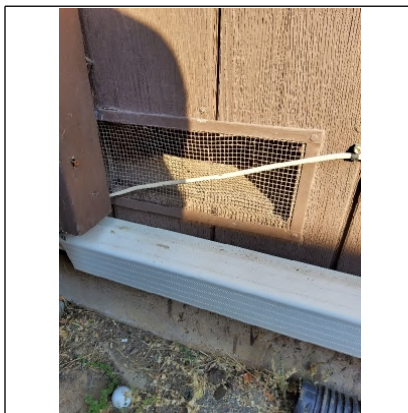
Recommend sealing off open vent location.

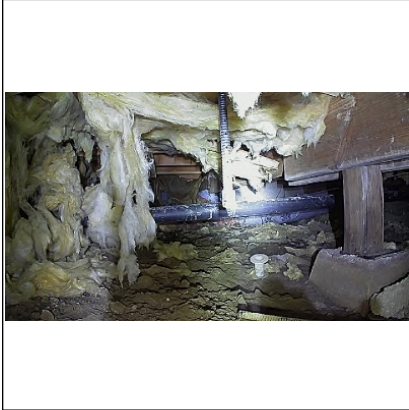
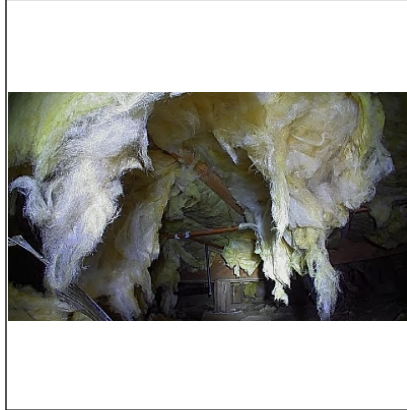
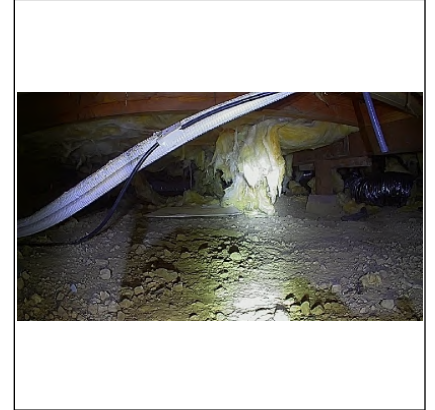
Comments **1. Recommend removing all insulation to provide proper ventilation in the crawl space. If new insulation batts are to be added then more vents will need to be installed to meet the minimum 1 vent per 150 sq ft.**

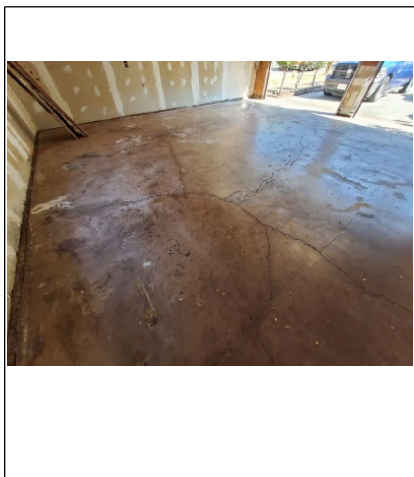
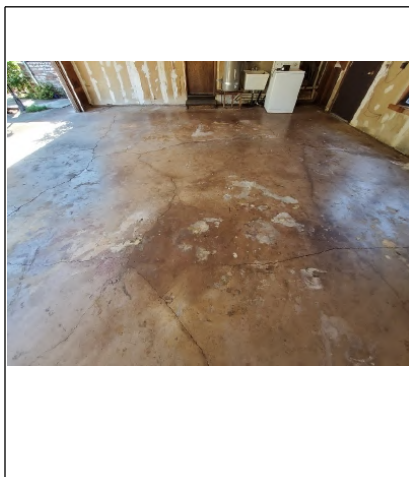
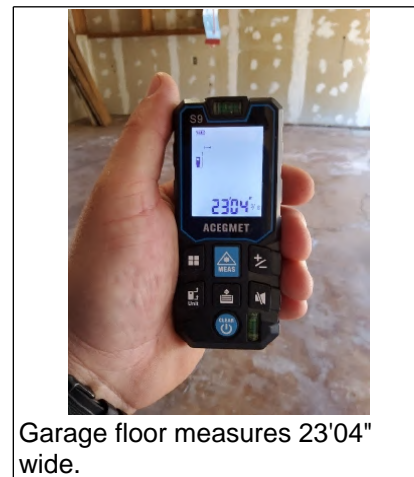
Garage floor measures 23'04" wide.

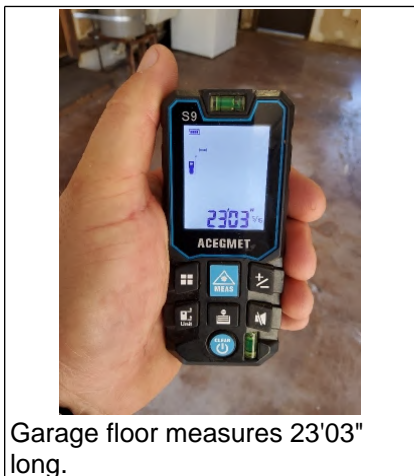
Garage floor measures 23'03" long.

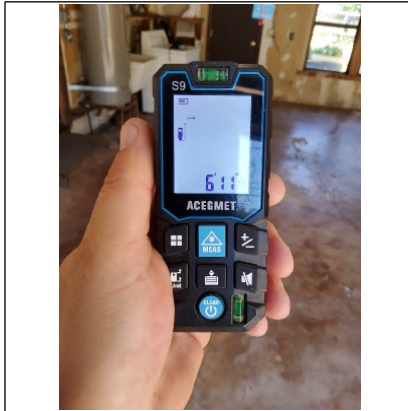
Garage opening measures 6'11" tall.

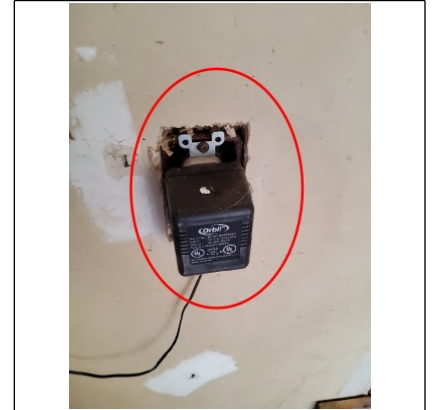
Missing coverplate

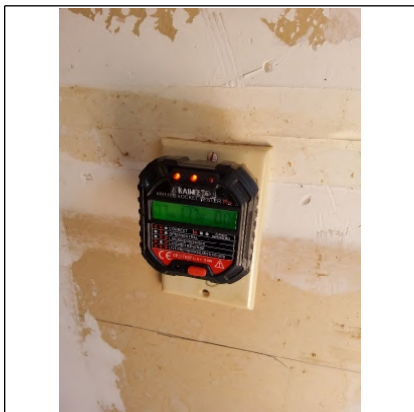
Electrical outlet shows proper operation, grounding and polarity.
