# Home Inspection Report

9472 Yaquima Drive, Kelseyville, CA 95451

Wednesday July 22, 2020

Dustin J. Wallace Construction and Home Inspections  
16496 Main St.  
Lower Lake, CA 95457  
(707) 293-6307  
dustinjameswallace1985@gmail.com

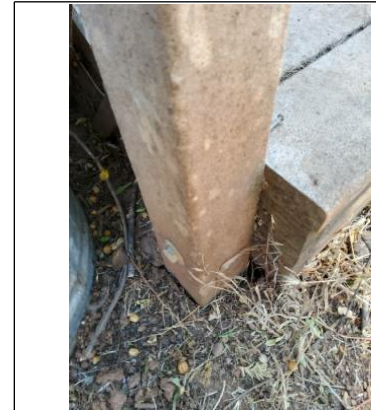
Not properly closing due hardware, installation and age.

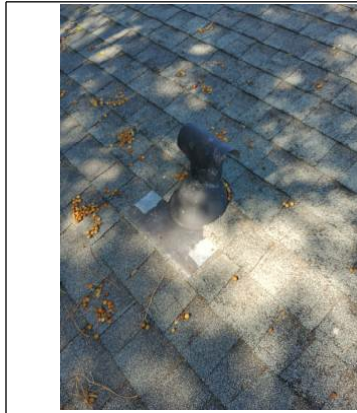
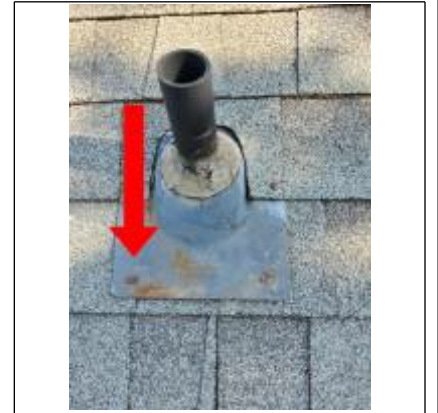
Again, rusted nails since nails are not to be used on exposed roof jacks. use a roofing tar over the nails to avoid future leaks.

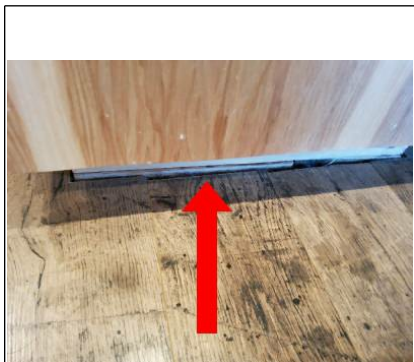
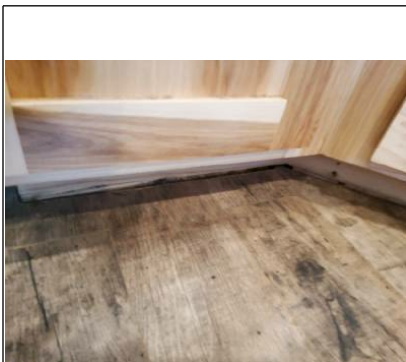
Toe kicks needed below cabinets.

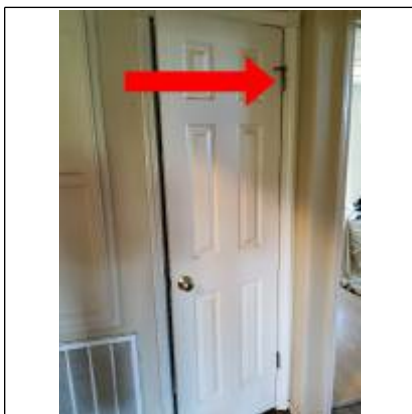
Run 3 inch screw in hinge to ease operation.

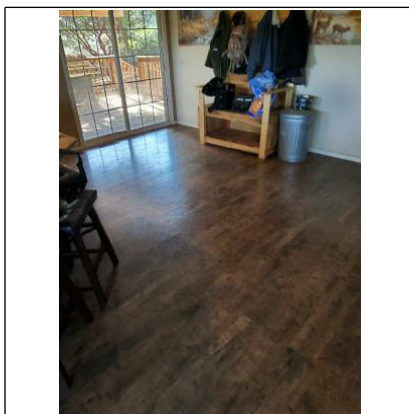
**Comments** Hardwood floor not properly installed. Install quarter round to baseboard to hide end cuts of flooring

install quarterround throughout house where ending cuts of hardwood floor are exposed.
